**RE – Noise Monitoring -Tharbogang Quarry and Landfill Operations 18-393**

Impact on six sensitive receivers adjacent to quarry and landfill operations

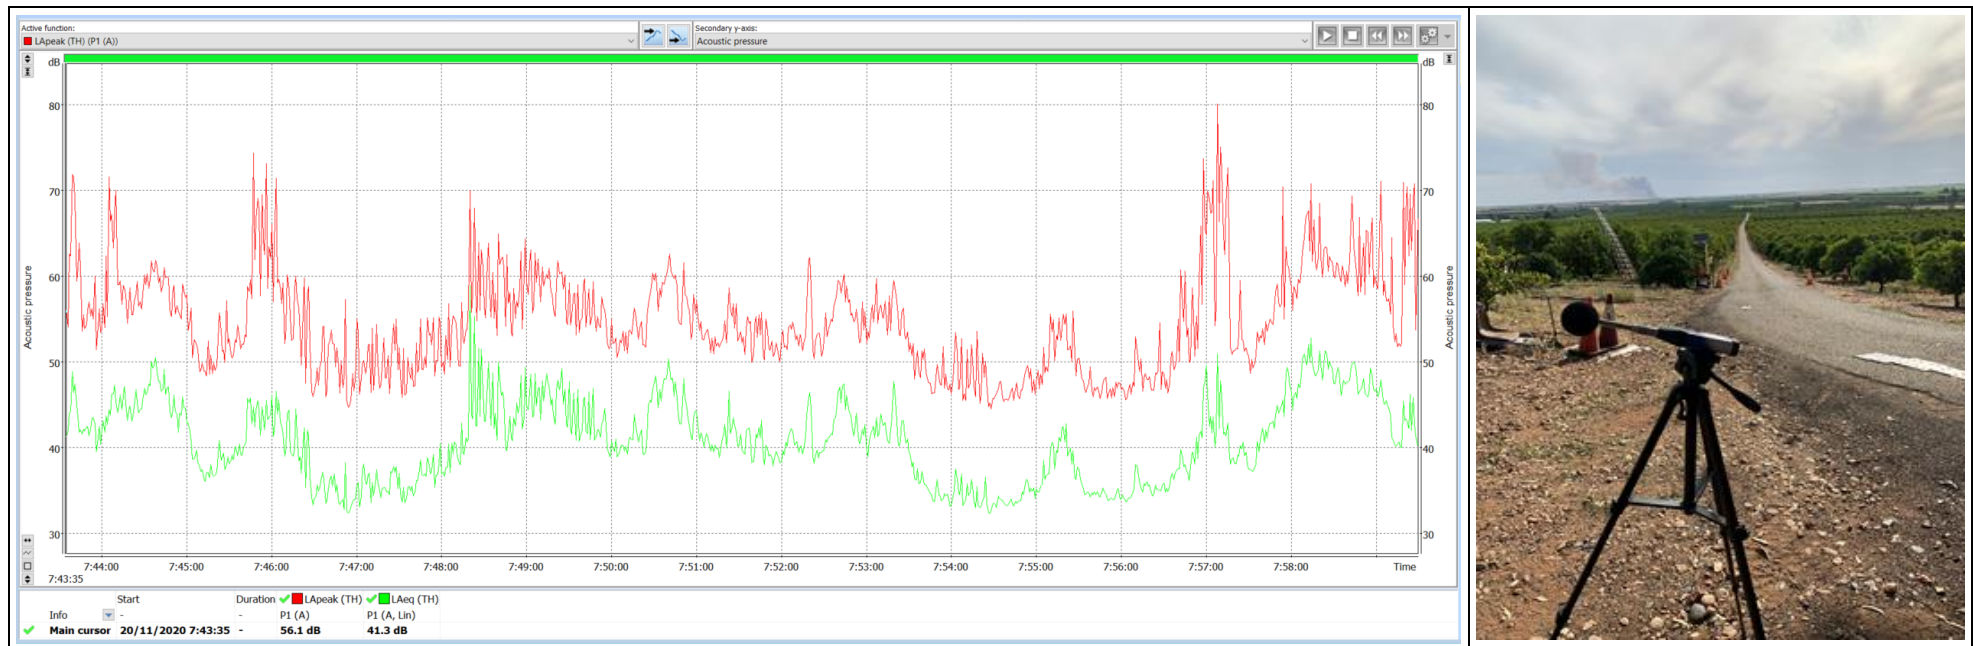
The noise logger was positioned facing north, approximately 50 m from the residence at the edge of the orange orchard as shown in Figure 3. Dominant noises included traffic from Kidman Way, pickers working in the orchard (with a tractor) and bird activity. Landfill activities were inaudible. The  $L_{Aeq}$  (15 min) attended monitoring period was 41.3 dB, exceeding the 35  $L_{Aeq}$  (15 min) criteria.

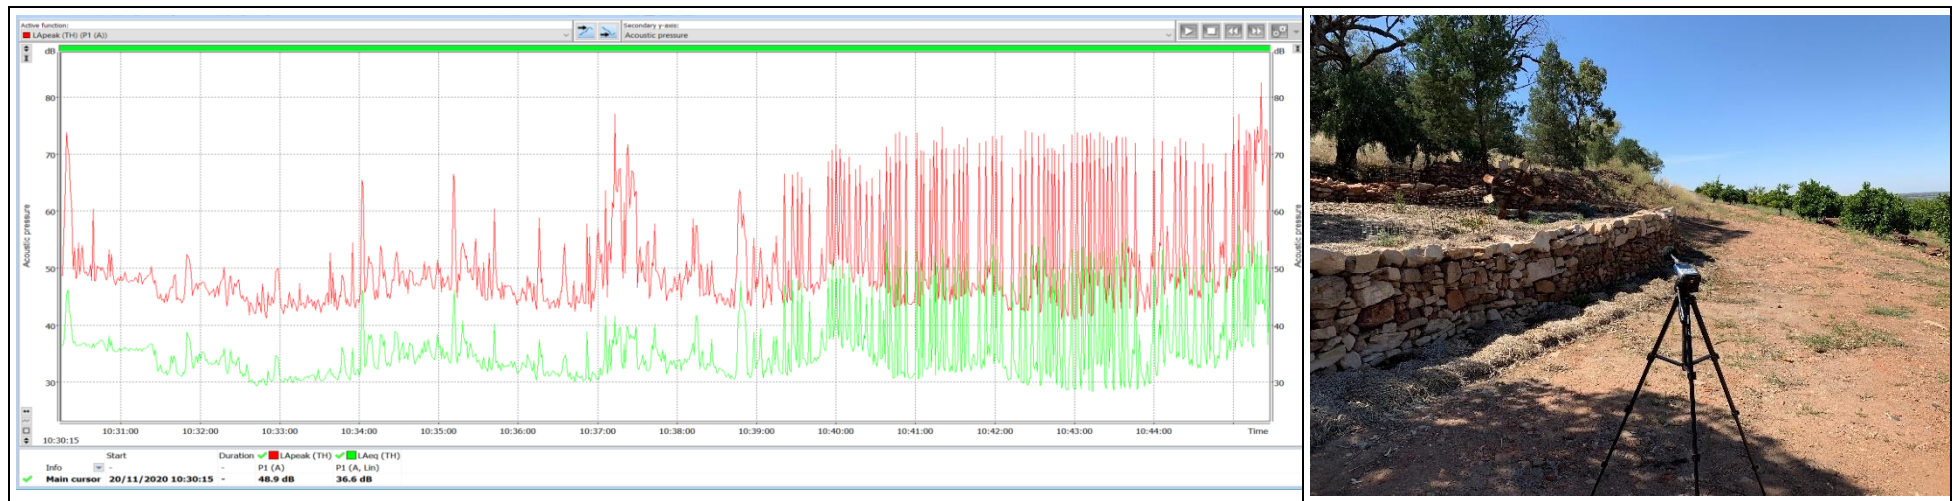
**Figure 4 – Sensitive Receiver 1 Midday**

The noise logger was positioned facing north, approximately 10 m from the residence as shown in **Figure 4**. Dominant noises included traffic from Kidman Way and bird activity. Landfill activities were inaudible. The LAeq (15 min) attended monitoring period was 36.6 dB, slightly exceeding the 35 LAeq (15 min) criteria.

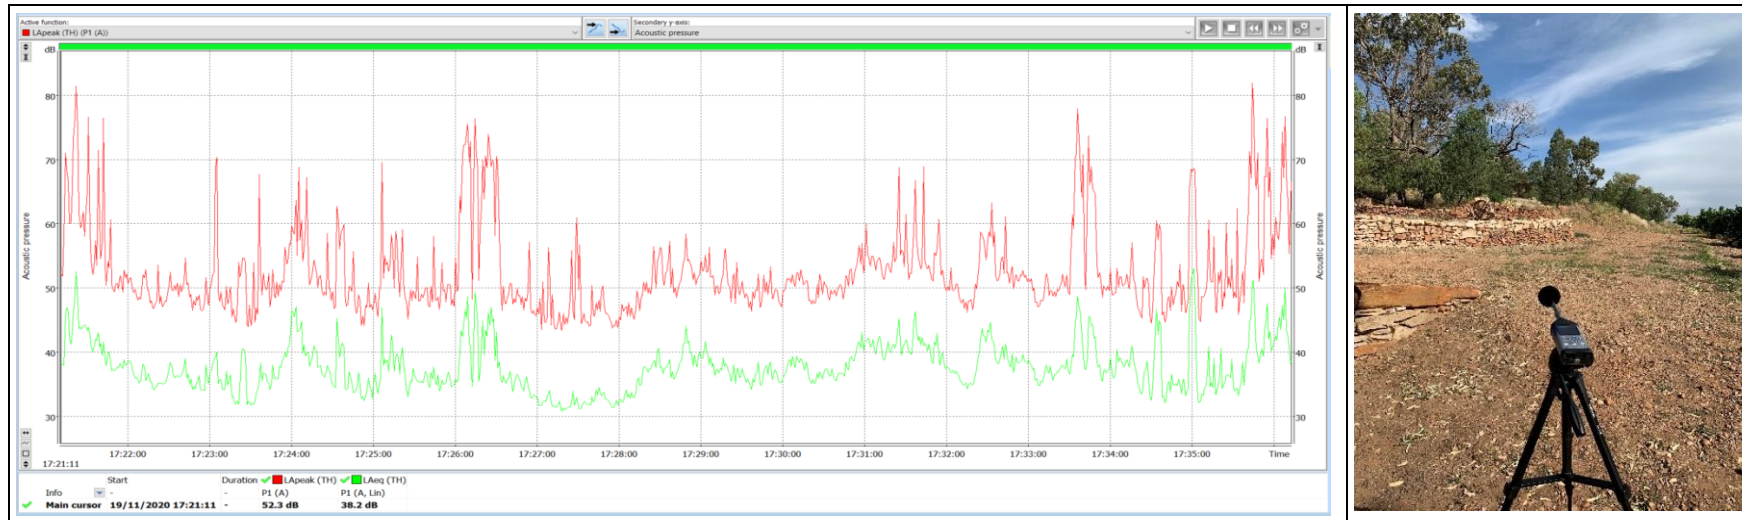
Figure 5 – Sensitive Receiver 1 Afternoon

The noise logger was positioned outside the garden wall near the orchard facing north as shown in Figure 5. The dominant background noise was again the drone of traffic southeast of the location, a dog barking, and birds. The LAeq (15 min) was 41.2 dB, above the 35 LAeq (15 min) assessment criterion.

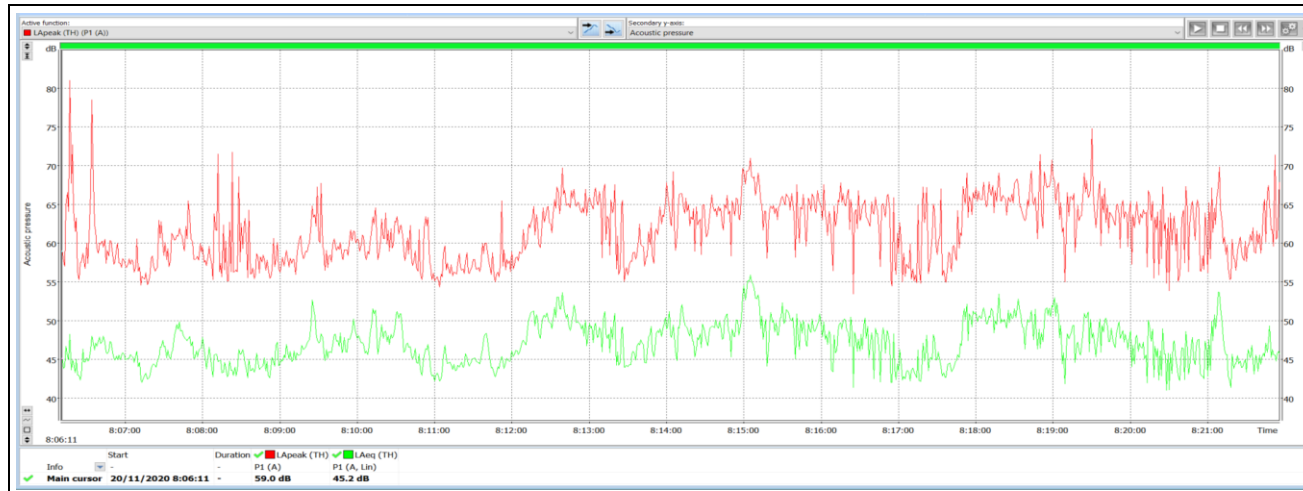
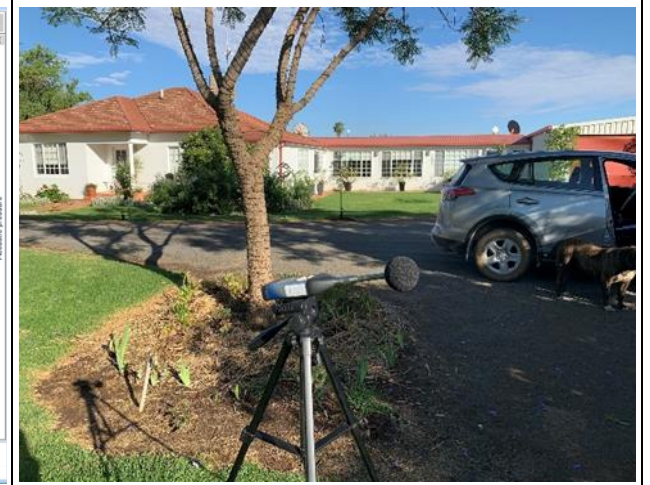
Figure 6 – Sensitive Receiver 2 Morning

The noise logger was positioned at the base of the driveway, approximately 30 m from the southwestern wall of the dwelling, facing northeast as shown in Figure 6.

The dominant foreground noises were music and the air conditioner coming from the residence. Noise from the landfill was inaudible. The  $L_{Aeq}$  (15 min) for the period was 45.2 dB, over the 35  $L_{Aeq}$  (15 min) criterion. The dominant background noise was the drone of light vehicle traffic from main roads to the southeast.

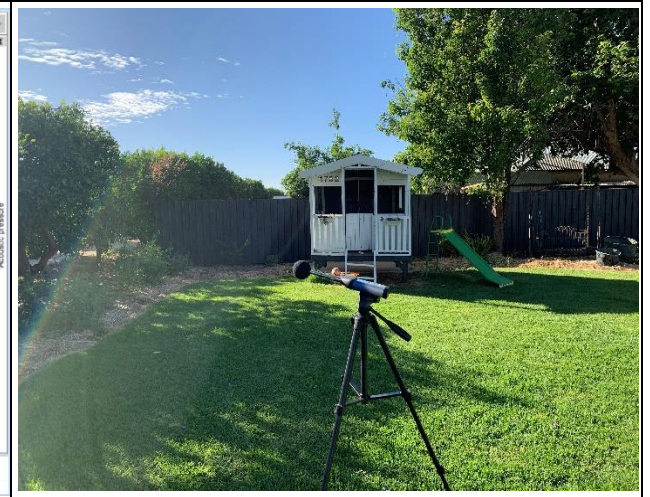
Figure 7 – Sensitive Receiver 2 Midday

The noise logger was set up in the front yard, approximately 10 m from the residential building, facing east. The dominant foreground noise sources were again music and the air conditioner throughout the monitoring period. The  $L_{Aeq}$  (15 min) for the midday period was 39.5 dB, exceeding the 35  $L_{Aeq}$  (15 min) assessment criterion.

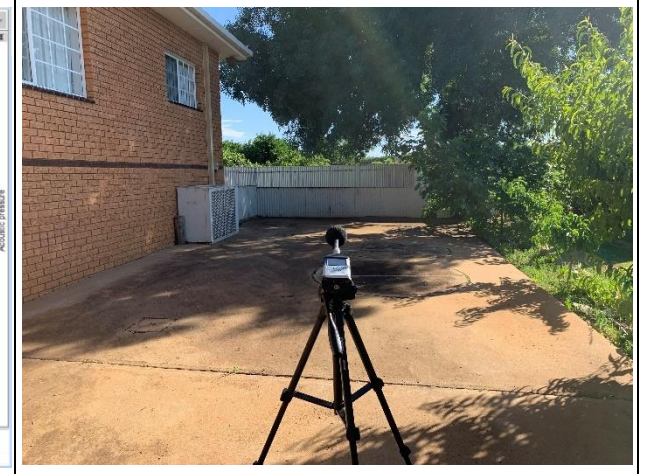
**Figure 9 – Sensitive Receiver 3 Morning**

The noise logger was positioned on the edge of Slopes Road, 5 m from the southern external wall of the residence.

The dominant background noise source was the constant drone of vehicle traffic emitted from main roads including Kidman Way, approximately 220 m from the monitoring location. Dominant foreground noise included activity from the residents moving around within the dwelling, and birds in the trees nearby. Machinery from the landfill was inaudible. The  $L_{Aeq}$  (15 min) for the period was 55.8 dB, exceeding the 35  $L_{Aeq}$  (15 min) criterion.

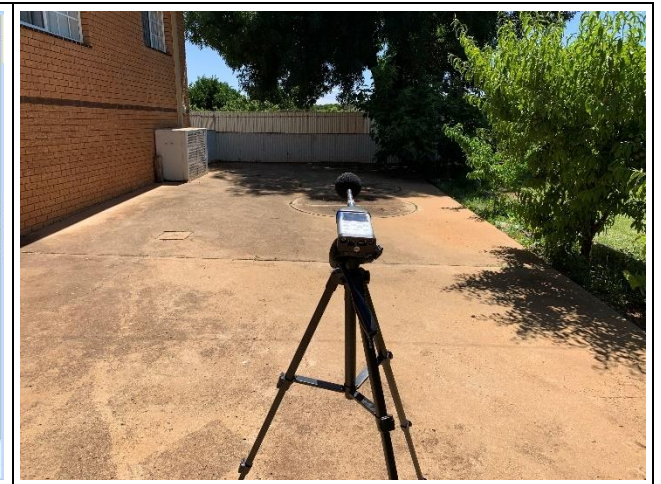
Figure 10 – Sensitive Receiver 3 Midday

The noise logger was positioned in the same location as for the morning period as shown in Figure 10 below.

A vehicles passed the residence on Slopes Road at 11:10, and two light vehicles passed at 11:13 and 11:17. The dominant background noise was vehicle traffic emitted from main roads, south of the Tharbogang area. Noise from the landfill was audible. The  $L_{Aeq}$  (15 min) for the period was 34.9 dB, which is just below the 35  $L_{Aeq}$  (15 min) assessment criterion.

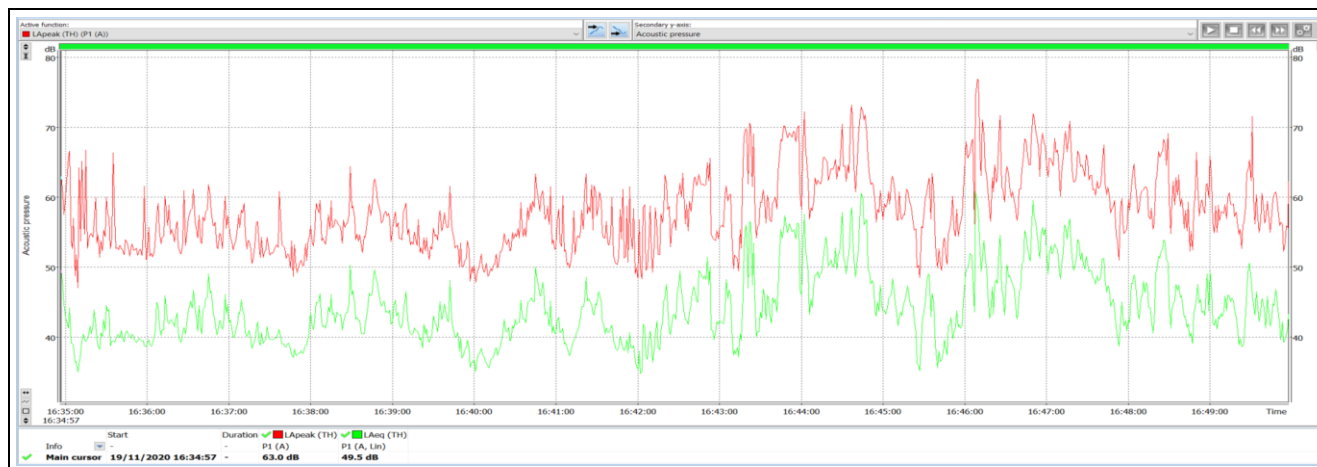
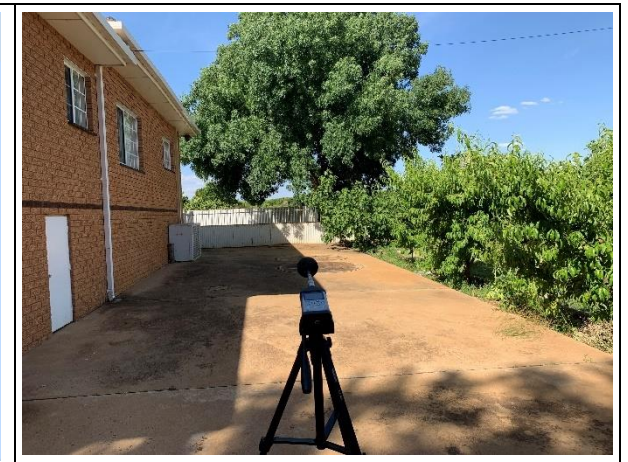
Figure 11 – Sensitive Receiver 3 Afternoon

The noise logger was positioned in the same location at front of the residence, just off Slopes Road. The dominant background noise source was the drone of traffic from the southwest. The dominant foreground noises were wind in the trees. An aeroplane passed overhead at 4:44pm. The  $L_{Aeq}$  (15 min) was 49.5 dB, above the 35  $L_{Aeq}$  (15 min) assessment criterion.

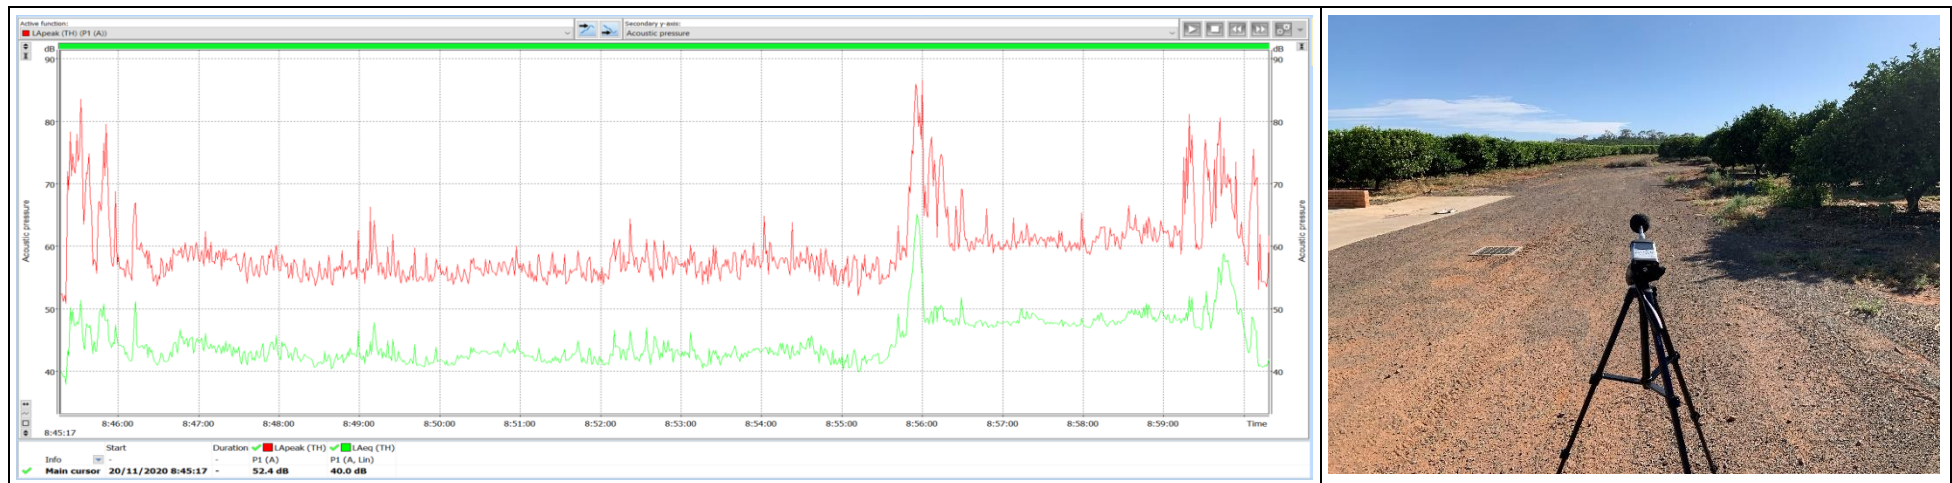
Figure 12 – Sensitive Receiver 4 Morning

The noise logger was positioned facing east into orange orchard, approximately 20 m from the residence as shown in Figure 12 below. Music from the premises included music playing in the shed nearby and sprinklers on the lawn. The pool pump and birds also contributed to local noise. A light vehicle passed the property at 8:56am. Audible background noise included the distant drone of continuous traffic only. The  $L_{Aeq}$  (15 min) for the period was 40.0 dB, which was over the 35  $L_{Aeq}$  (15 min) criterion.

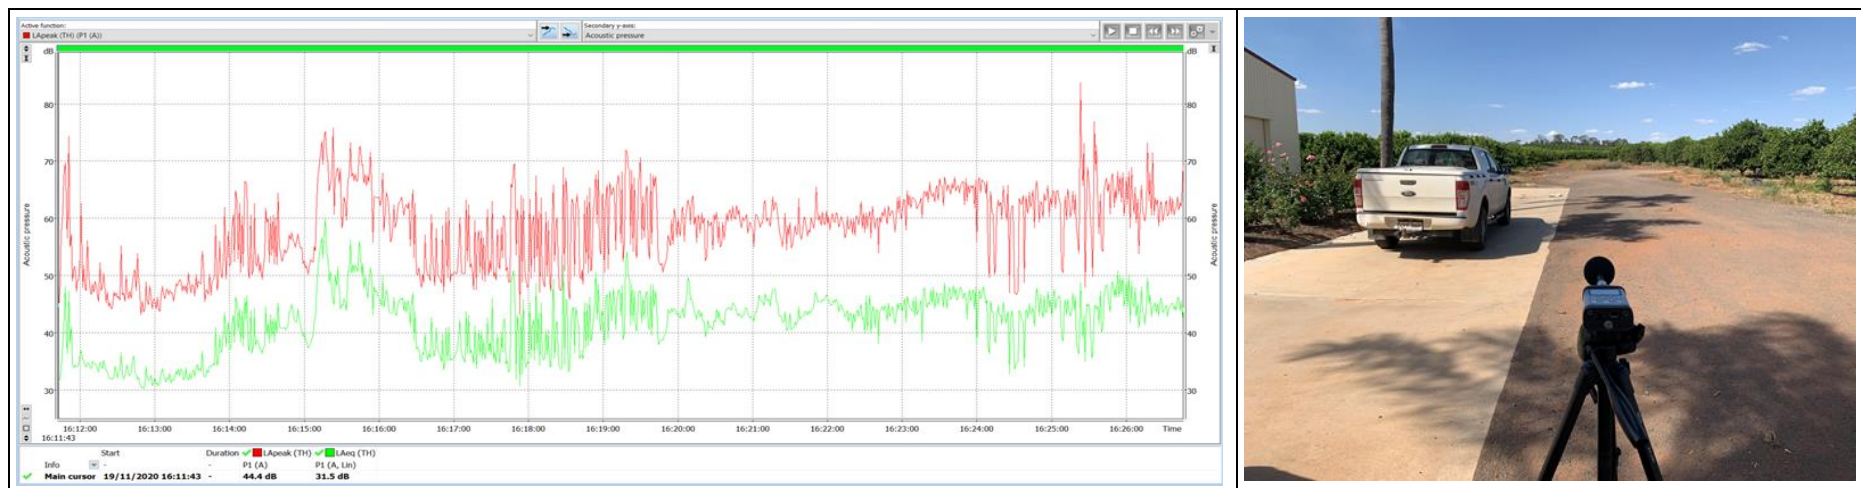
Figure 14 – Sensitive Receiver 4 Afternoon

The noise logger was placed closer to the residence, facing northeast, approximately 10 m from the eastern external wall as shown in Figure 14. The dominant background noise source was heavy vehicle movements from the quarry as well as the drone of vehicles on main roads to the south. The foreground was generally quiet with birds chattering throughout the monitoring period. The  $L_{Aeq}$  (15 min) was 31.5 dB, under the assessment criterion of 35  $L_{Aeq}$  (15 min).

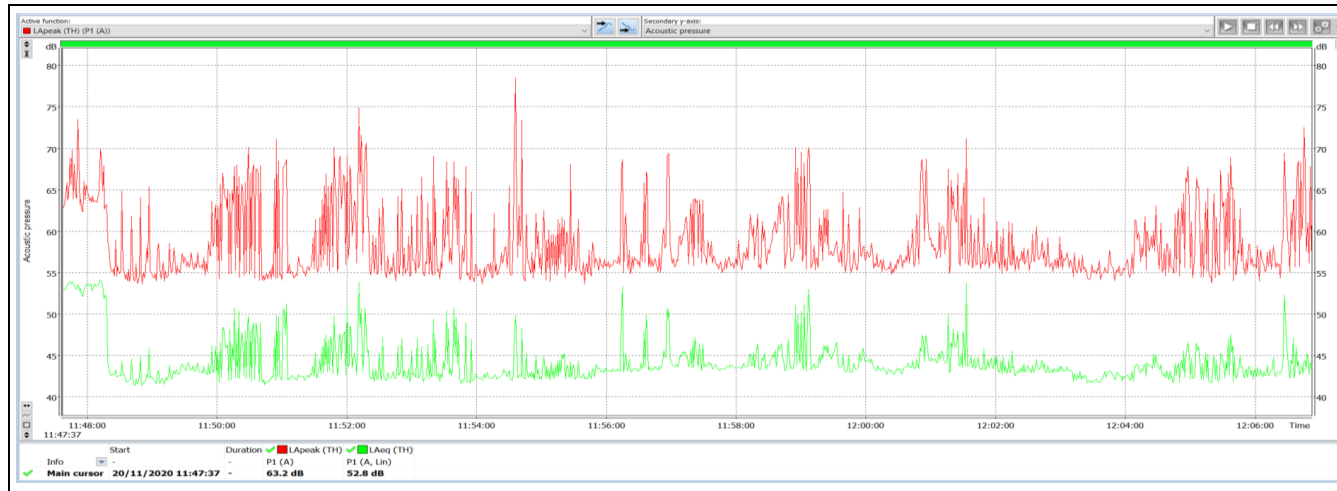
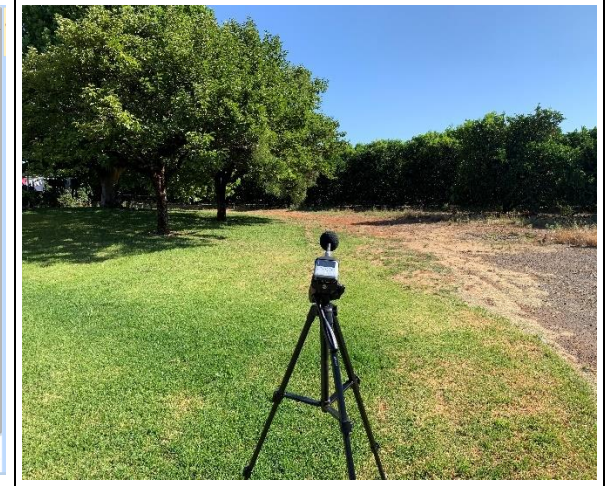
**Figure 16 – Sensitive Receiver 5 Midday**

The noise logger was positioned facing northeast 10 m southwest of the residential building. The constant hum of the commercial fridge 30 m from the house and a tap was also running. The drone of traffic from main roads south of the location was also audible at low levels. The  $L_{Aeq}$  (15 min) over the period was 52.8 dB, which is above the 35  $L_{Aeq}$  (15 min) assessment criterion.

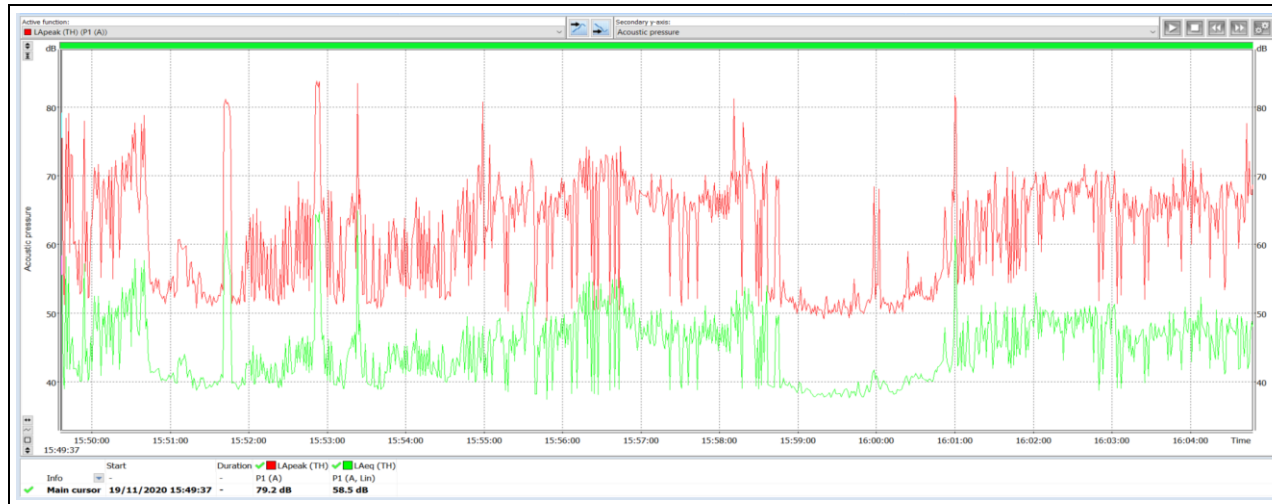
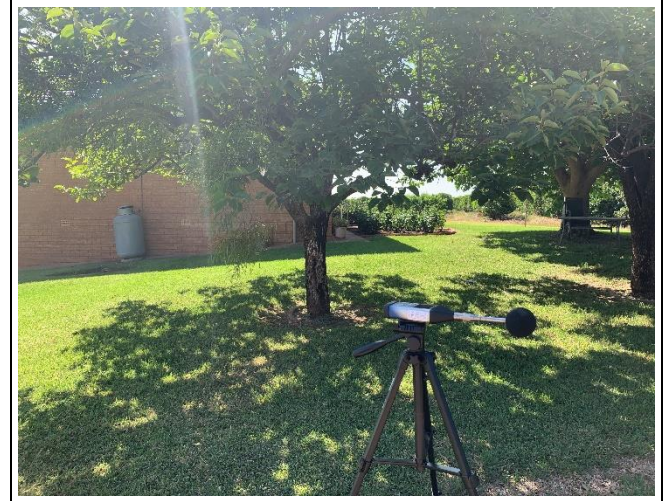
Figure 17 – Sensitive Receiver 5 Afternoon

The noise logger was positioned 10 m southeast of the residence, facing northeast as shown in Figure 17.

Audible background noise was limited to traffic from the local road network. The dominant foreground noises were rustling lives, birds singing and the commercial refrigerator, located 30 m east of the residence. The  $L_{Aeq}$  (15 min) was 58.5 dB, which exceeded the assessment criterion of 35  $L_{Aeq}$  (15 min).

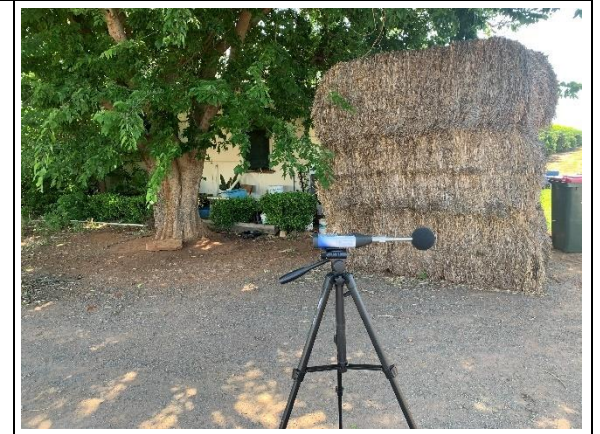
Figure 18 – Sensitive Receiver 6 Morning

The noise logger was positioned within the yard, approximately 25 m southeast of the nearest external wall of the building as shown in Figure 18. The dominant noise in the foreground was the resident's dogs barking for the first four minutes prior to 9:27am. The other dominant noise was a heavy vehicle movement on Hillside Drive at 9:27am. Background noise from the landfill was inaudible. Traffic noise from the local road network was consistent throughout the monitoring period. The  $L_{Aeq}$  (15 min) was 68 dB, well above the 35  $L_{Aeq}$  (15 min) assessment criterion.

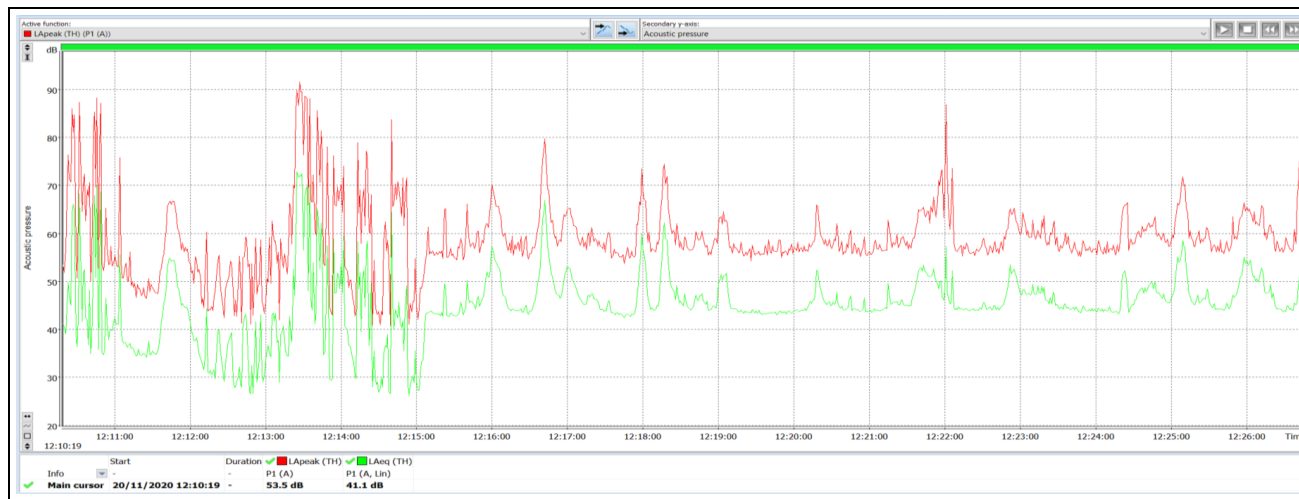
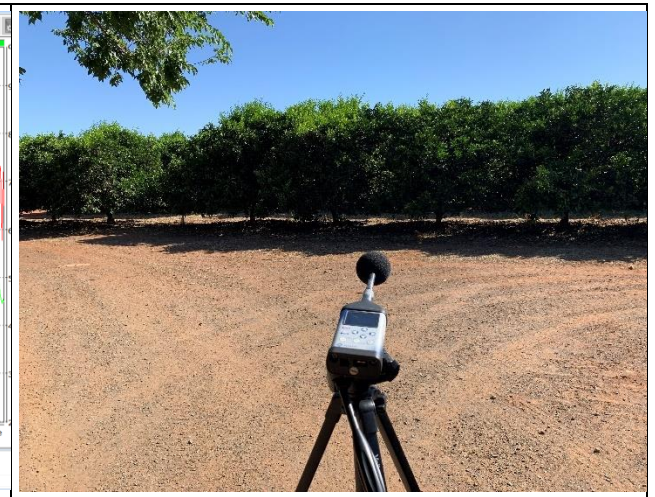
Figure 19 – Sensitive Receiver 6 Midday

The noise logger was placed in the orange orchard adjacent to the residence, facing northeast towards the quarry/landfill as shown in Figure 19. The dominant noise source was the dog barking for the first five minutes, followed by birds and the resident of the house talking at 12:13pm. The occupants switched on their air conditioning unit at 12:15pm. Heavy and light vehicles passed along Kidman Way at 12:16pm. The  $L_{Aeq}$  (15 min) over the period was 41.1 dB, which is over the 35  $L_{Aeq}$  (15 min) assessment criterion.

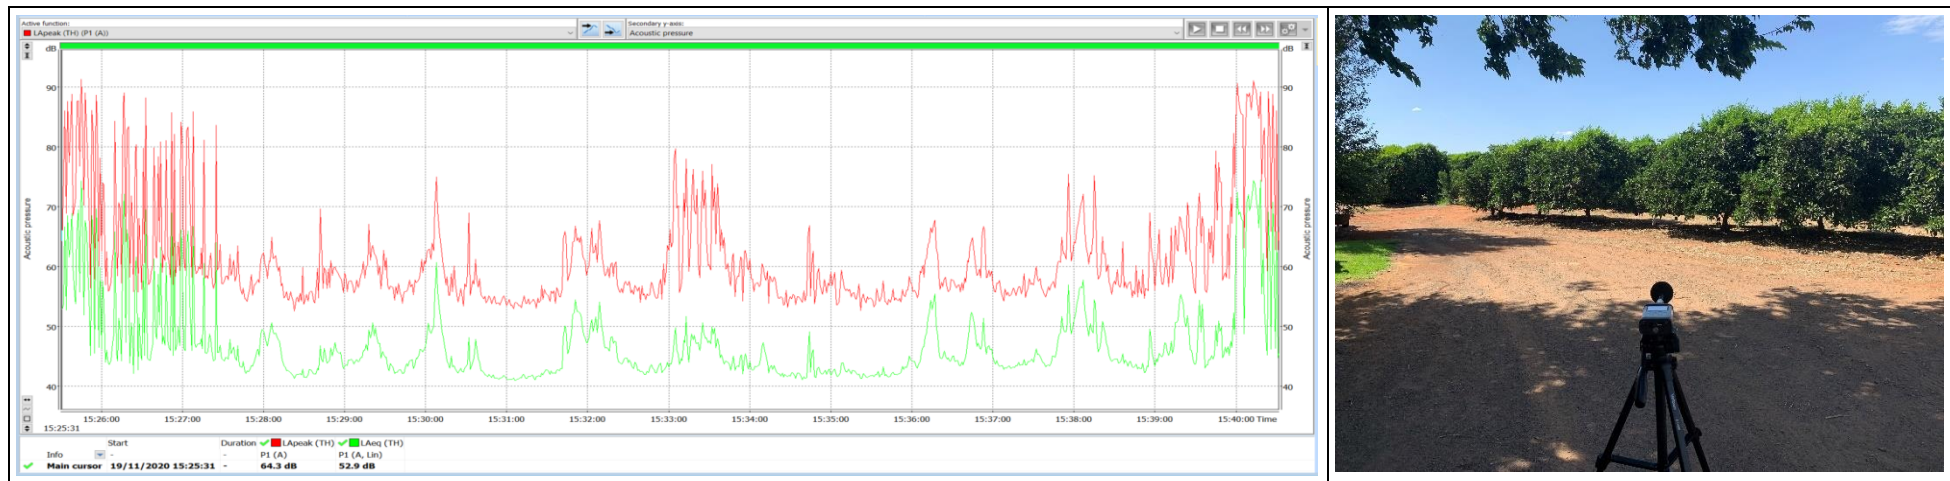
Figure 20 – Sensitive Receiver 6 Afternoon

The noise logger was placed in the orange orchard adjacent to the residence, facing northeast towards the quarry/landfill and Hillside Drive as shown in Figure 20.

The dominant background noise source was the drone of traffic from main roads south of the location. Light vehicles passed at 15:30pm and 15:31pm. Noise from the landfill was inaudible. The  $L_{Aeq}$  (15 min) was 52.9 dB, well above the assessment criterion of 35  $L_{Aeq}$  (15 min).

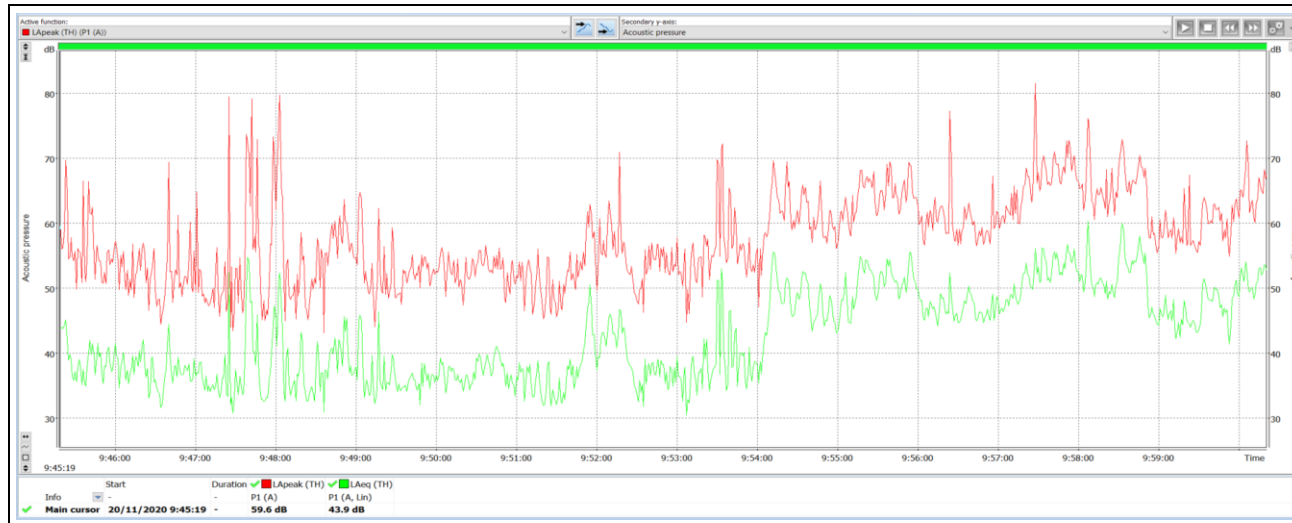
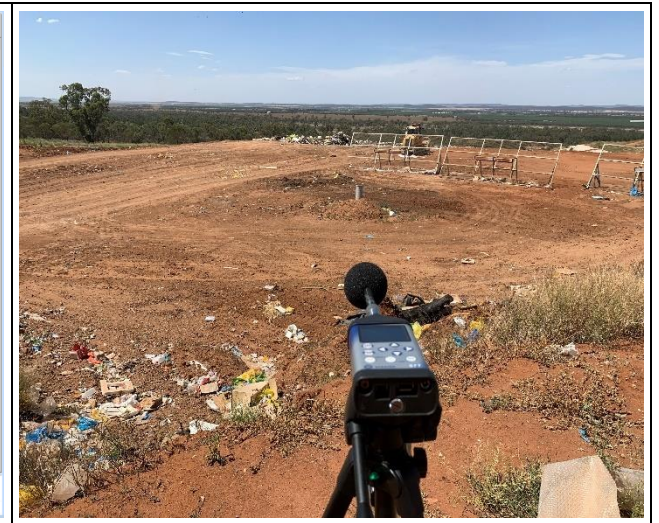
**Figure 21 – Landfill Morning**

The noise logger was positioned facing onto the landfill at the approximately 100 m from the edge of the tip face. At the time of monitoring the compactor was not working, two heavy vehicles arrived onsite to deliver waste and one light vehicle entered and exited the site. Traffic noise from the local road network was audible in the background throughout the monitoring period. The  $L_{Aeq}$  (15 min) for the monitoring period was 43.9 dB, which was above the 35  $L_{Aeq}$  (15 min) assessment criterion but noticeably lower than the morning  $L_{Aeq}$  (15 min) recorded for receivers 2, 3 and 6.

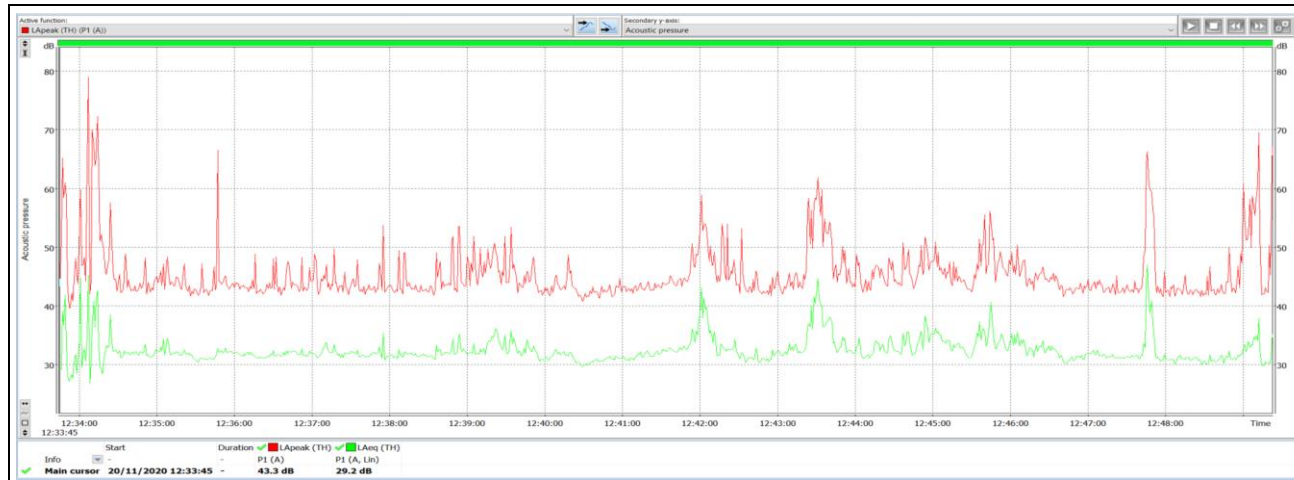
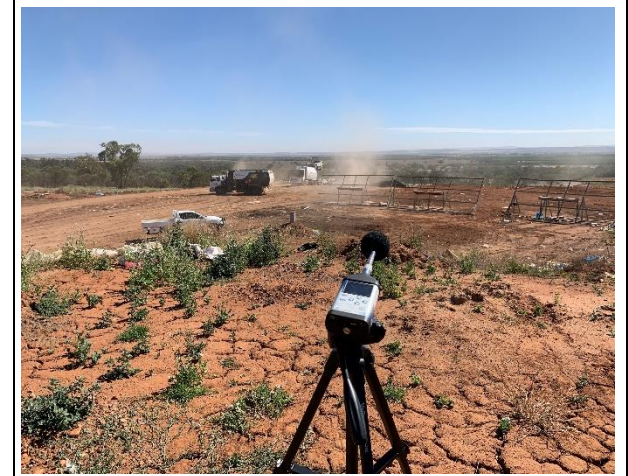
Figure 22 – Landfill Middy

The noise logger was again positioned facing onto the landfill at the approximately 100 m from the edge of the tip face. No activity occurred at the landfill when monitoring commenced. The dominant noise was background traffic from the local road network. The  $L_{Aeq}$  (15 min) for the period was 29.9 dB, which was below the 35  $L_{Aeq}$  (15 min) assessment criterion and the  $L_{Aeq}$  (15 min) recorded at all receivers.

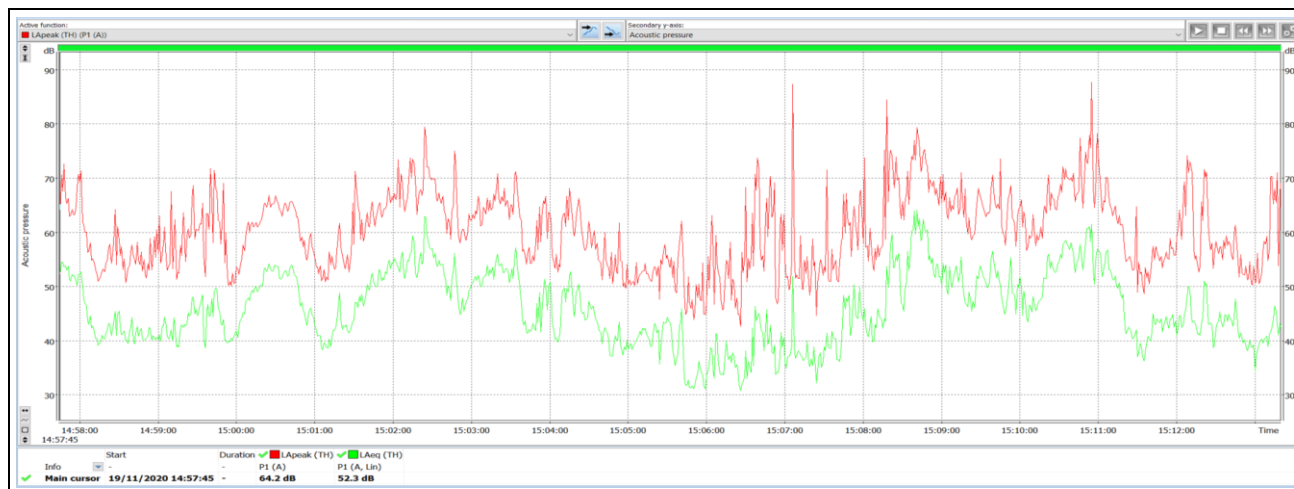
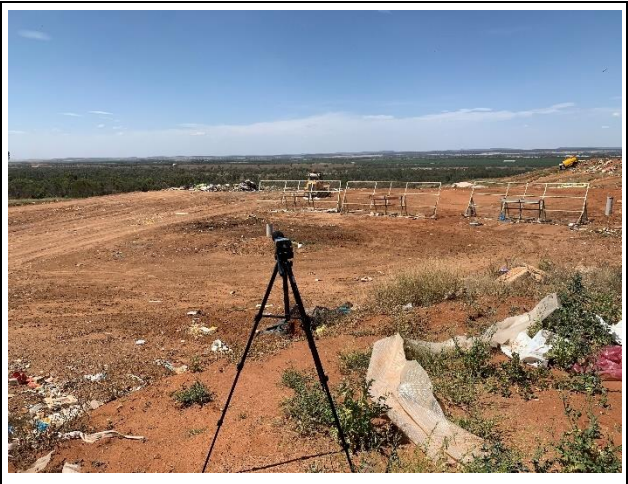
Figure 23 – Landfill Afternoon

The noise logger was again positioned facing northwest onto the landfill at the approximately 100 m from the edge of the tip face. The compactor was working during the afternoon monitoring period. Two heavy vehicles delivered waste at 3:07pm and 3:11pm. The  $L_{Aeq}$  (15 min) for the period was 52.3 dB, which well above the 35  $L_{Aeq}$  (15 min) assessment criterion and the  $L_{Aeq}$  (15 min) recorded at all receivers during the afternoon except receiver 5.
