# Annual Noise Monitoring Report

## Tharbogang Quarry and Landfill Operations

December 2021

Project Number: 18-393

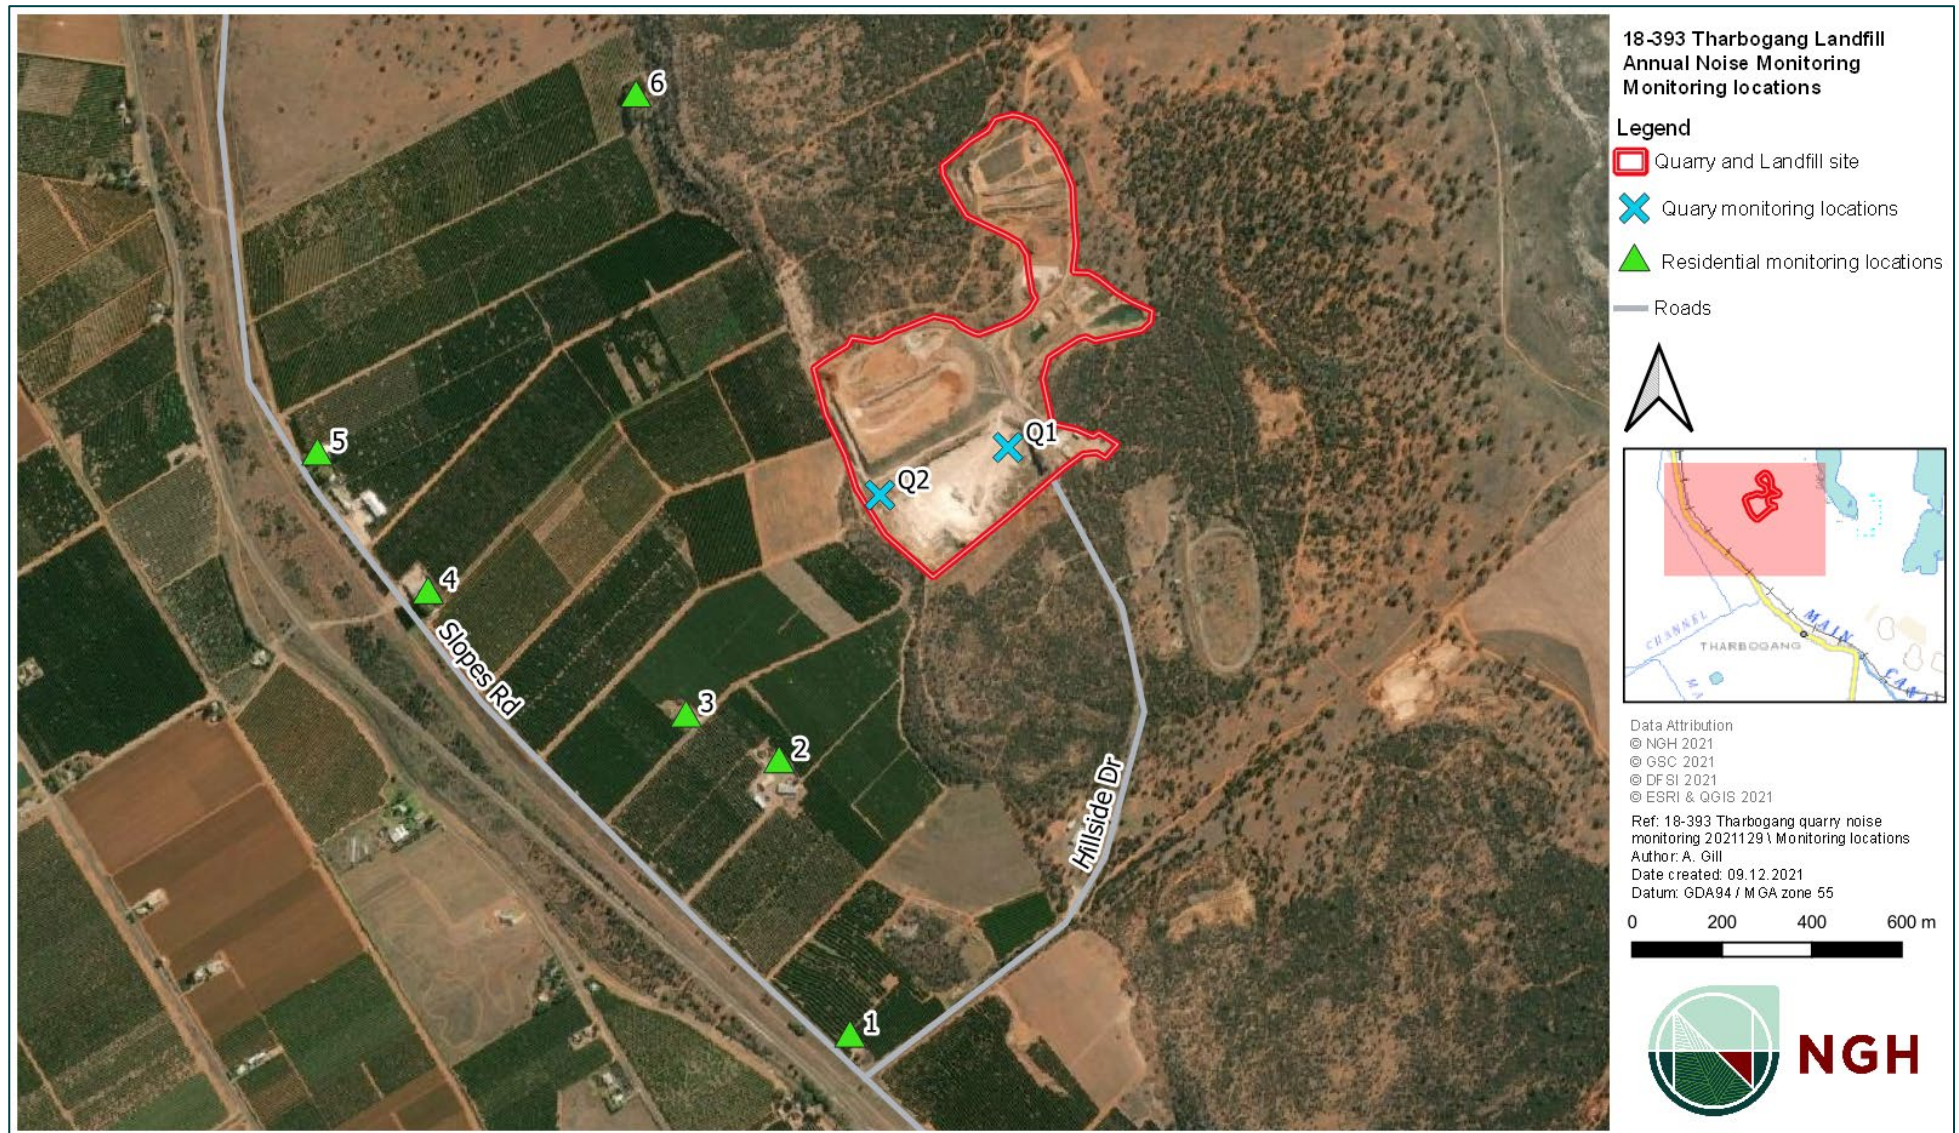
Figure 1-1 Monitoring locations

Monitoring noise from facility operations enabled comparisons between actual noise levels from the facility and noise management levels at six sensitive receiver locations (Figure 1-1).

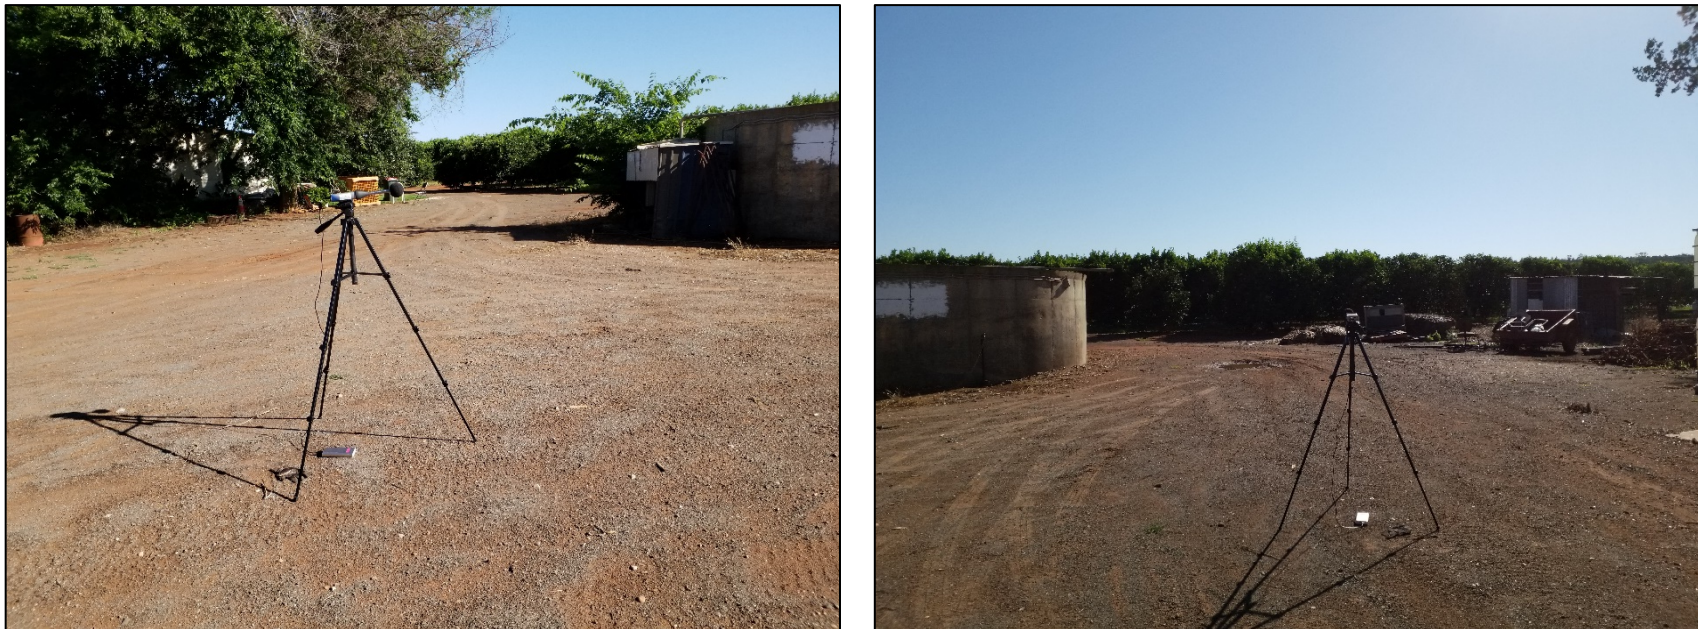
Figure 2-1 Location of noise monitor at residential receiver 1

The noise logger was positioned within the yard, approximately 30m southeast of the nearest external wall of the building (Figure 2-1).

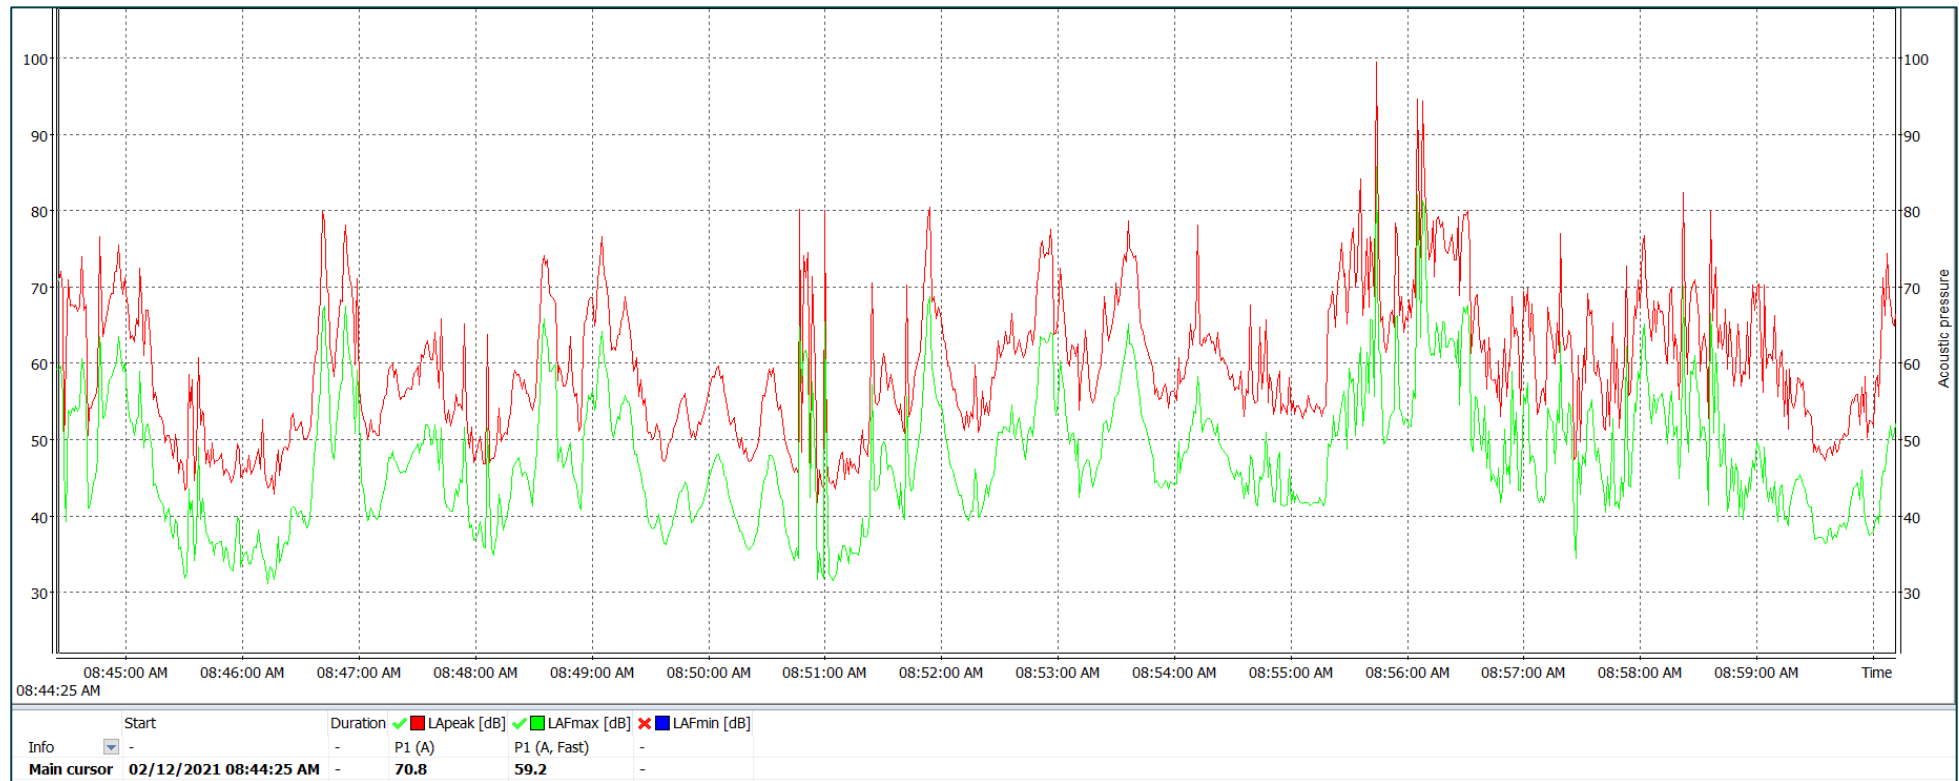
The dominant noise source was the dog barking for the first two minutes and at 8.51am, followed by birds and the resident of the house taking out their bin at 8.56am. Heavy and light vehicles passed the household periodically via Slopes Road. Operations at the landfill were inaudible. The  $L_{Aeq}$  (15 min) over the period was 59.2dB, which is over the 35  $L_{Aeq}$  (15 min) assessment criterion.

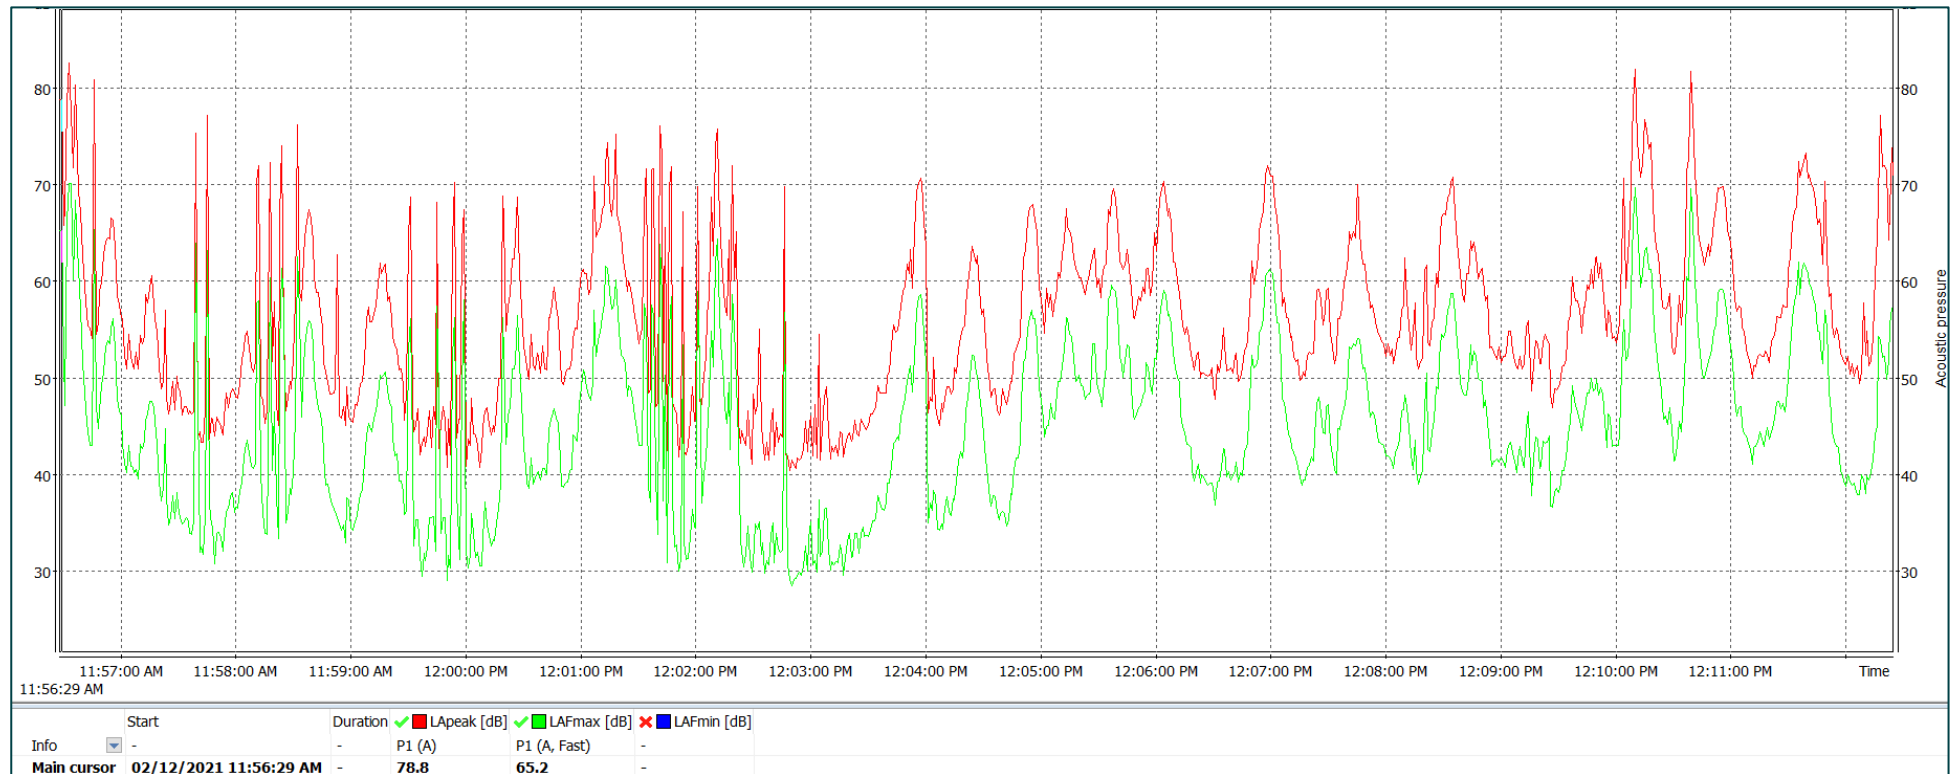
The dominant noise source was the dog barking for the first five minutes, and the landholder calling his dog at 12:10pm. Background noise from birds and local road traffic was observed. Operations at the landfill were inaudible. The  $L_{Aeq}$  (15 min) over the period was 65.2dB, which is over the 35  $L_{Aeq}$  (15 min) assessment criterion.

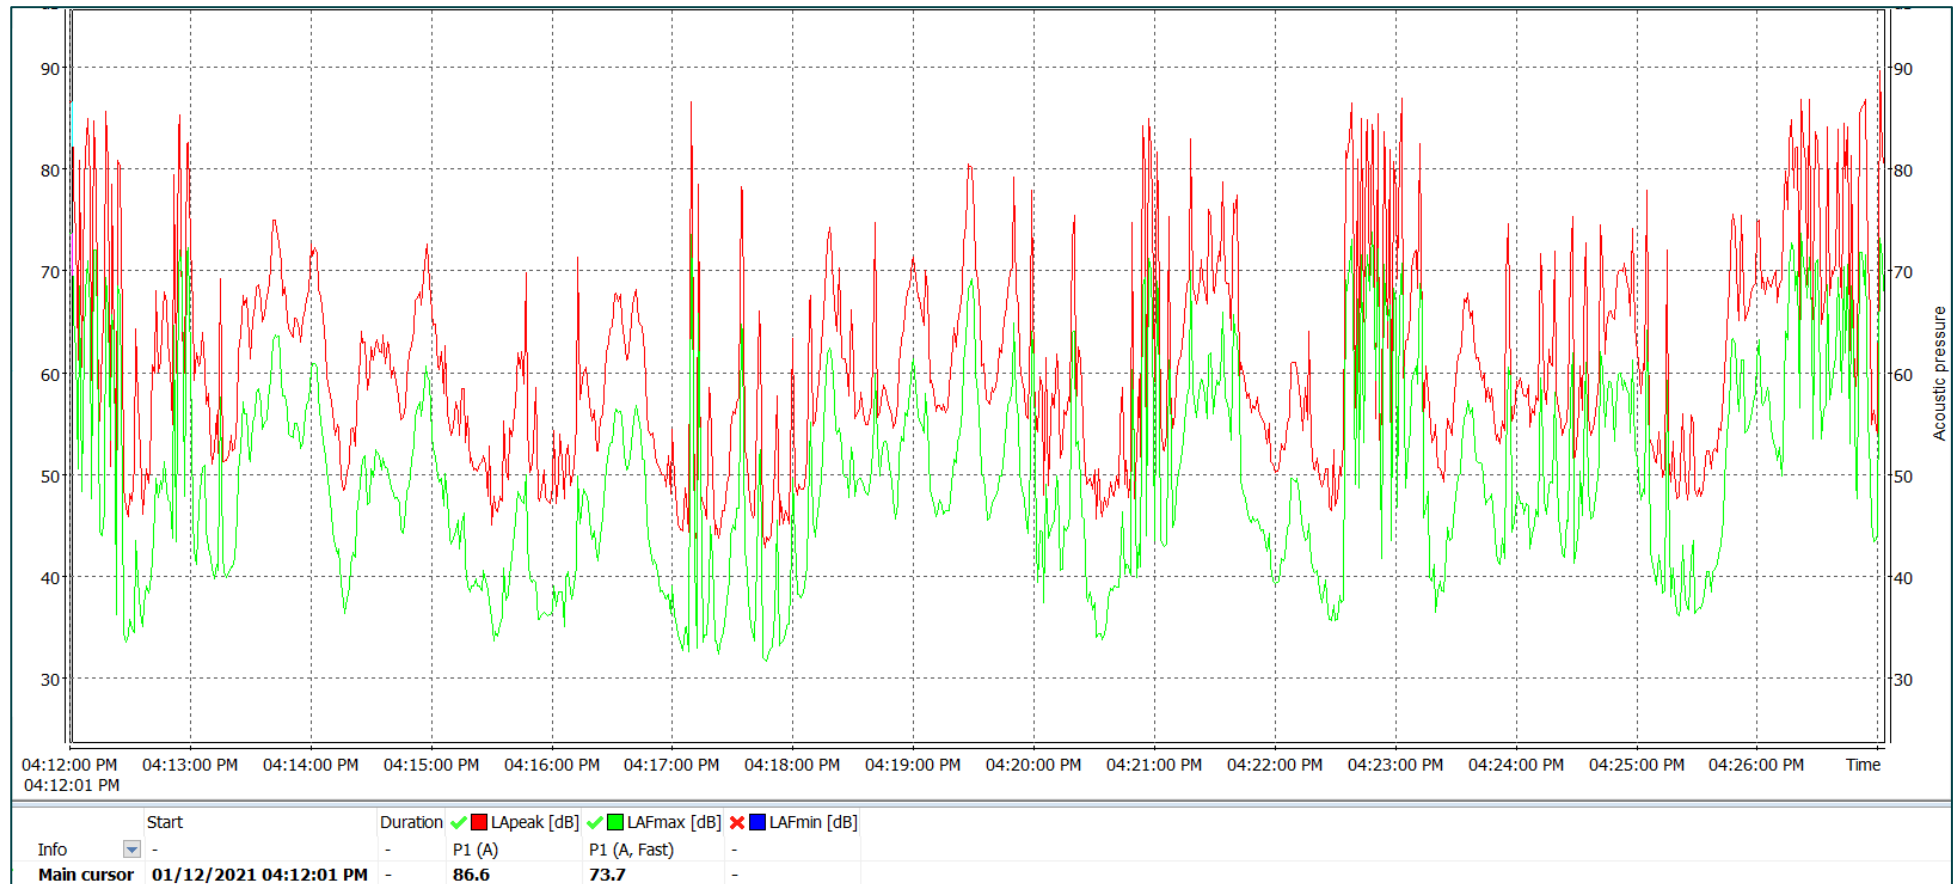
The dominant noise in the foreground included the resident's dogs barking and bird noises throughout the recording. The other dominant noise was a heavy vehicle movement on Hillside Drive at 4.23pm. Background noise from the landfill was inaudible. Traffic noise from the local road network was consistent throughout the monitoring period. Operations at the landfill were inaudible. The  $L_{Aeq}$  (15 min) was 73.7dB, exceeding the 35  $L_{Aeq}$  (15 min) assessment criterion.

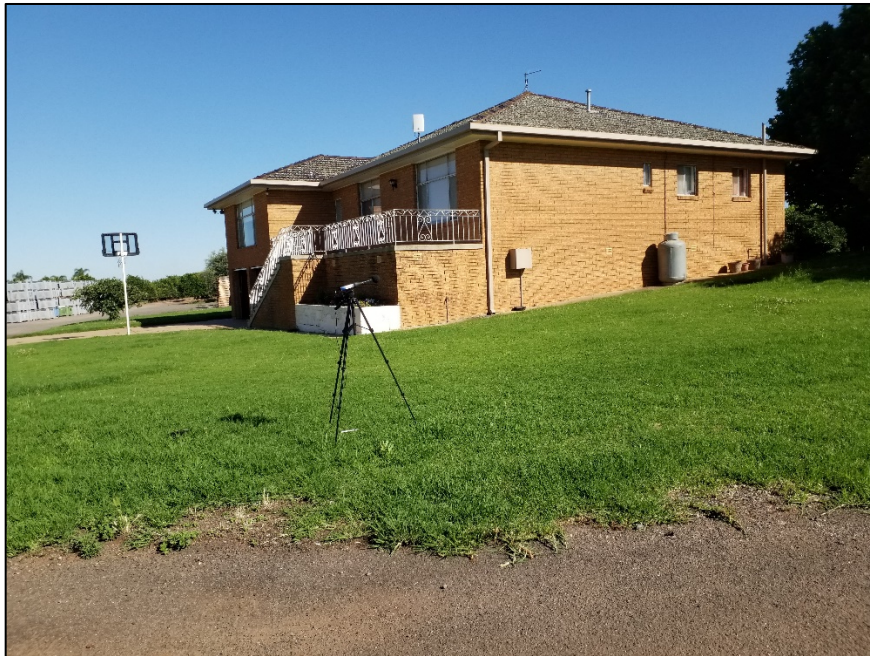
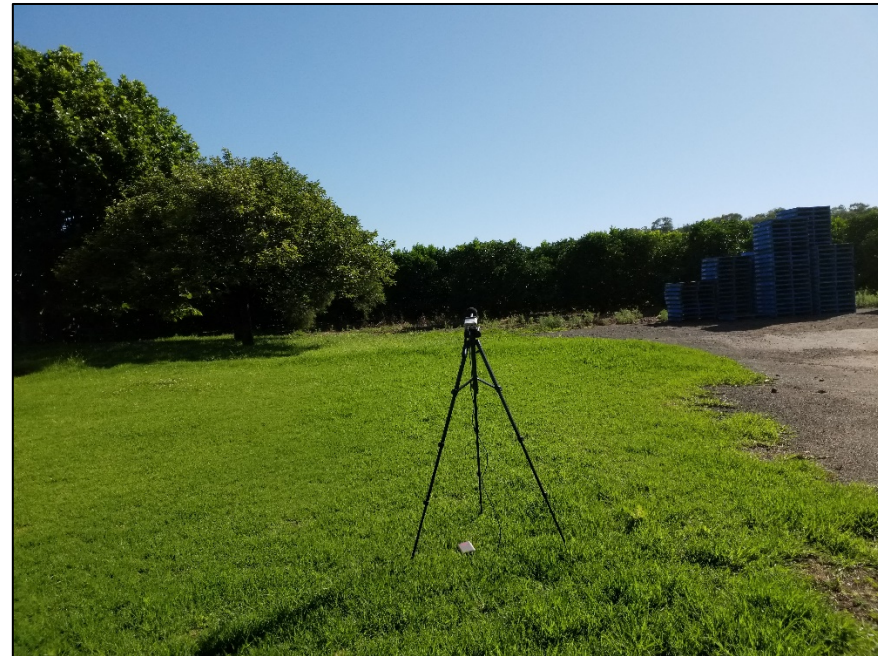
Figure 2-2 Location of noise monitor at residential receiver 2

This sensitive receiver is located within an orange orchard, approximately 350m off Slopes Road and approximately 1020m from Tharbogang Quarry. The noise logger was positioned facing northeast, approximately 7m southeast of the residential building (Figure 2-2). The residential building is also within the same compound as two large sheds and a commercial refrigerator, which was operational and emitting an audible 'hum' throughout the day.

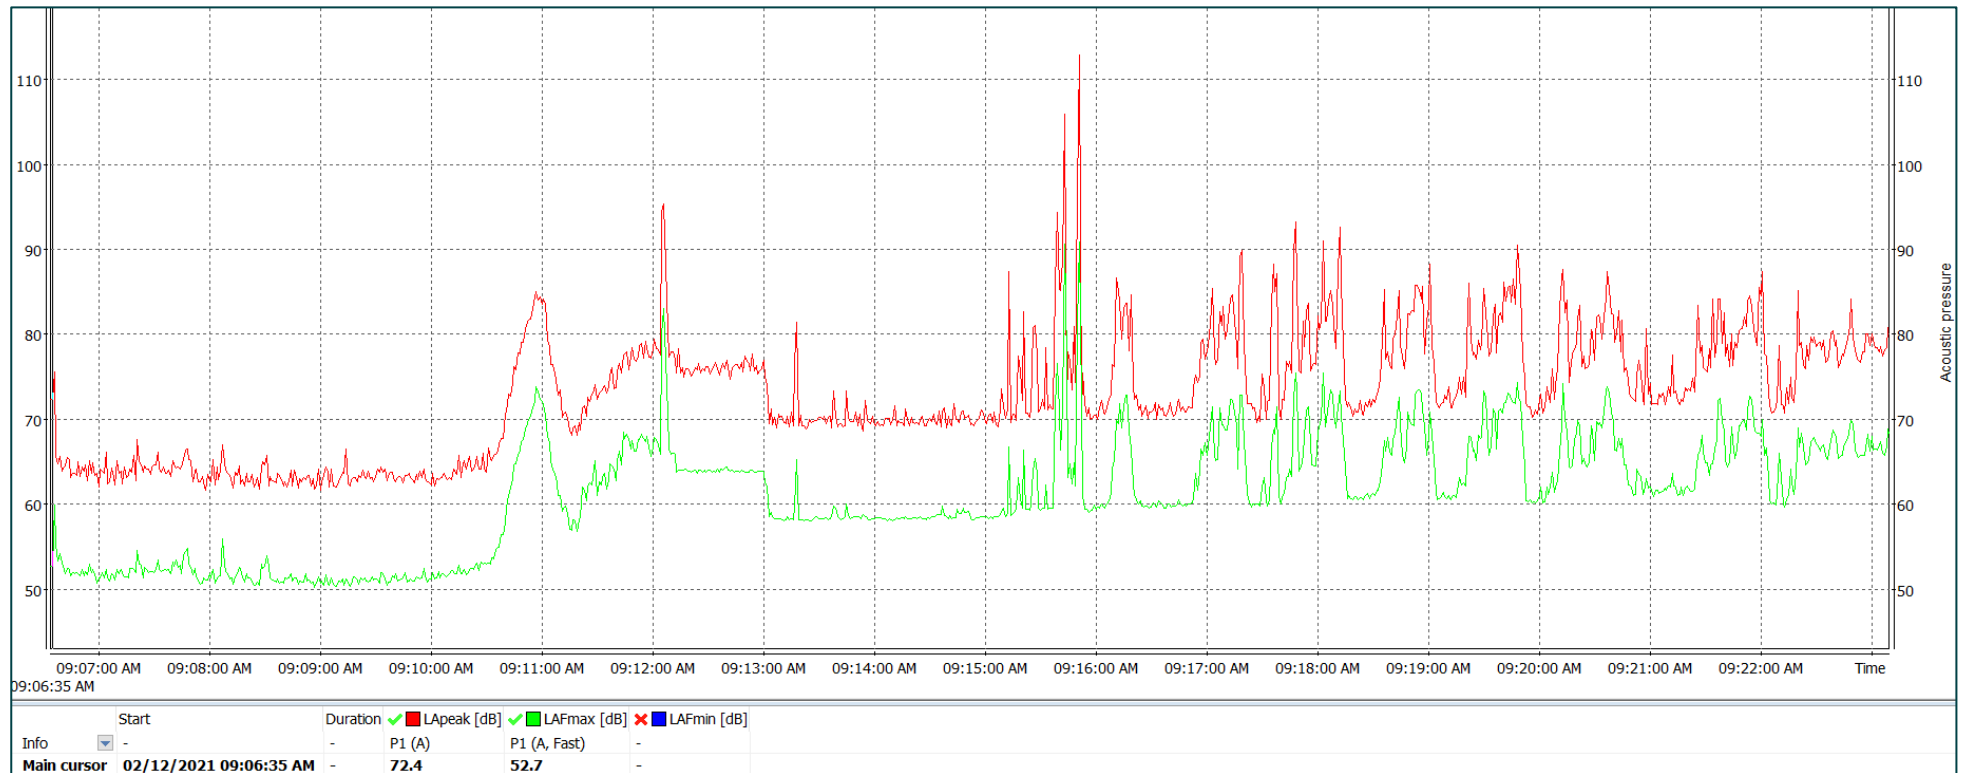
The constant hum of the commercial fridge 30m from the house and bird activity were audible in the foreground and a dog barked loudly at 9:12am during the recording. At 9.16am a landholder vehicle pulled into the driveway. Operations at the landfill were inaudible. The dominant background noise was road traffic from Slopes Road. The  $L_{Aeq}$  (15 min) over the period was 52.7dB, which is above the 35  $L_{Aeq}$  (15 min) assessment criterion.

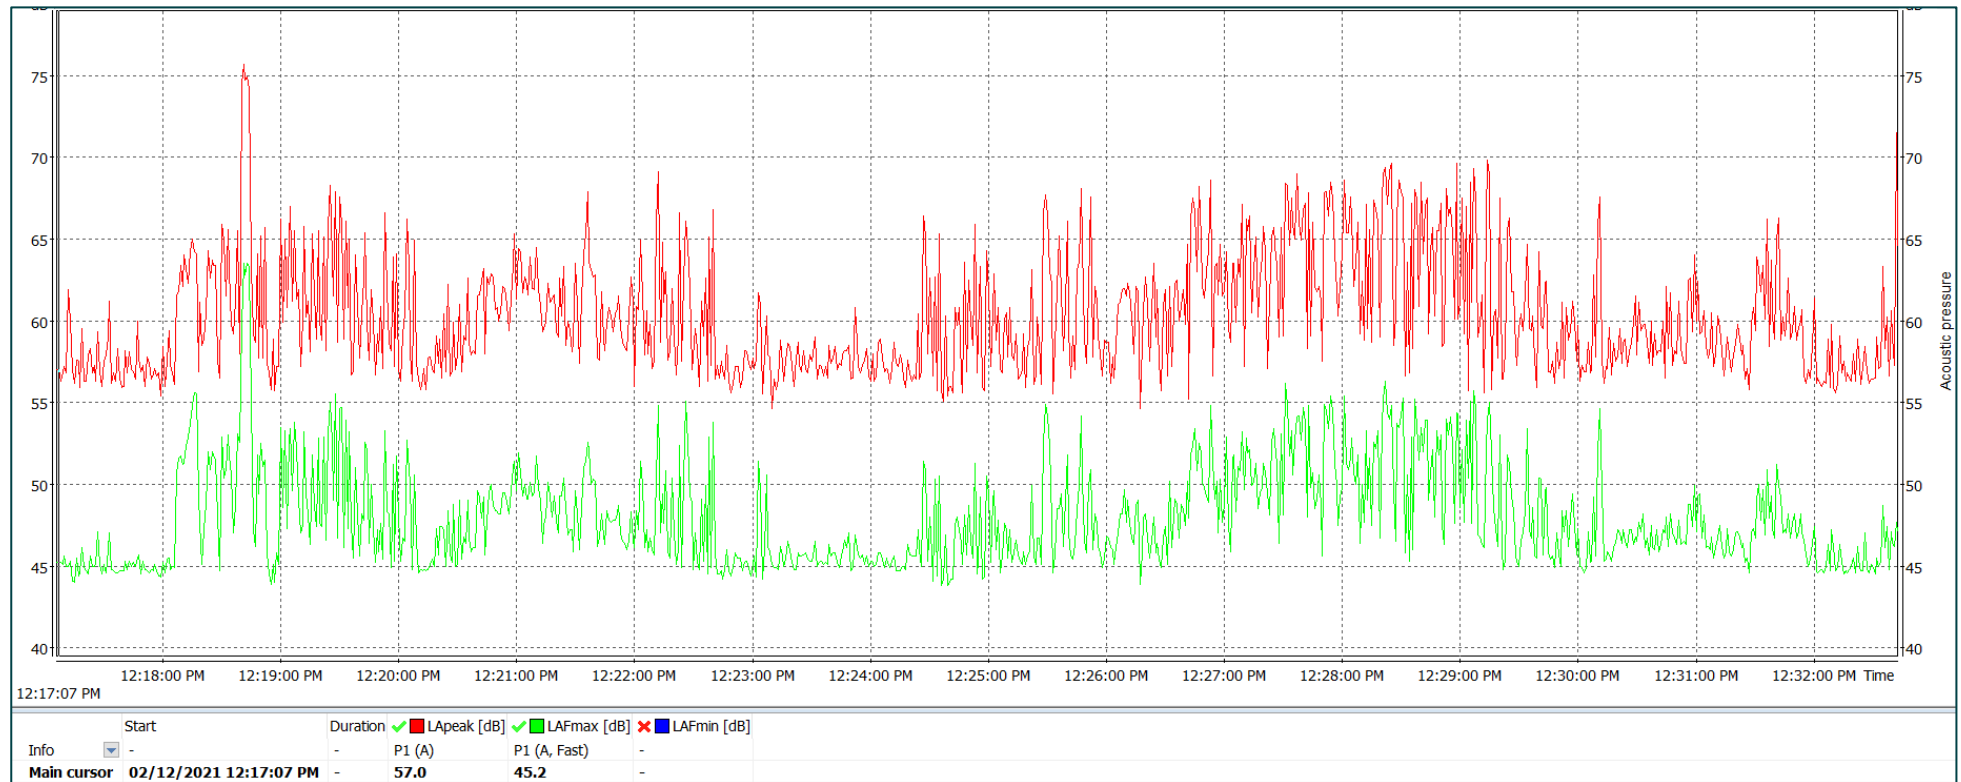
The constant hum of the commercial fridge 30m from the house and bird activity were audible in the foreground during the recording period. At 12.19pm a semi-trailer pulled into the driveway. The truck was left idling, which continued until the end of the recording. Operations at the landfill were inaudible. The  $L_{Aeq}$  (15 min) over the period was 45.2dB, which is above the 35  $L_{Aeq}$  (15 min) assessment criterion.

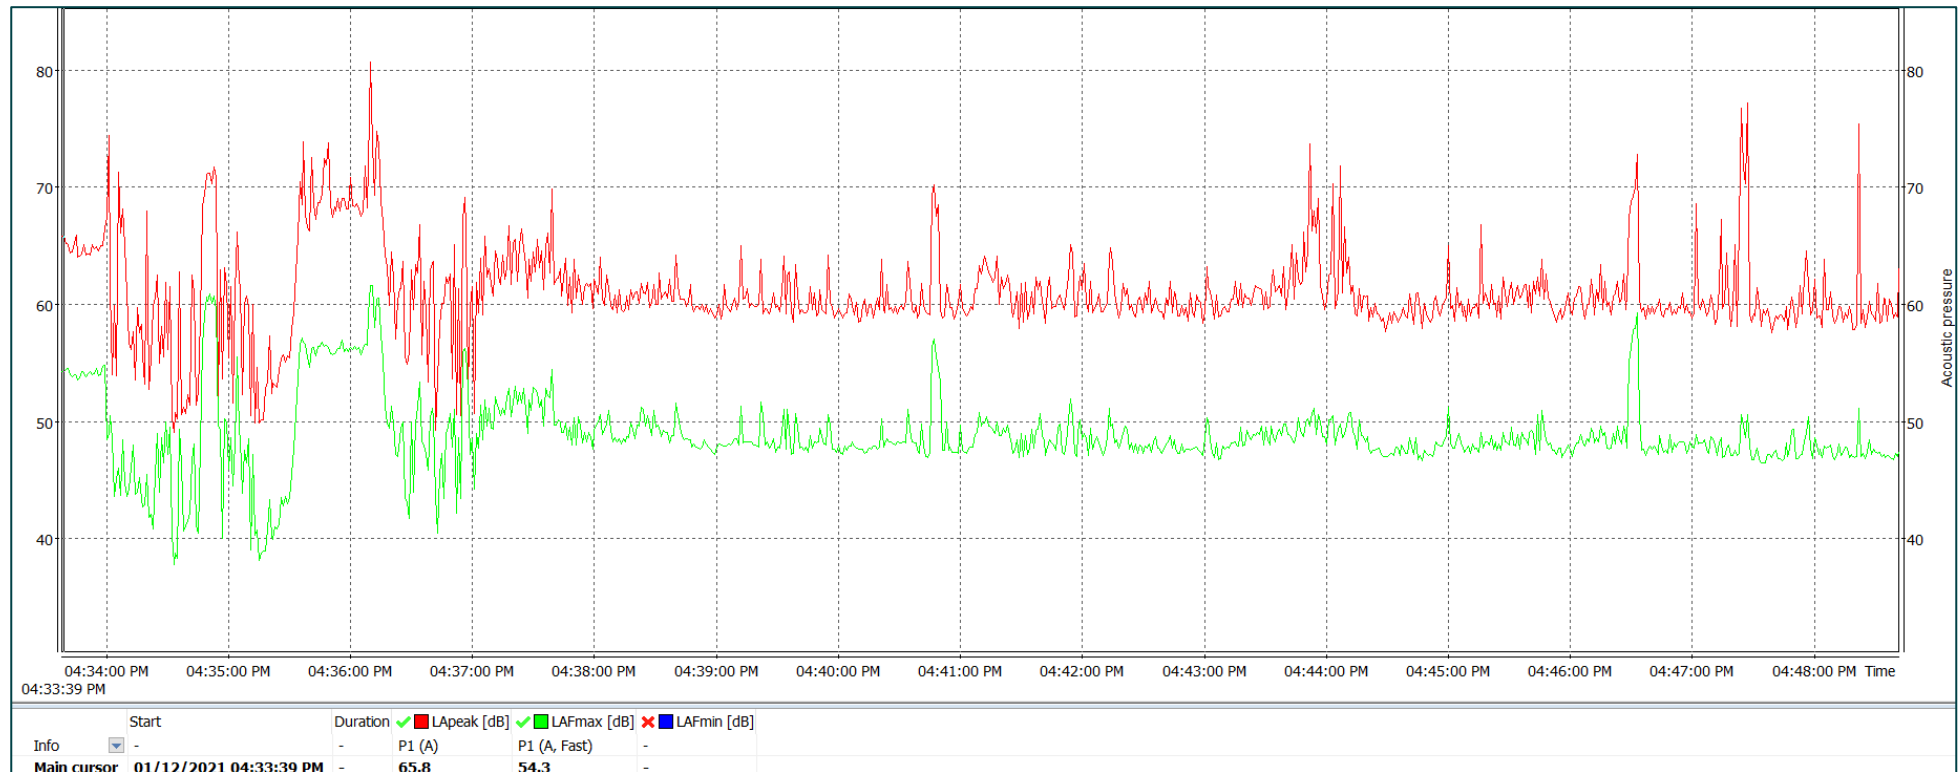
The constant hum of the commercial fridge 30m from the house and bird activity were audible in the foreground during the recording period. At 4.36pm, a vehicle pulled into the driveway and car doors were opened and shut. At 4.44pm, people were observed talking near a shed. Bird noise was the dominant background noise. Operations at the landfill were inaudible. The  $L_{Aeq}$  (15 min) over the period was 54.3dB, which is above the 35  $L_{Aeq}$  (15 min) assessment criterion.

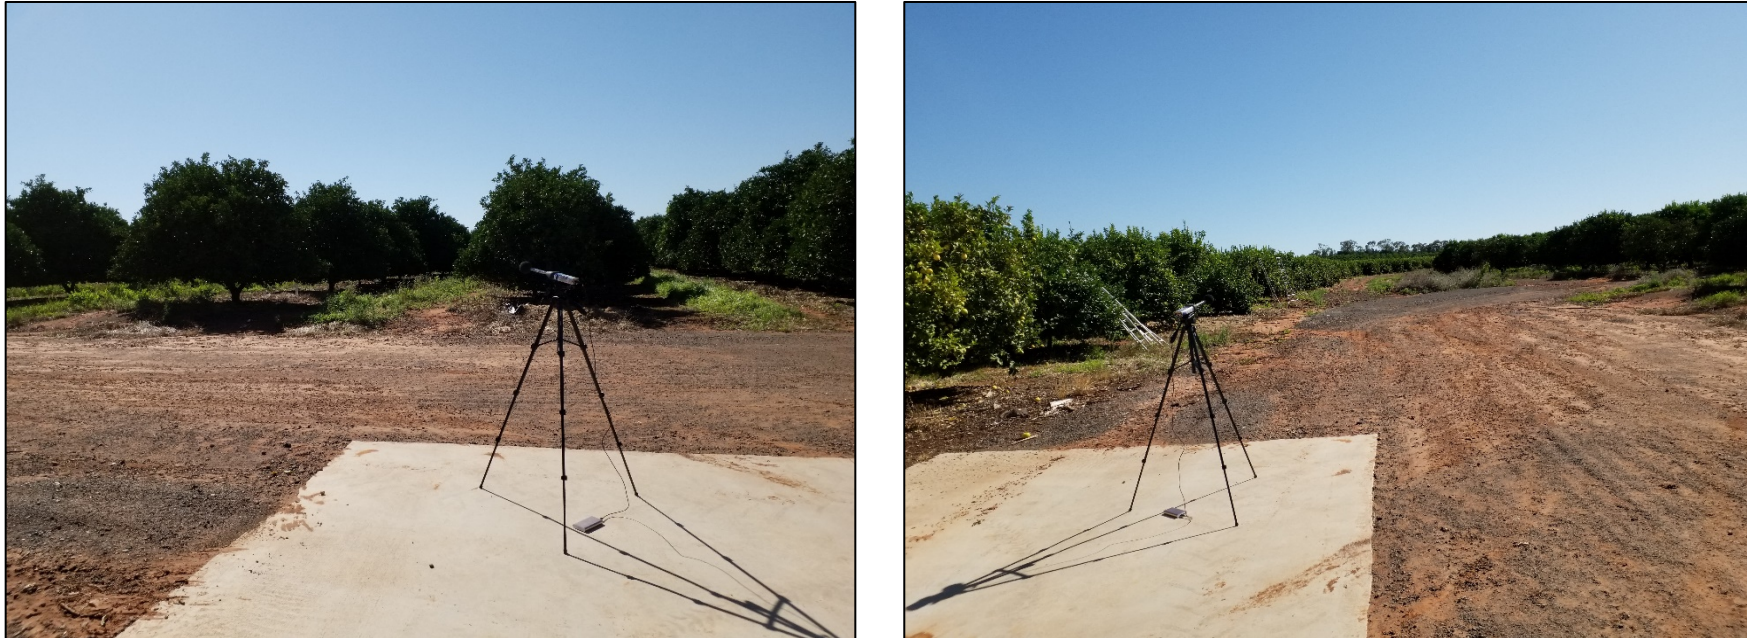
Figure 2-3 Location of noise monitor at residential receiver 3

This sensitive receiver is located approximately 280m off Slopes Road and approximately 1757m from the Tharbogang Quarry. The dwelling is located within an orange orchard with an internal access road connecting it with residential receiver 2. The noise logger was positioned facing northeast into the orange orchard, approximately 25m from the residence (Figure 2-3).

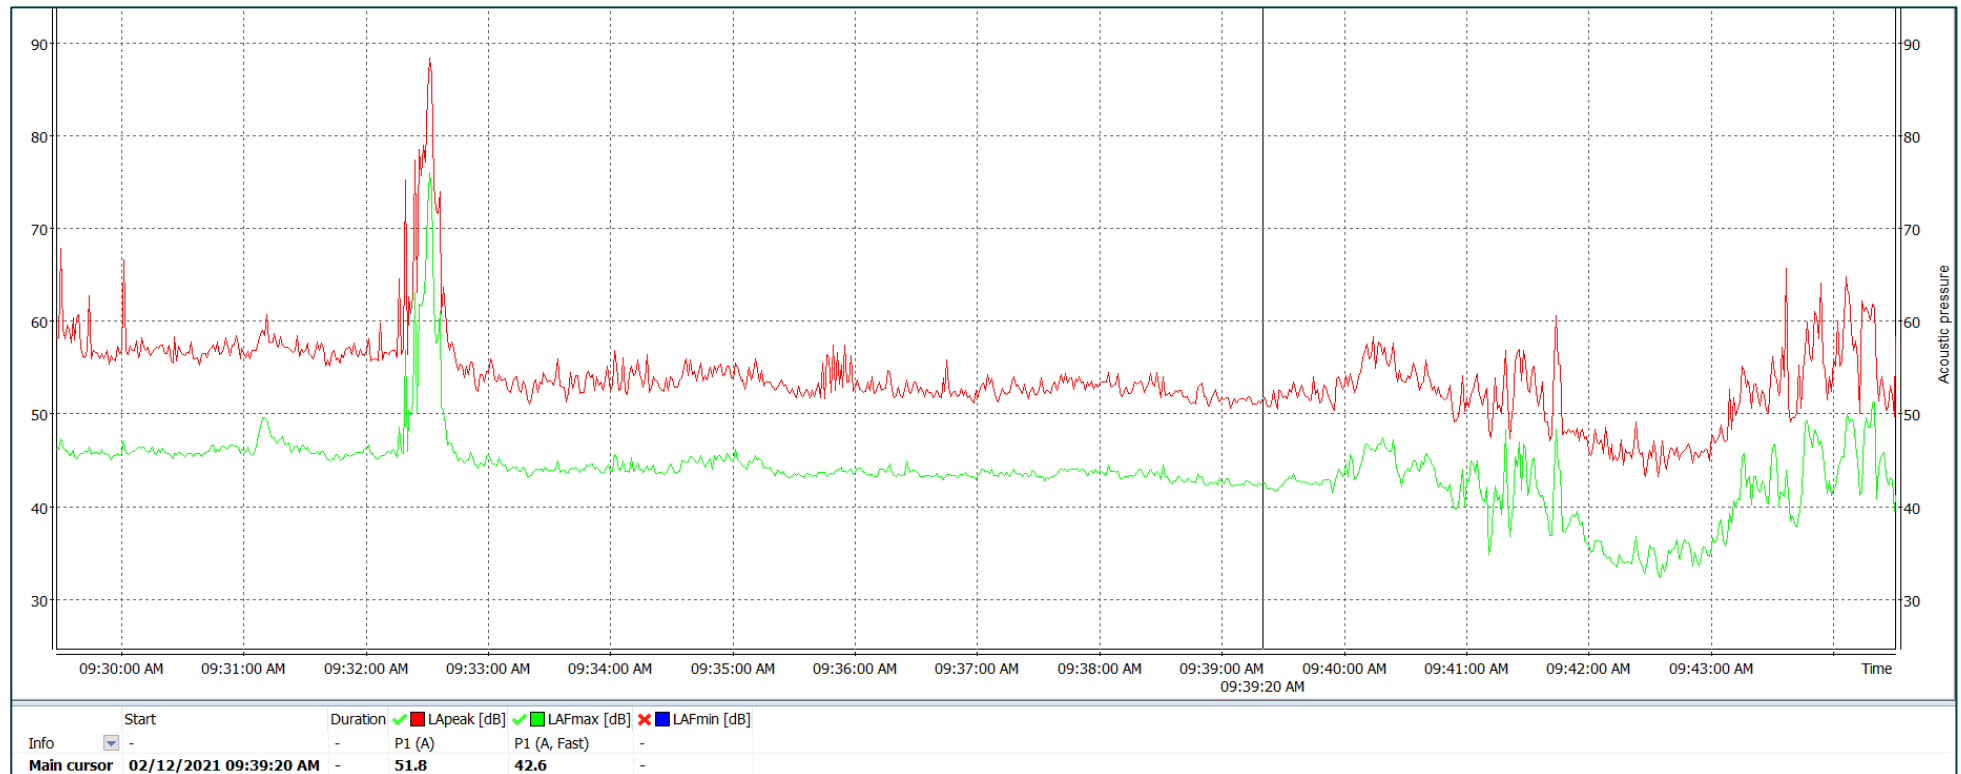
At 9.32am a landholder vehicle drove onto the property and past the noise meter and into the driveway. It idled until 9.42am, which was during the recording period. Background noise consisted of a pool pump, bird activity and vehicle movements on Slopes Road. Operations at the landfill were inaudible. The  $L_{Aeq}$  (15 min) for the period was 42.6dB, which was over the 35  $L_{Aeq}$  (15 min) criterion.

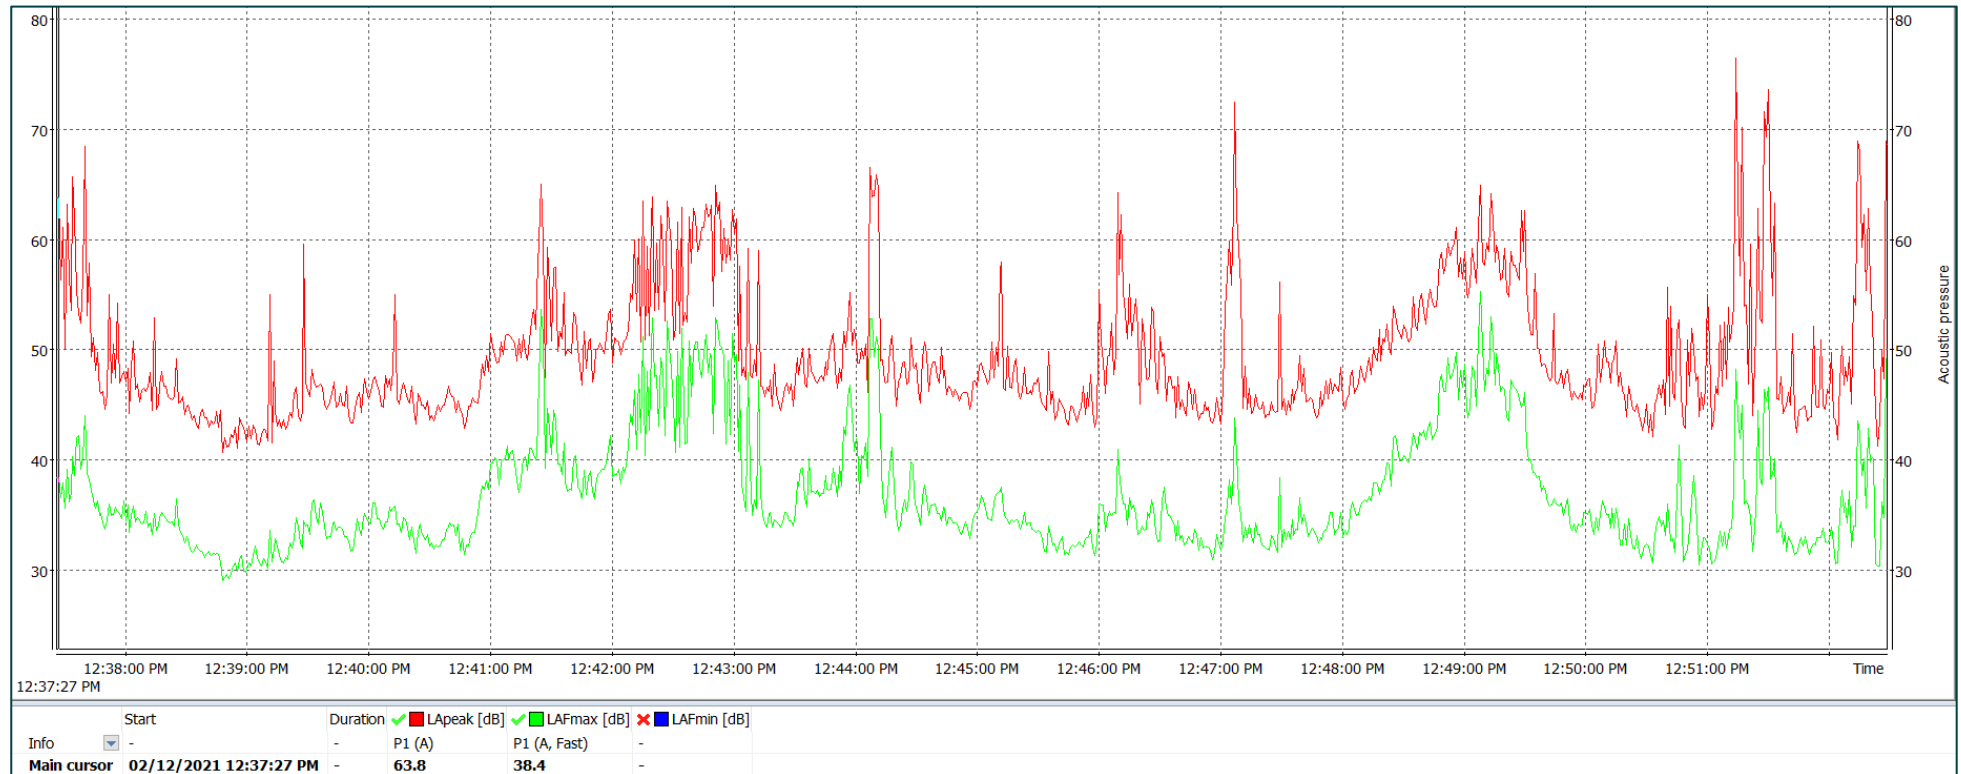
People talking and music could be heard from a shed beside the residence. Background noises included bird noise, the operation of a pool pump and vehicle movements on Slopes Road. The  $L_{Aeq}$  (15 min) for the period was 38.4dB, which was over the 35  $L_{Aeq}$  (15 min) criterion.

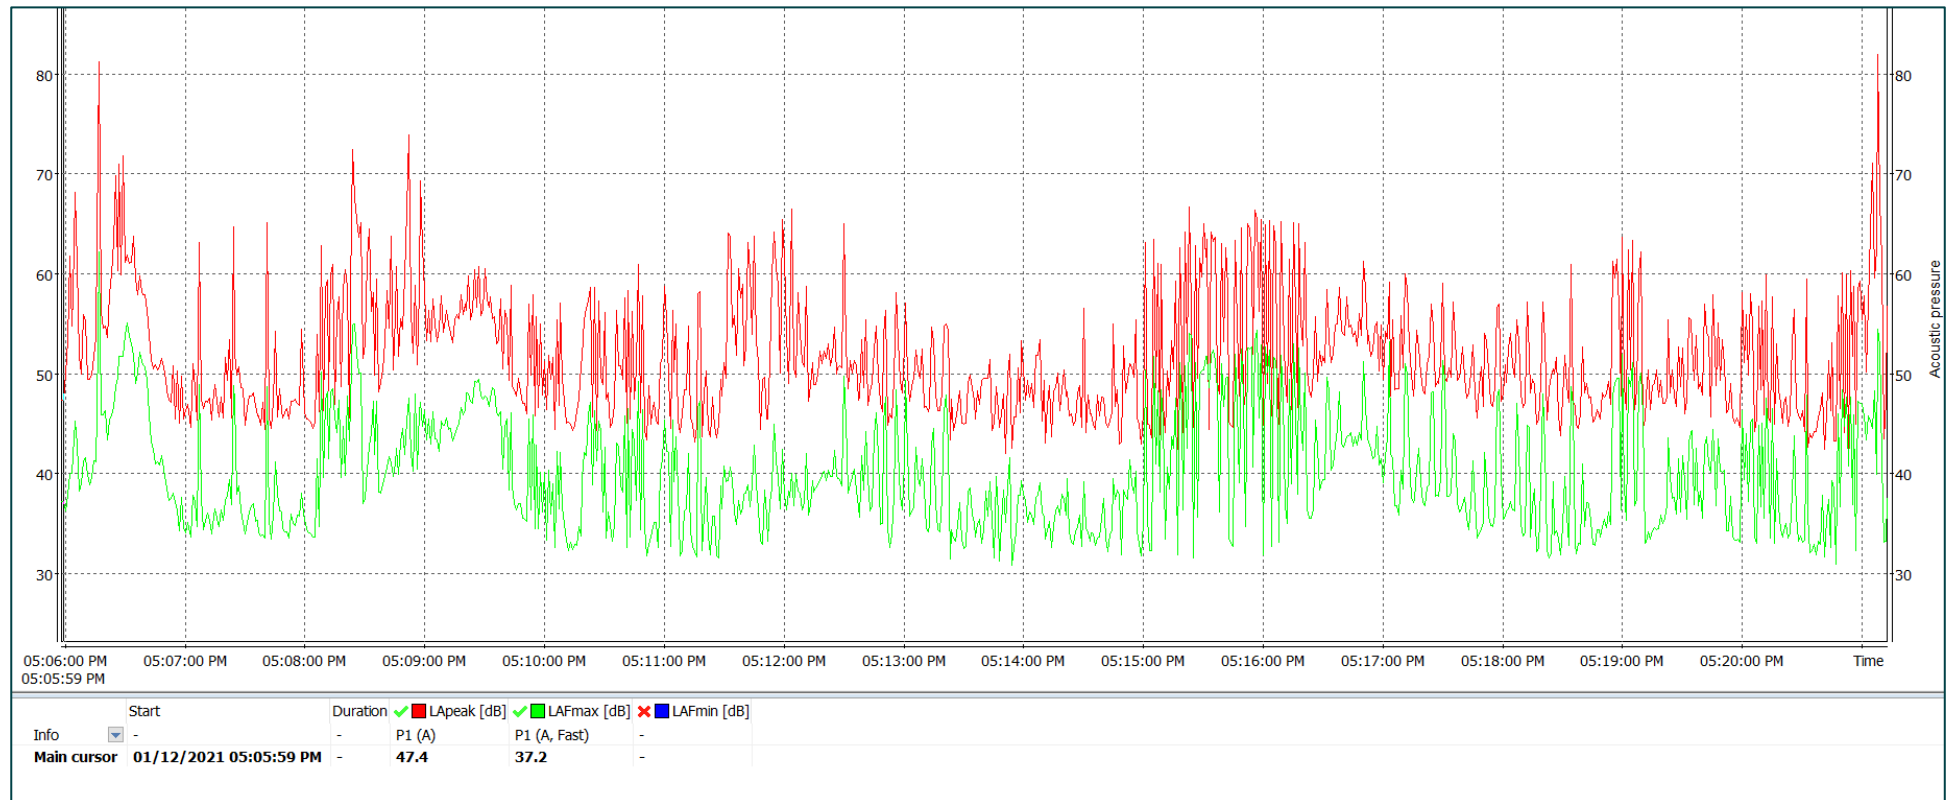
At 5.08pm a landholder vehicle drove down the driveway, opened a motorised garage door and parked. At 5.15pm two voices could be heard talking. Background noises included bird noise, the operation of a pool pump and vehicle movements on Slopes Road. The  $L_{Aeq}$  (15 min) for the period was 37.2dB, which was over the 35  $L_{Aeq}$  (15 min) criterion.

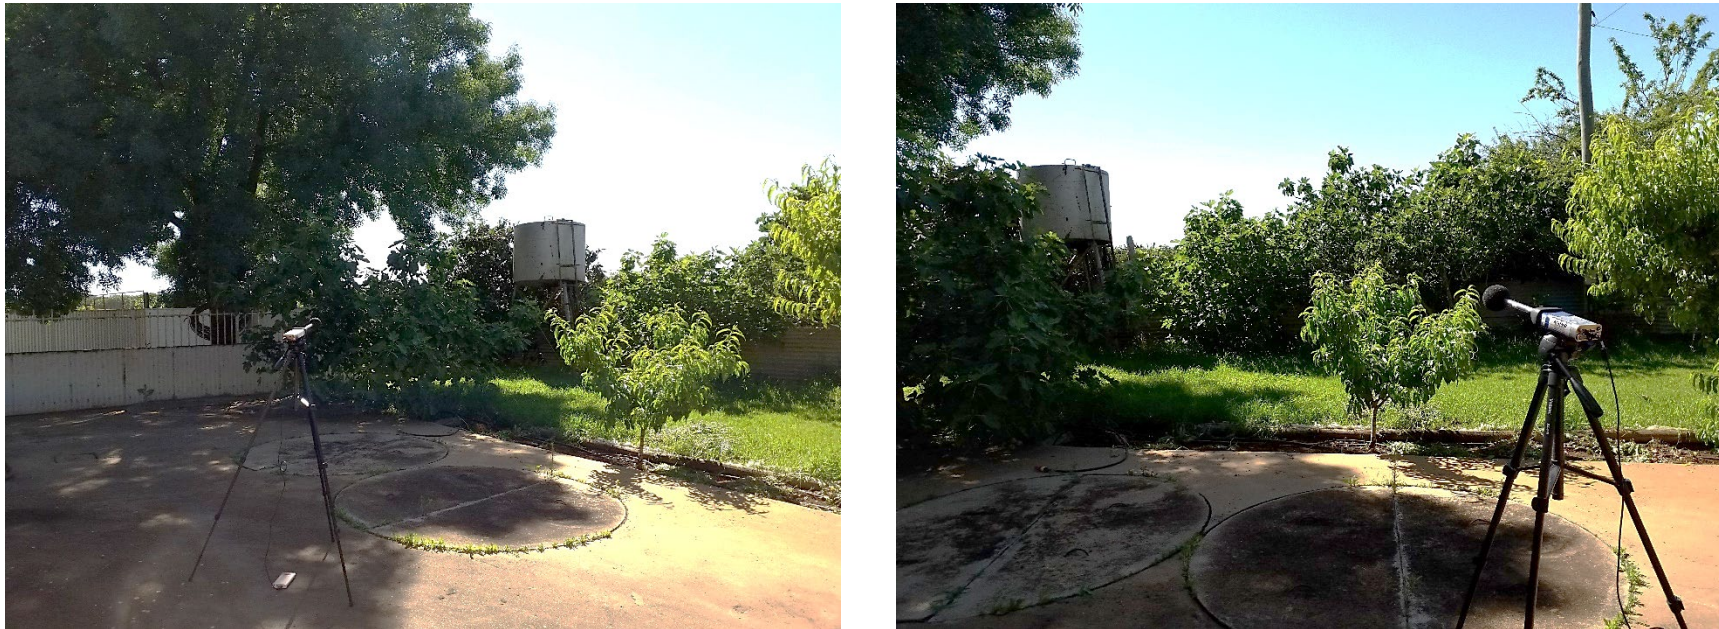
Figure 2-4 Monitoring locations for residential receiver 4

This sensitive receiver is located directly off Slopes Road, approximately 1760m from the Tharbogang Quarry. The residential building is surrounded by tall garden vegetation, which may have offered some protection from background noise emitted from the quarry, while increasing foreground noise emissions from birds, rustling leaves and insects. The noise logger was positioned 5m from the southern external wall of the residence (Figure 2-4).
