# Annual Noise Monitoring Report

## Tharbogang Quarry and Landfill Operations

December 2021

Project Number: 18-393

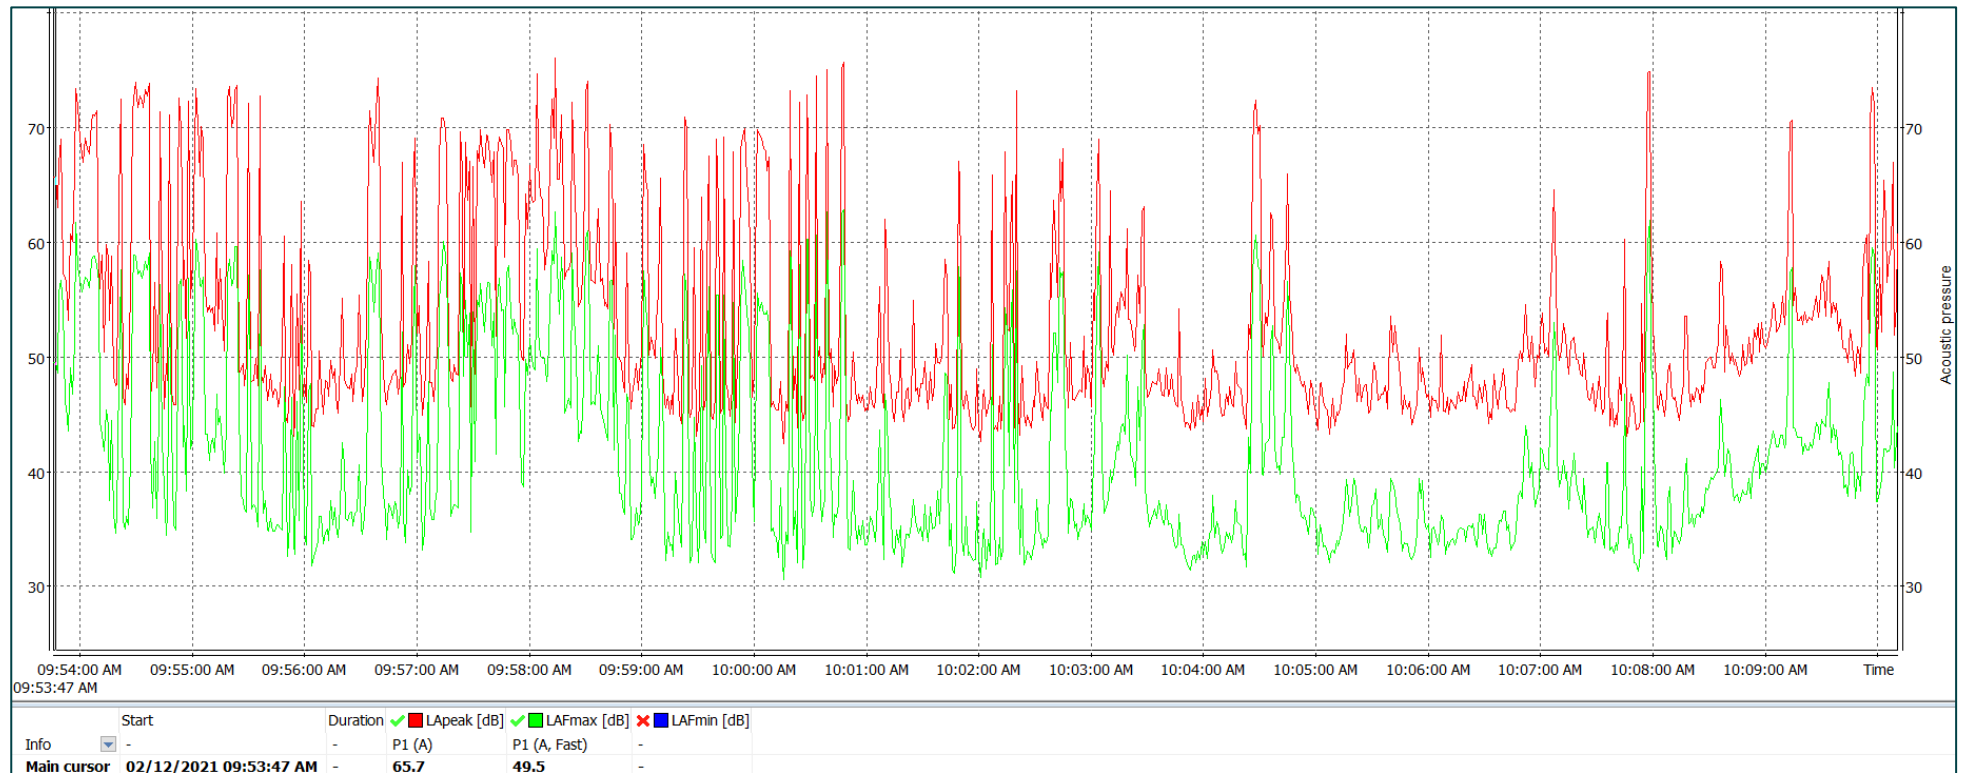
The landholders had engaged a gardening service of three people, who were conducting a pre-start meeting throughout the recording. Background noises included bird activity and traffic on Slopes Road. Operations at the landfill were inaudible. The  $L_{Aeq}$  (15 min) for the period was 49.5dB, which was over the 35  $L_{Aeq}$  (15 min) criterion.

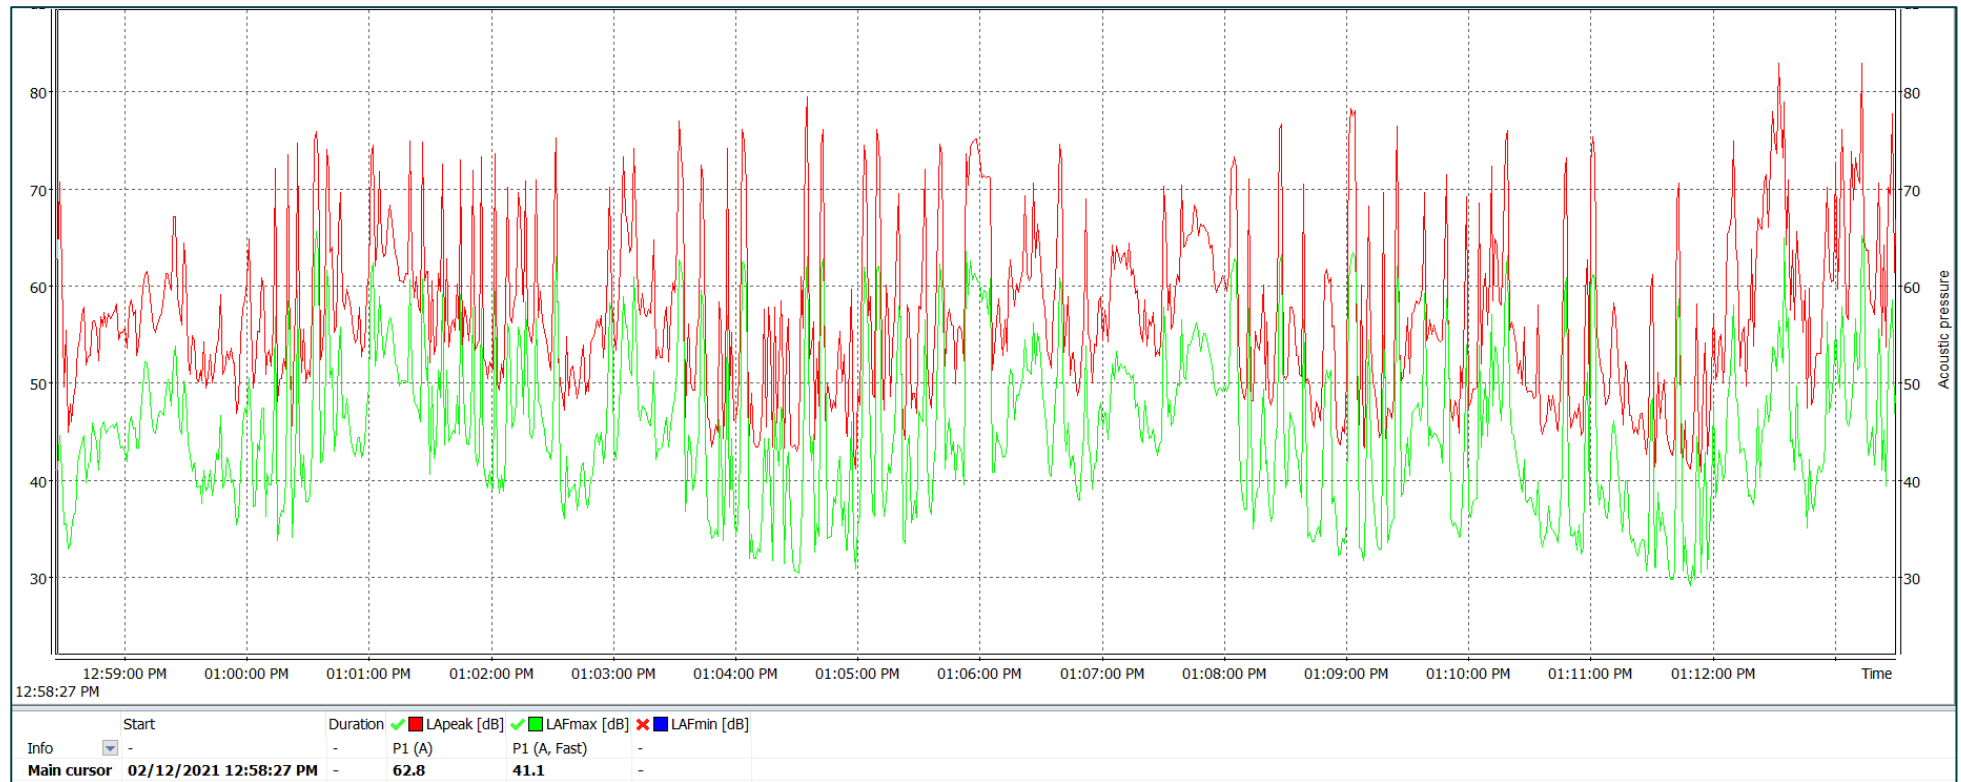
The landholders had engaged a gardening service of three people, who were working throughout the recording. At 1.08pm, one of the workers was observed raking leaves nearby to the noise meter. He continued to work in this location until the noise recording ended. Background noise consisted of people conversing, bird activity and vehicle movements on Slopes Road. Operations at the landfill were inaudible. The  $L_{Aeq}$  (15 min) for the period was 41.1dB, which was over the 35  $L_{Aeq}$  (15 min) criterion.

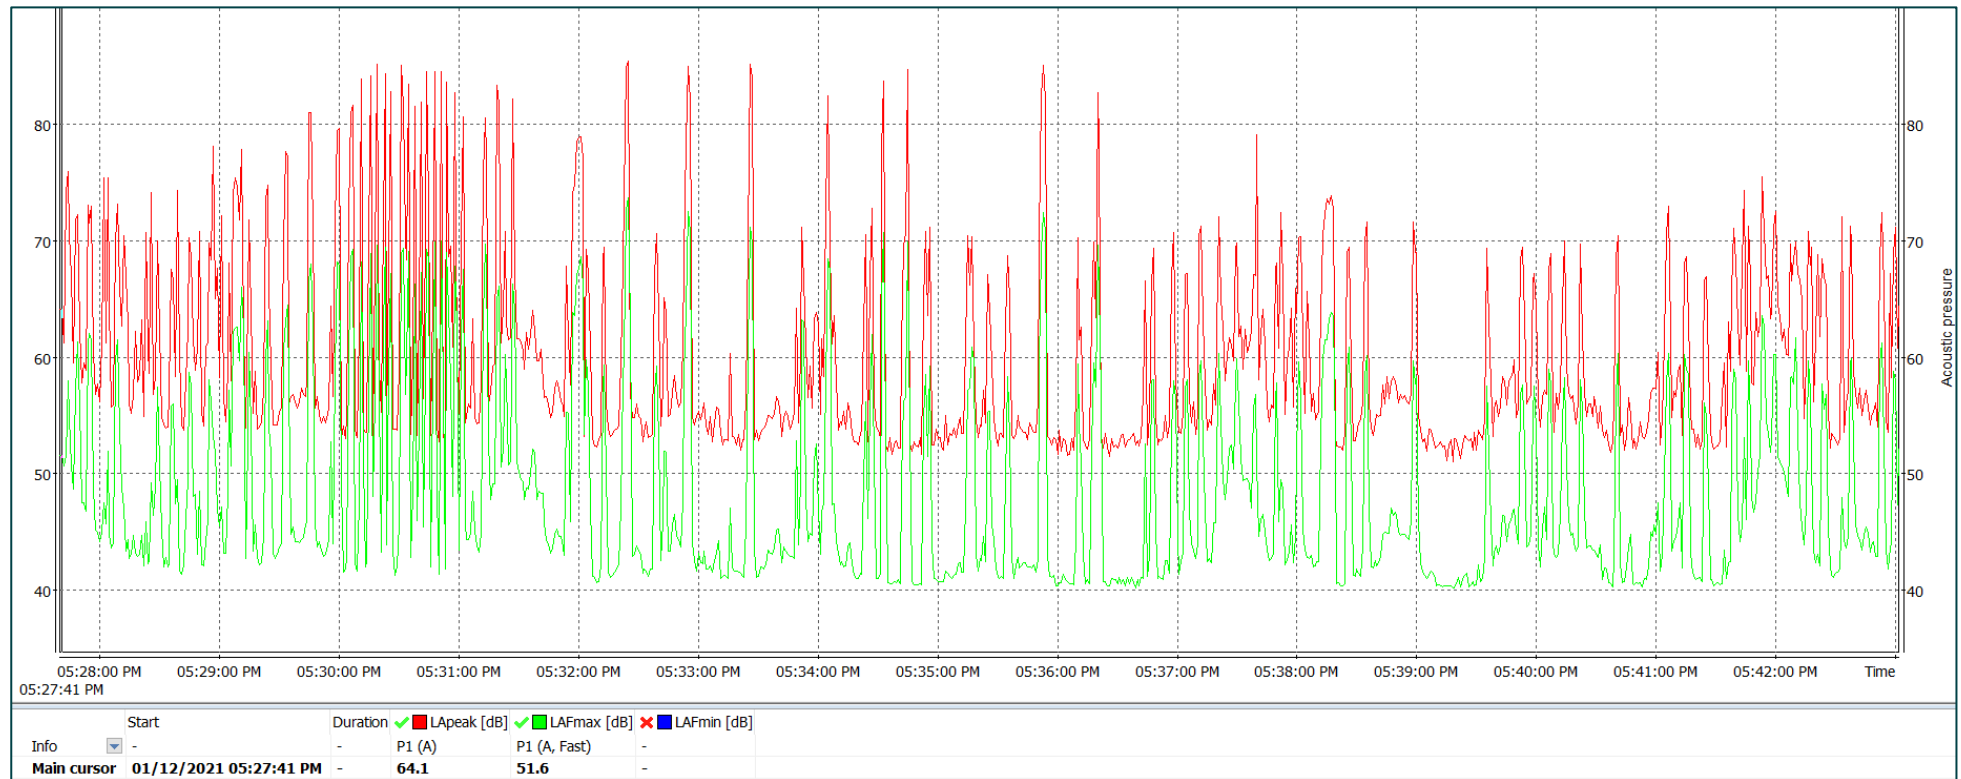
The main noise source detected during this monitoring period was an operational air conditioning unit, which was within proximity to the noise meter. Background noise consisted of bird activity and vehicle movements on Slopes Road. Noting that operations at the development site had ceased for the day, the  $L_{Aeq}$  (15 min) for the period was 51.6dB, which was higher than that observed during operational hours, and over the 35  $L_{Aeq}$  (15 min) criterion.

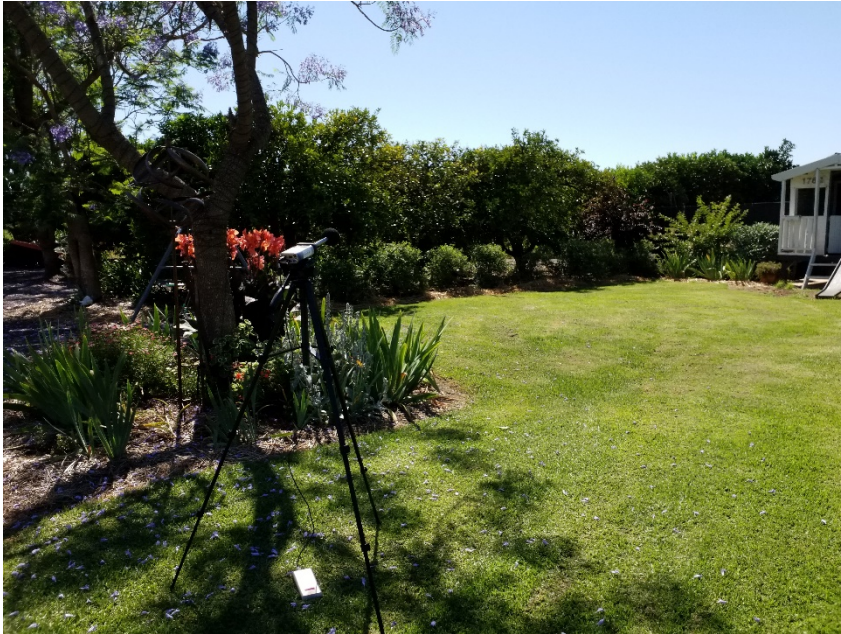
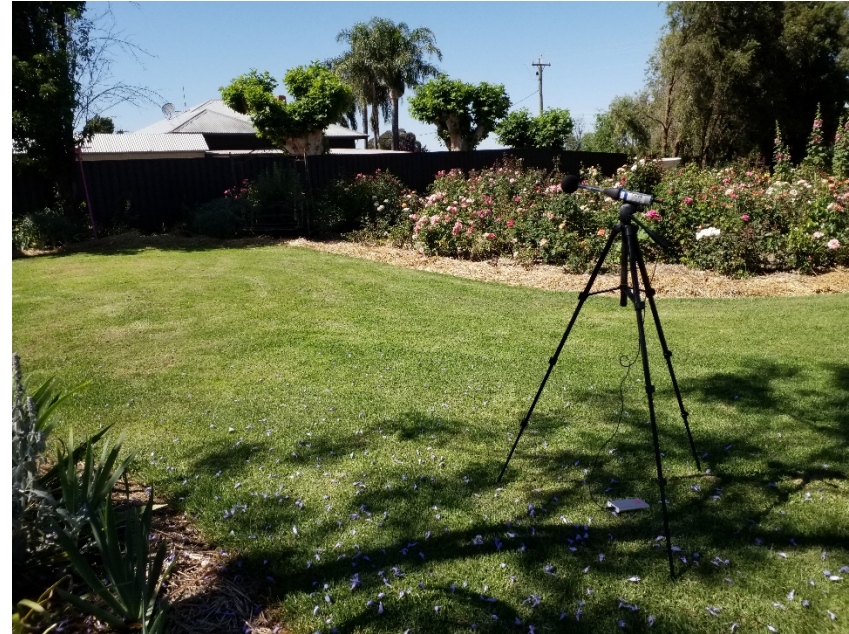
Figure 2-5 Monitoring locations for residential receiver 5

The residential building was surrounded by tall garden vegetation, which may have offered some protection from background noise emitted from the quarry, while increasing foreground noise emissions from birds, rustling leaves and insects. The noise logger was positioned at the end of the driveway, approximately 30m from the south-eastern wall of the dwelling, facing northeast (Figure 2-5).

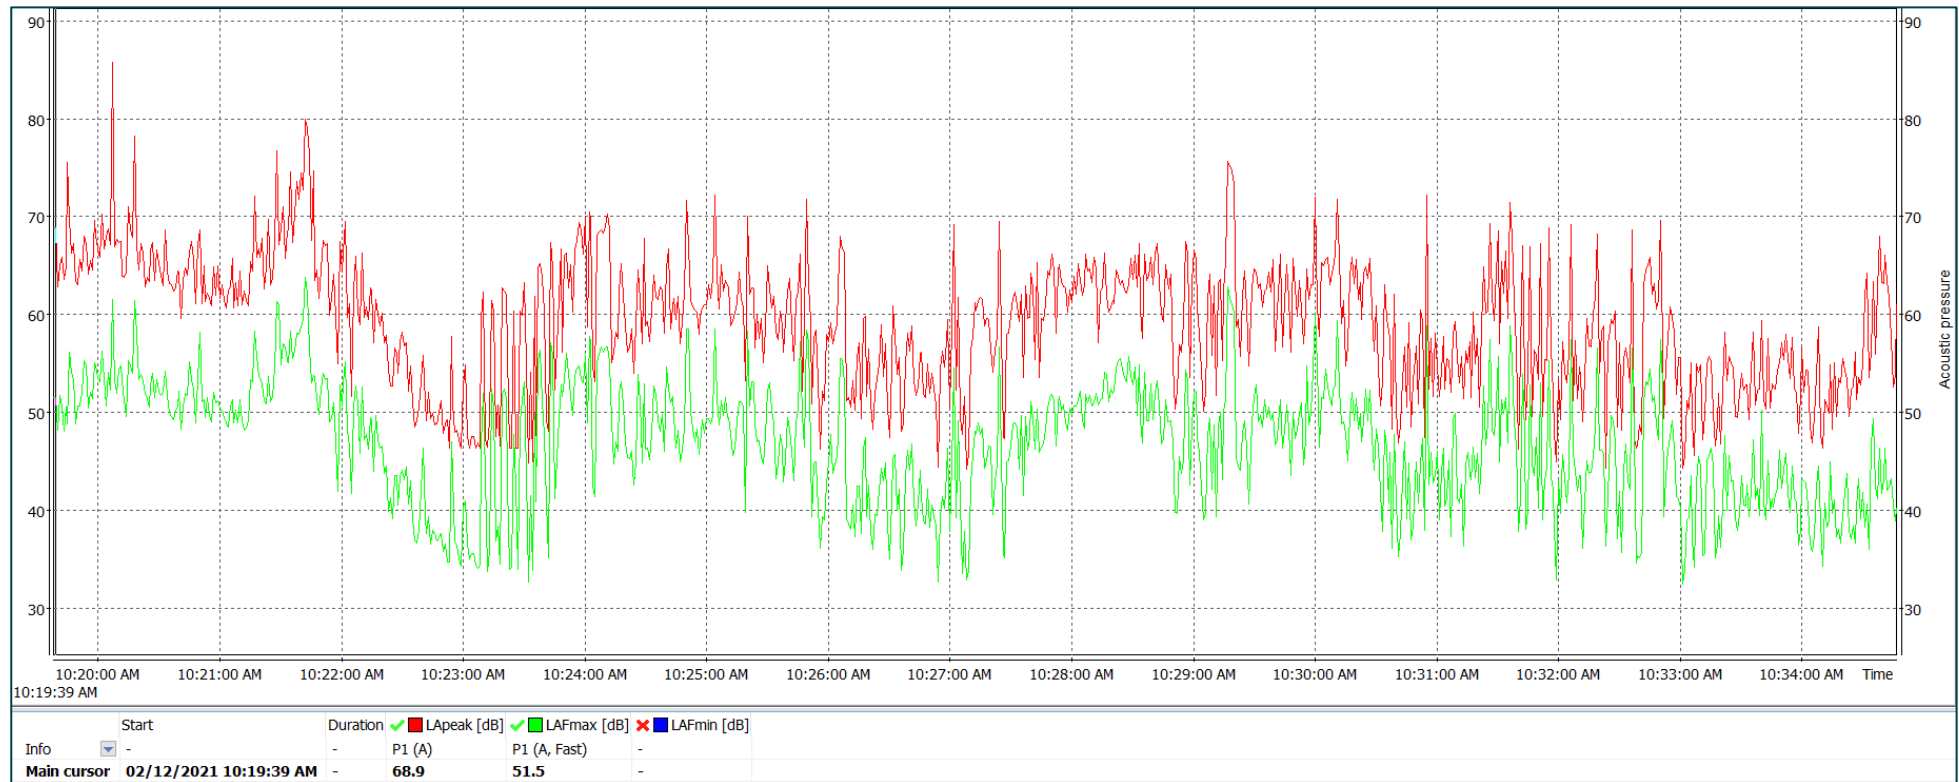
During the recording, two people were observed talking within 15m of the monitoring device. The people proceeded to pack some things into a nearby vehicle, before re-entering the house. Background noises included bird activity and traffic on Slopes Road. Operations at the landfill were inaudible. The  $L_{Aeq}$  (15 min) for the period was 51.5dB, which was over the 35  $L_{Aeq}$  (15 min) criterion.

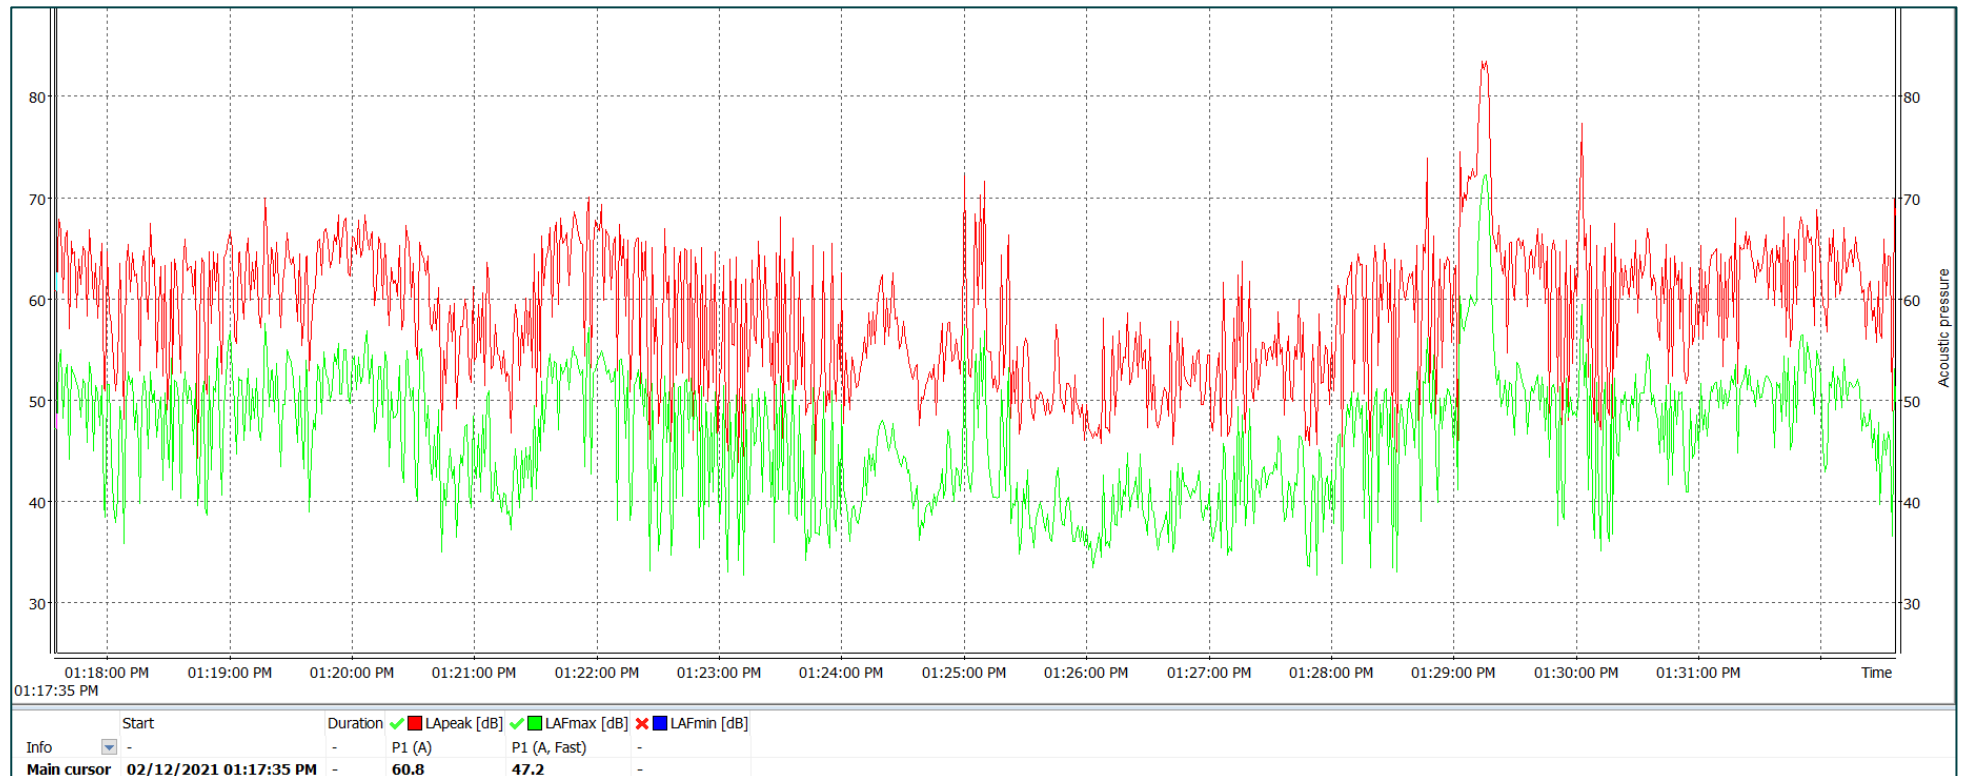
At 1.29pm, a landholder drove a vehicle onto the property and parked within proximity to the noise meter. Background noises included bird activity, wind in the trees and traffic on Slopes Road. Operations at the landfill were inaudible. The  $L_{Aeq}$  (15 min) for the period was 47.2dB, which was over the 35  $L_{Aeq}$  (15 min) criterion.

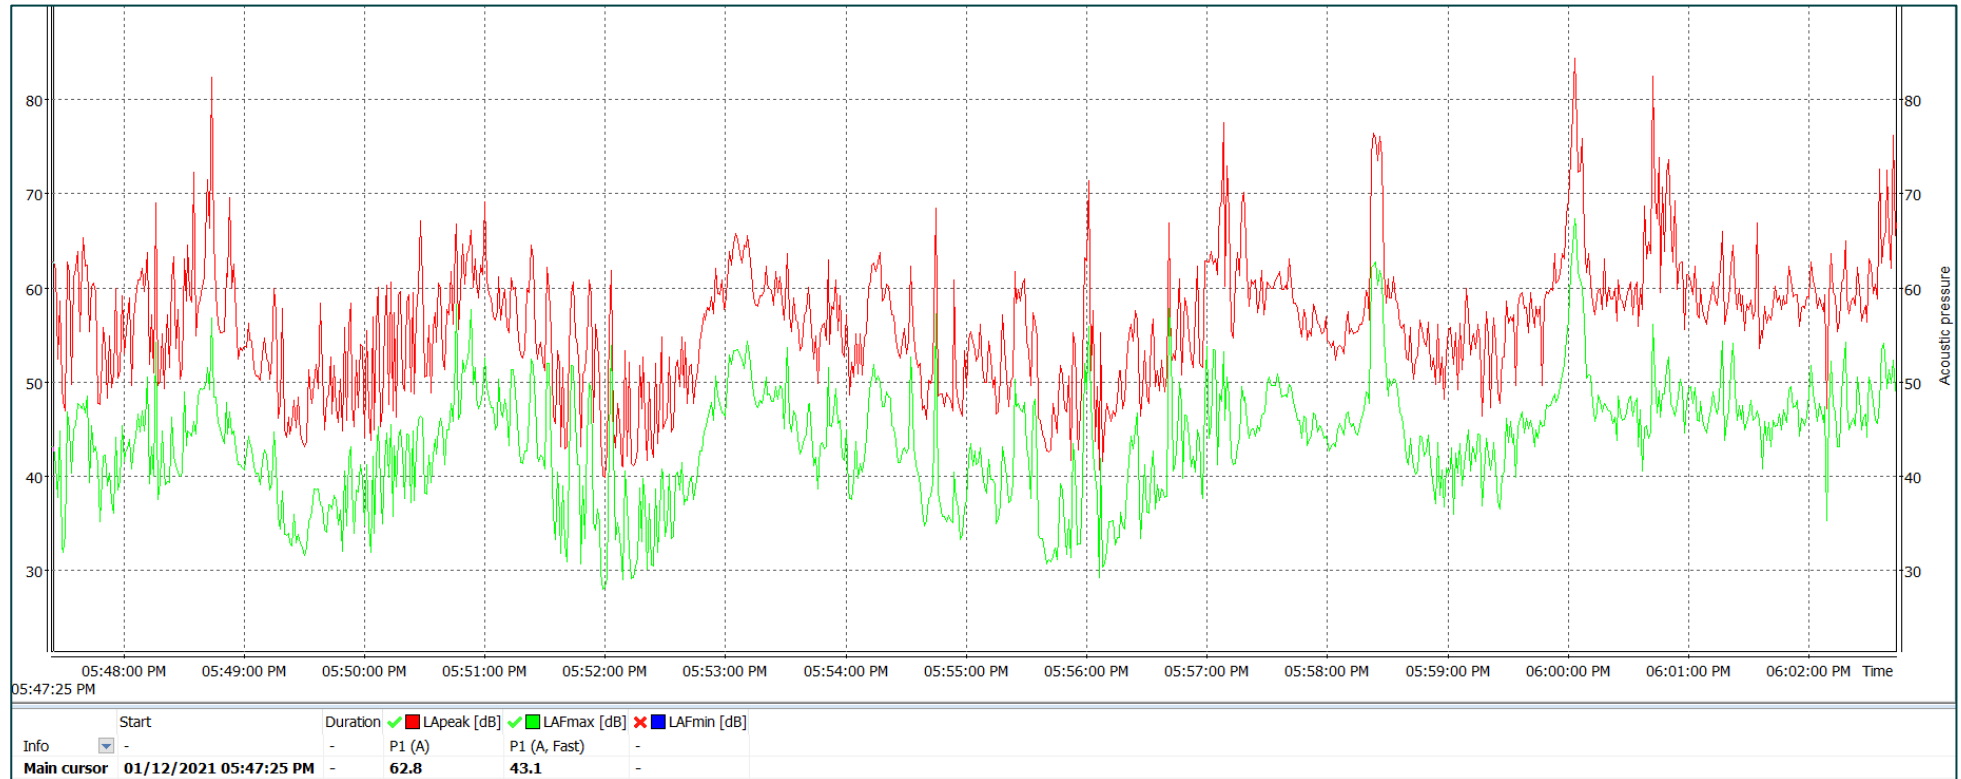
During this recording, background noises included bird activity, wind in the trees and traffic on Slopes Road. Noting that operations at the development site had ceased for the day, the  $L_{Aeq}$  (15 min) for this monitoring period was 43.1dB, which is higher than the 35  $L_{Aeq}$  (15 min) criterion.

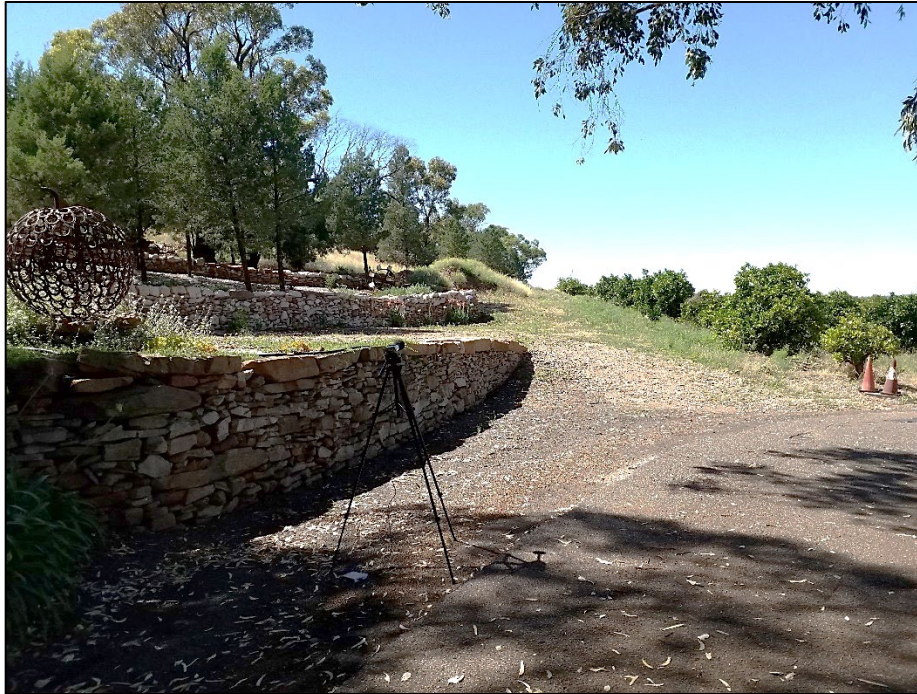
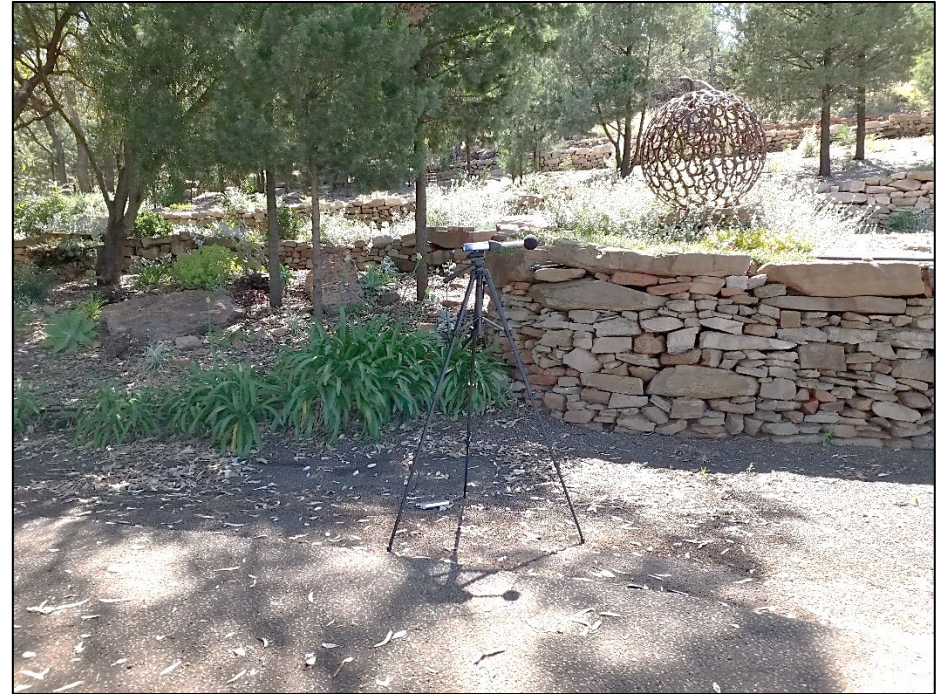
Figure 2-6 Monitoring locations for residential receiver 6

This sensitive receiver is located approximately 980m off Slopes Road and approximately 1020m from Tharbogang Quarry. The residence is situated overlooking an orange orchard to the south and was buffered by rocky hillside from the quarry to the southeast. The noise logger was positioned facing southeast, approximately 35m from the residence, at the edge of the orange orchard (Figure 2-6).

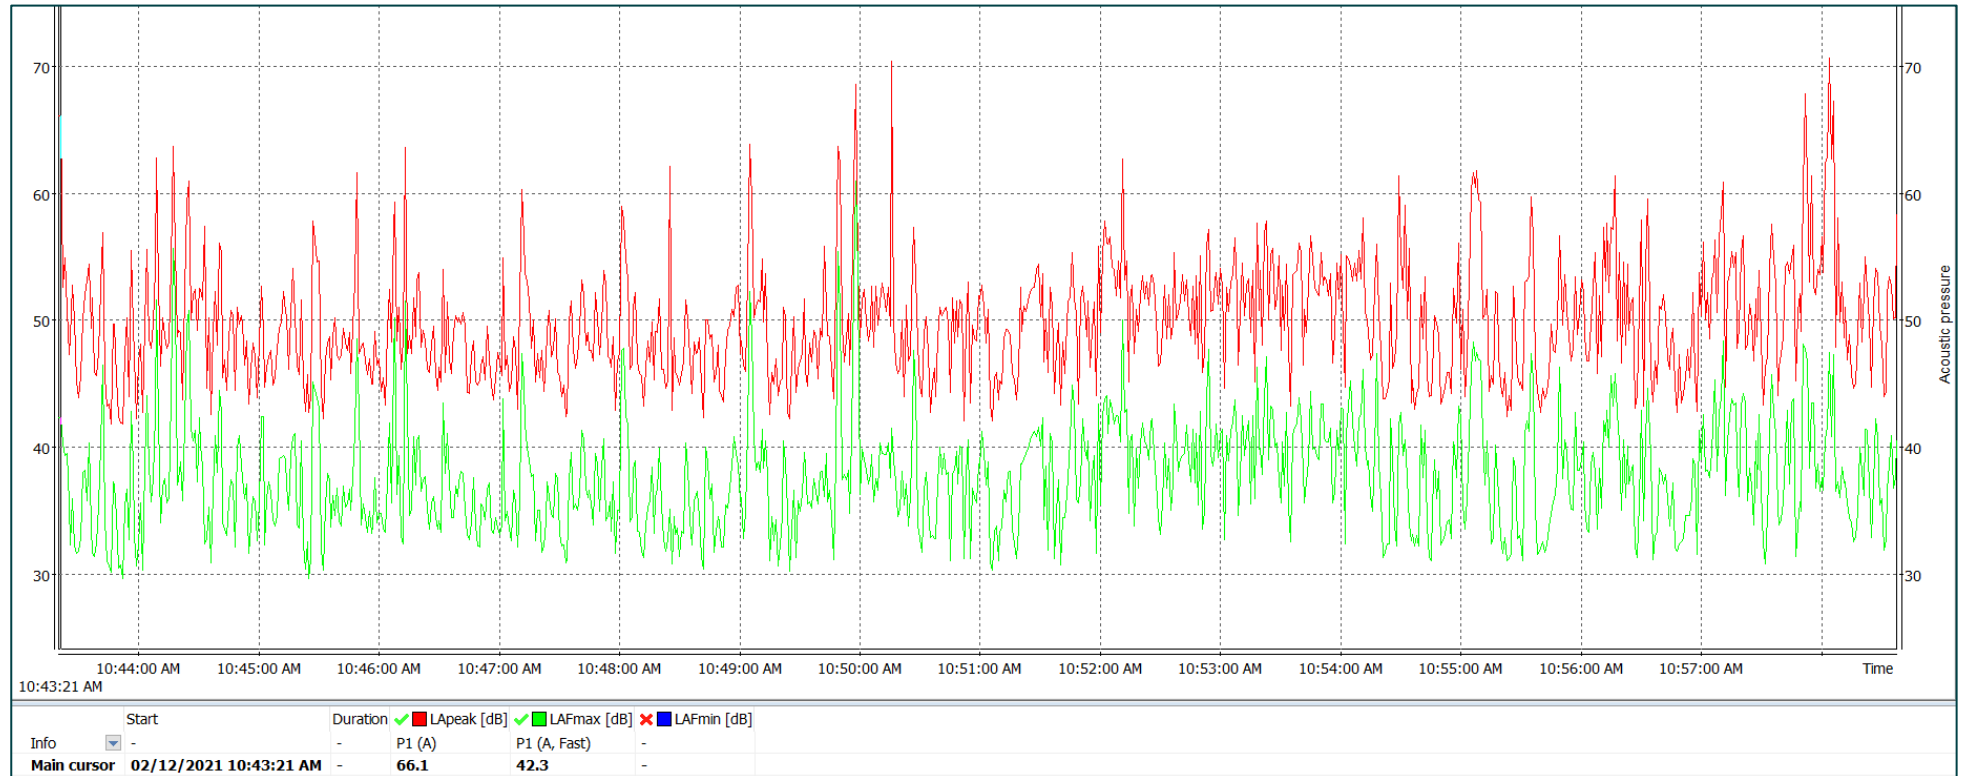
Dominant noises included bird activity and wind in nearby trees. Operations at the landfill were inaudible. The  $L_{Aeq}$  (15 min) attended monitoring period was 42.3dB, exceeding the 35  $L_{Aeq}$  (15 min) criteria.

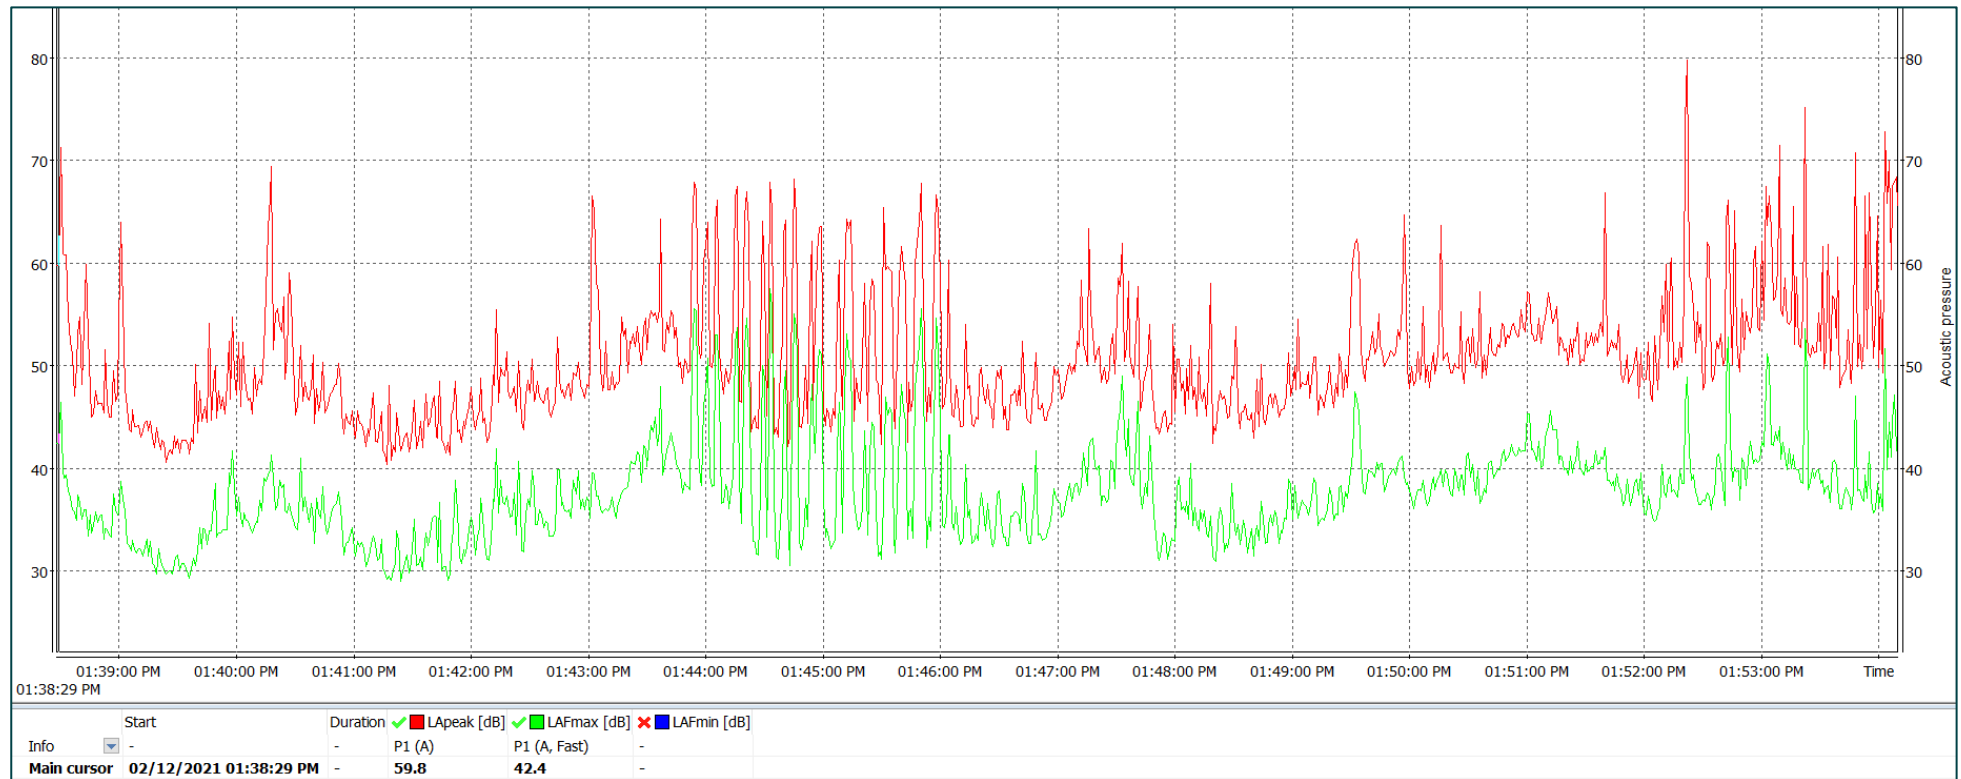
At 1.44pm the landholder was observed at the front of the house with a ladder. At 1.52pm the landholder greeted the onsite consultant. Background noises included bird activity and traffic along Kidman Way. Operations at the landfill were inaudible. The  $L_{Aeq}$  (15 min) attended monitoring period was 42.4dB, exceeding the 35  $L_{Aeq}$  (15 min) criteria.

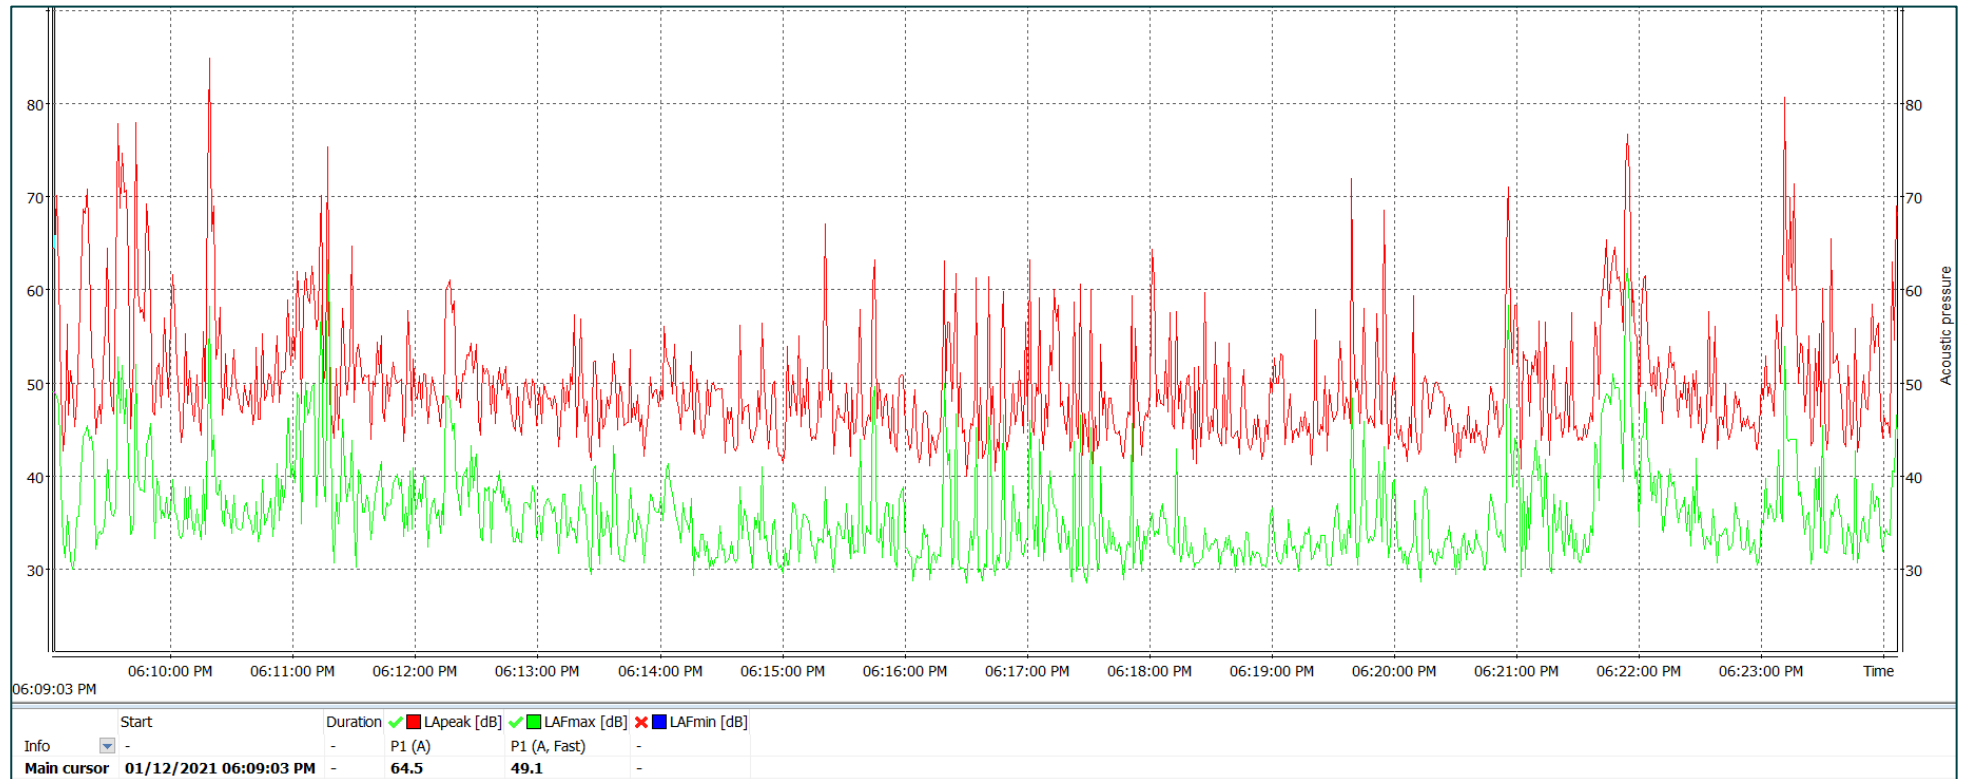
Dominant noises included bird activity, wind rustling the trees and road noise from Kidman Way. Noting that operations at the development site had ceased for the day, the  $L_{Aeq}$  (15 min) for this monitoring period was 49.1dB, which is higher than previous recordings and the 35  $L_{Aeq}$  (15 min) criterion.

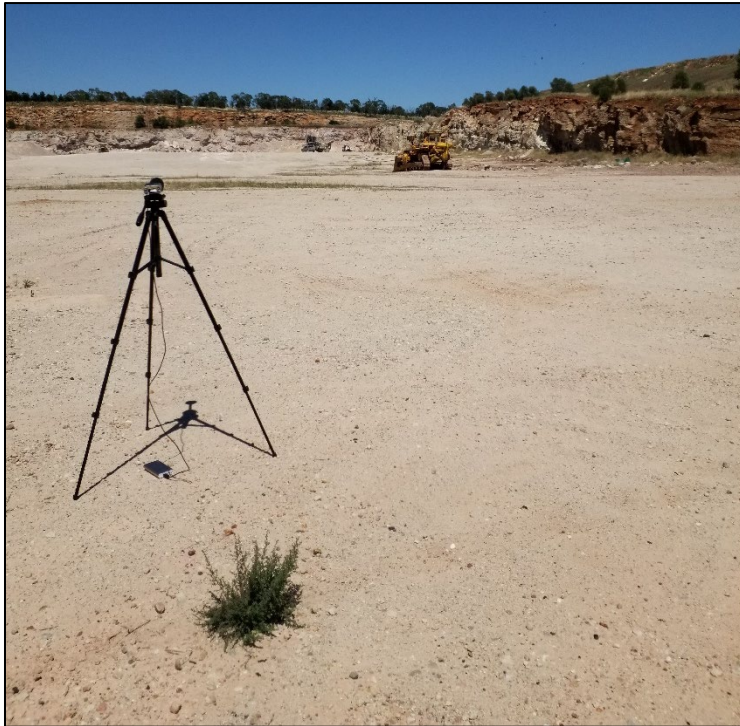
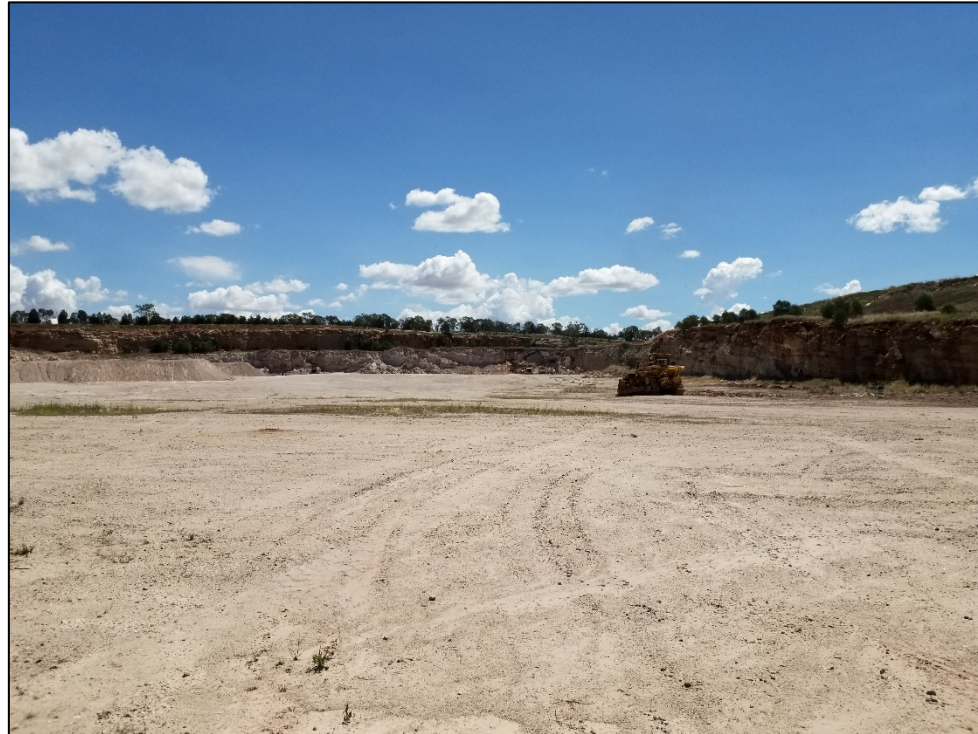
Figure 2-7 Noise monitoring location for Quarry location 1

The noise logger was positioned facing into the quarry, in a southwest direction, approximately 200m from operational machinery (Figure 2-7).

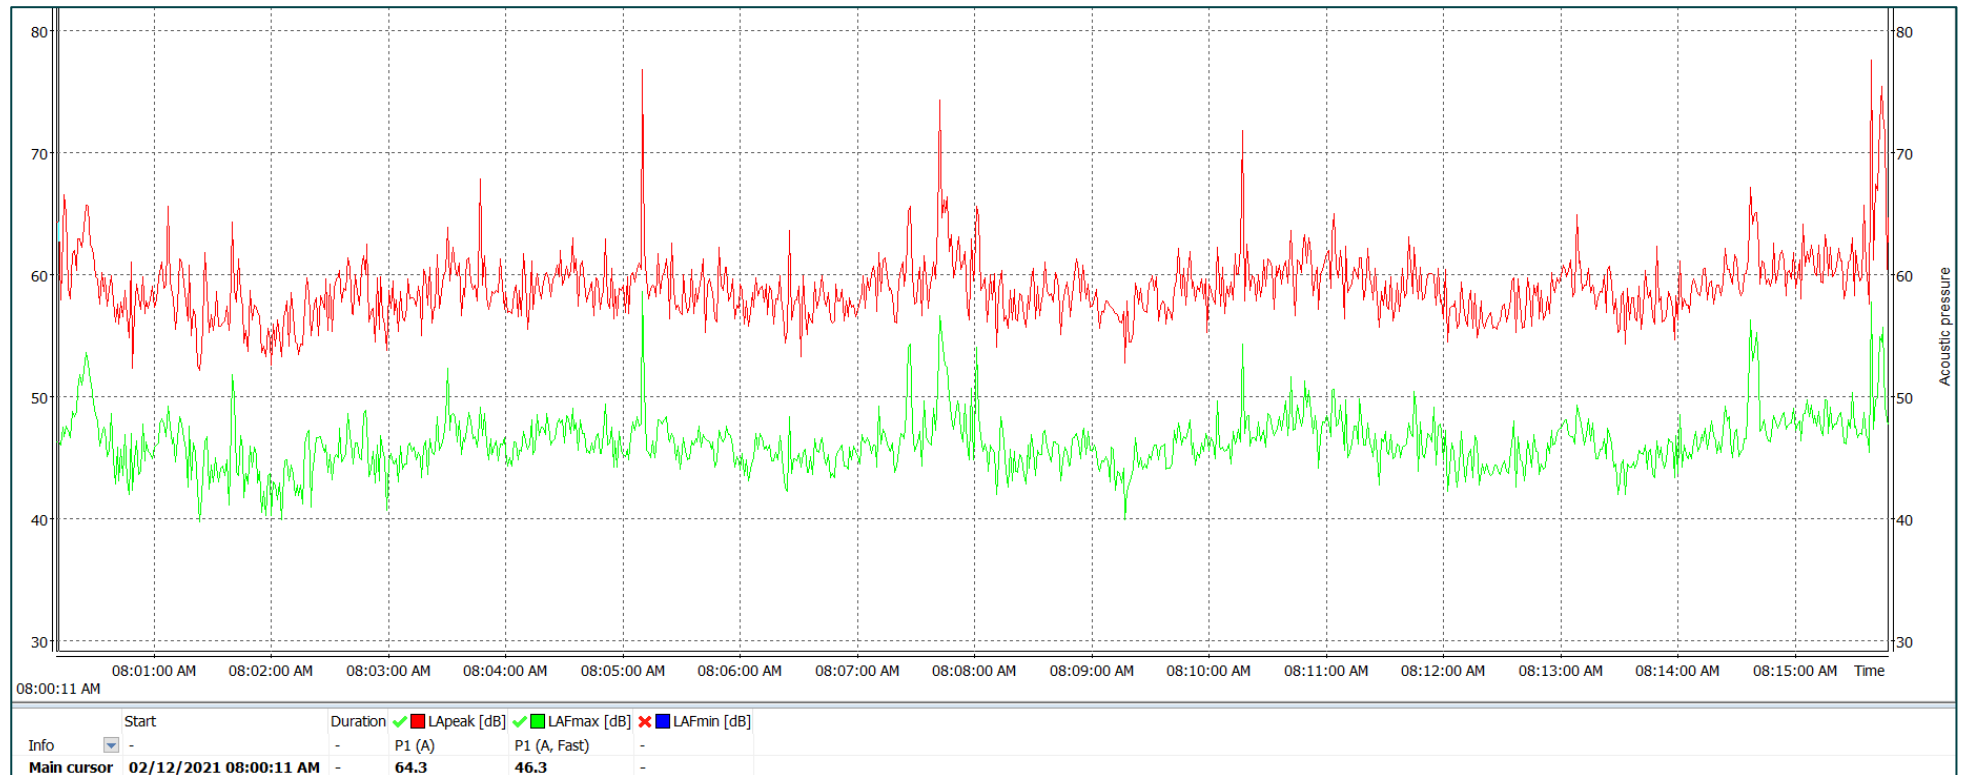
An on-site processing plant, excavator and two light vehicles were observed during the recording periods. At the time of monitoring a number of heavy vehicles arrived onsite to deliver waste and one light vehicle entered and exited the site. Background noises included bird activity. The  $L_{Aeq}$  (15 min) for the monitoring period was 46.3dB, which was above the 35  $L_{Aeq}$  (15 min) assessment criterion but lower than the morning  $L_{Aeq}$  (15 min) recorded for receivers 1, 2, 4 and 5.

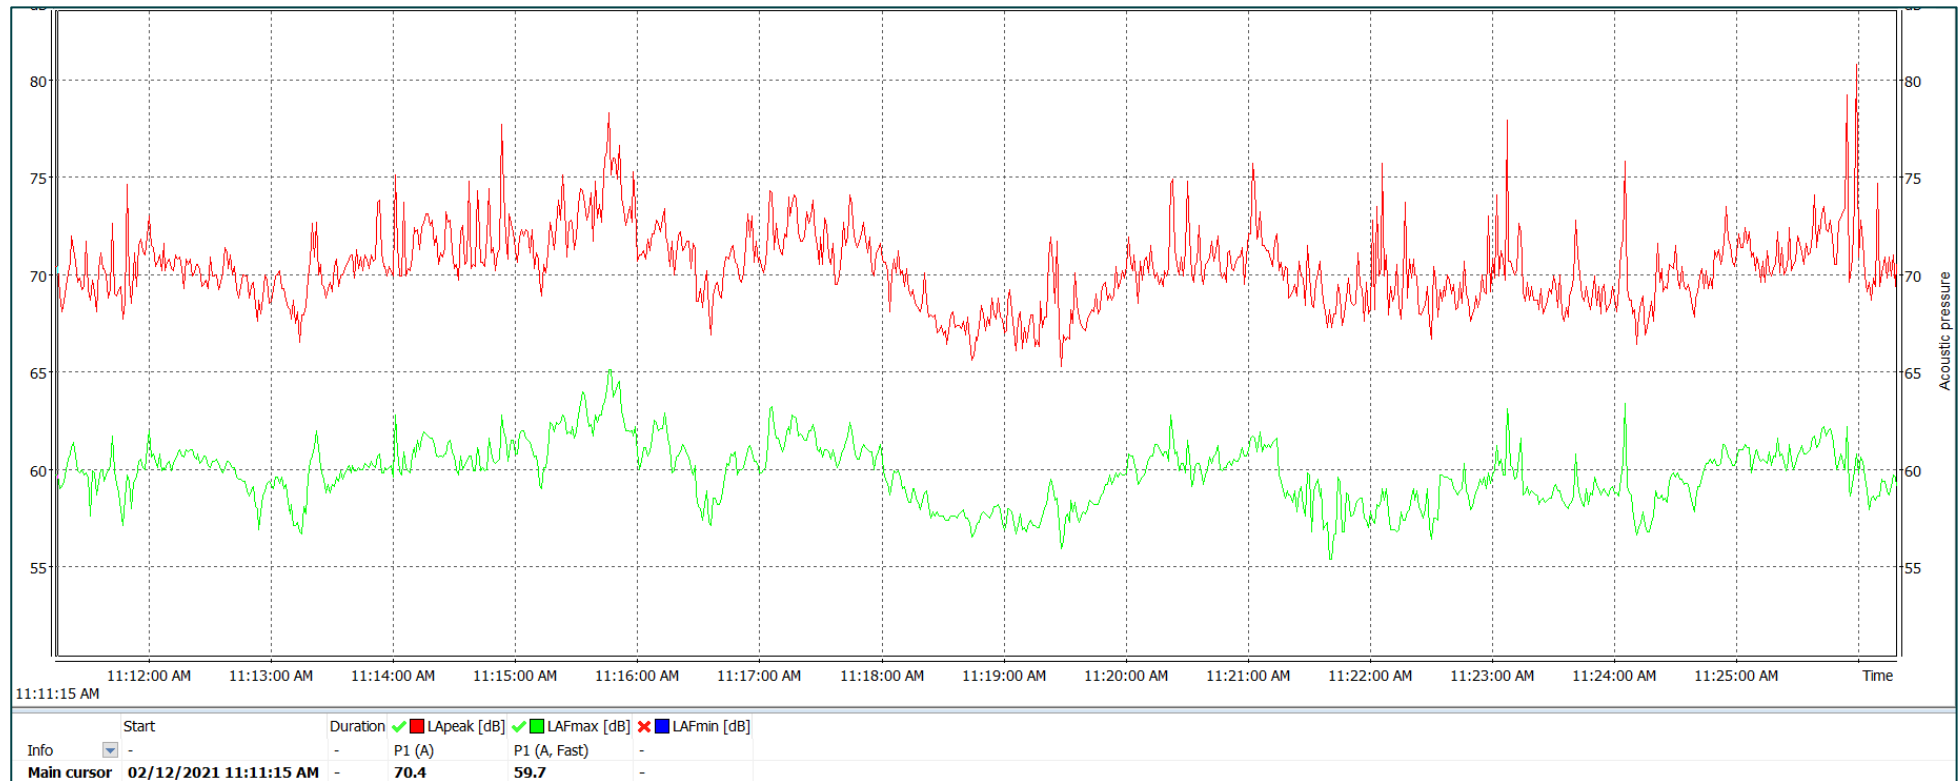
An on-site processing plant, excavator and two light vehicles were observed during the recording period. At the time of monitoring a number of heavy vehicles arrived onsite to deliver waste. Background noises included bird activity. The  $L_{Aeq}$  (15 min) for the monitoring period was 59.7dB, which was above the 35  $L_{Aeq}$  (15 min) assessment criterion but lower than the midday  $L_{Aeq}$  (15 min) recorded for receiver 1.
