# Annual Noise Monitoring Report

## Tharbogang Quarry and Landfill Operations

December 2021

Project Number: 18-393

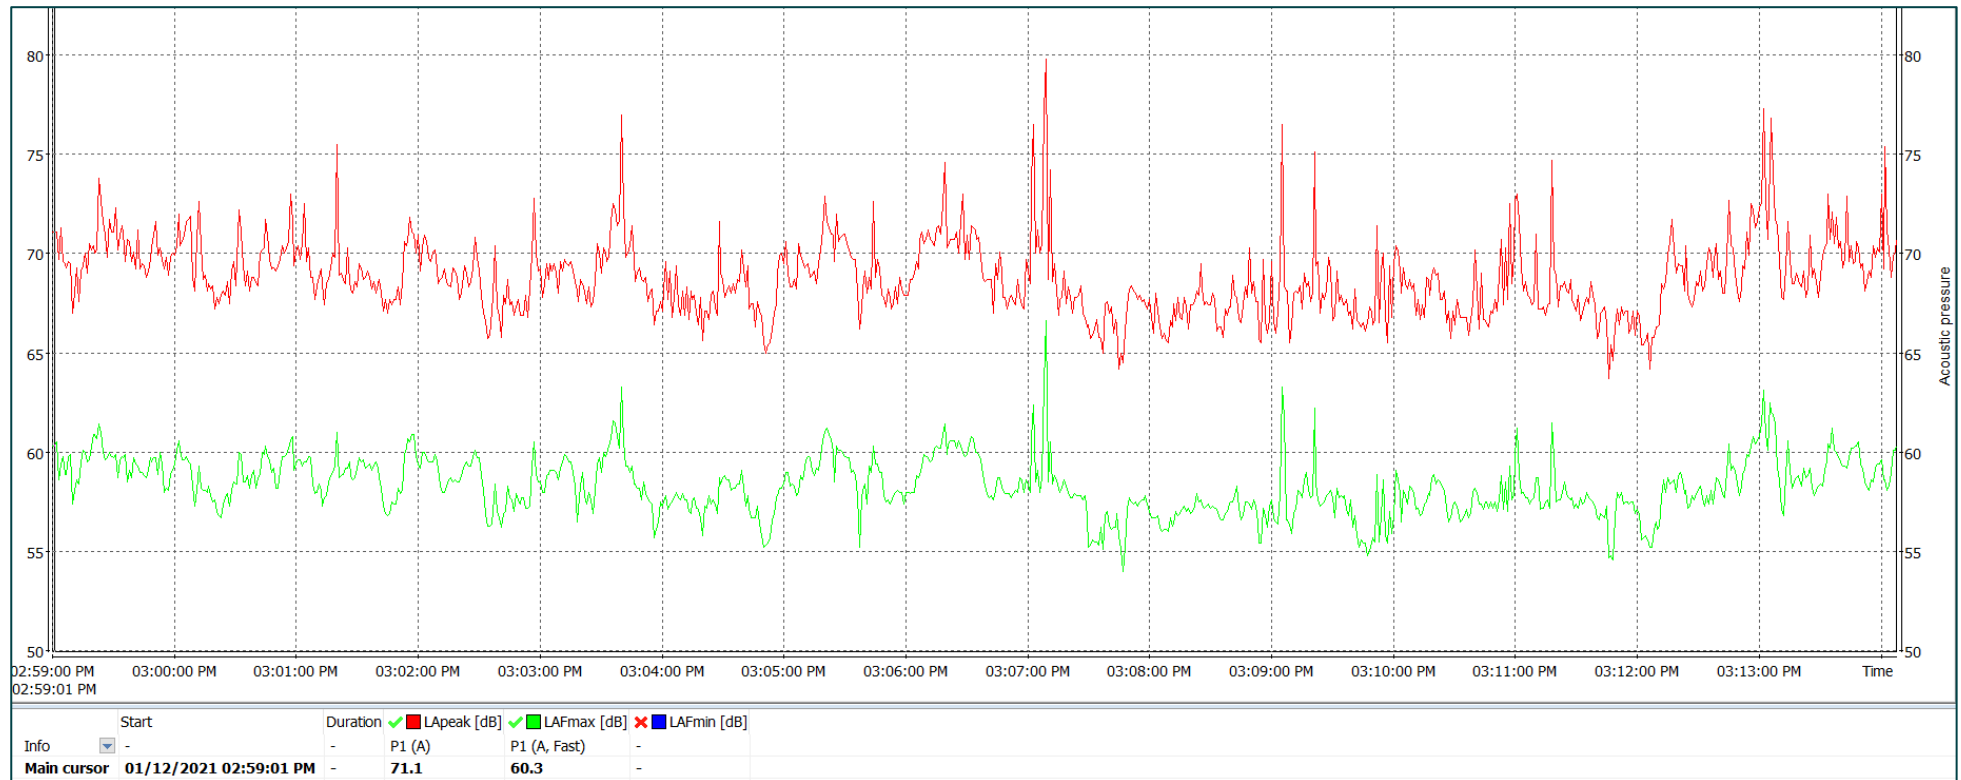
An on-site processing plant, front end loader and two light vehicles were observed during the recording periods. At the time of monitoring one heavy vehicle arrived onsite to deliver waste and one light vehicle entered and exited the site. Background noises included bird activity. The  $L_{Aeq}$  (15 min) for the monitoring period was 60.3dB, which was above the 35  $L_{Aeq}$  (15 min) assessment criterion but lower than the afternoon  $L_{Aeq}$  (15 min) recorded for receiver 1.

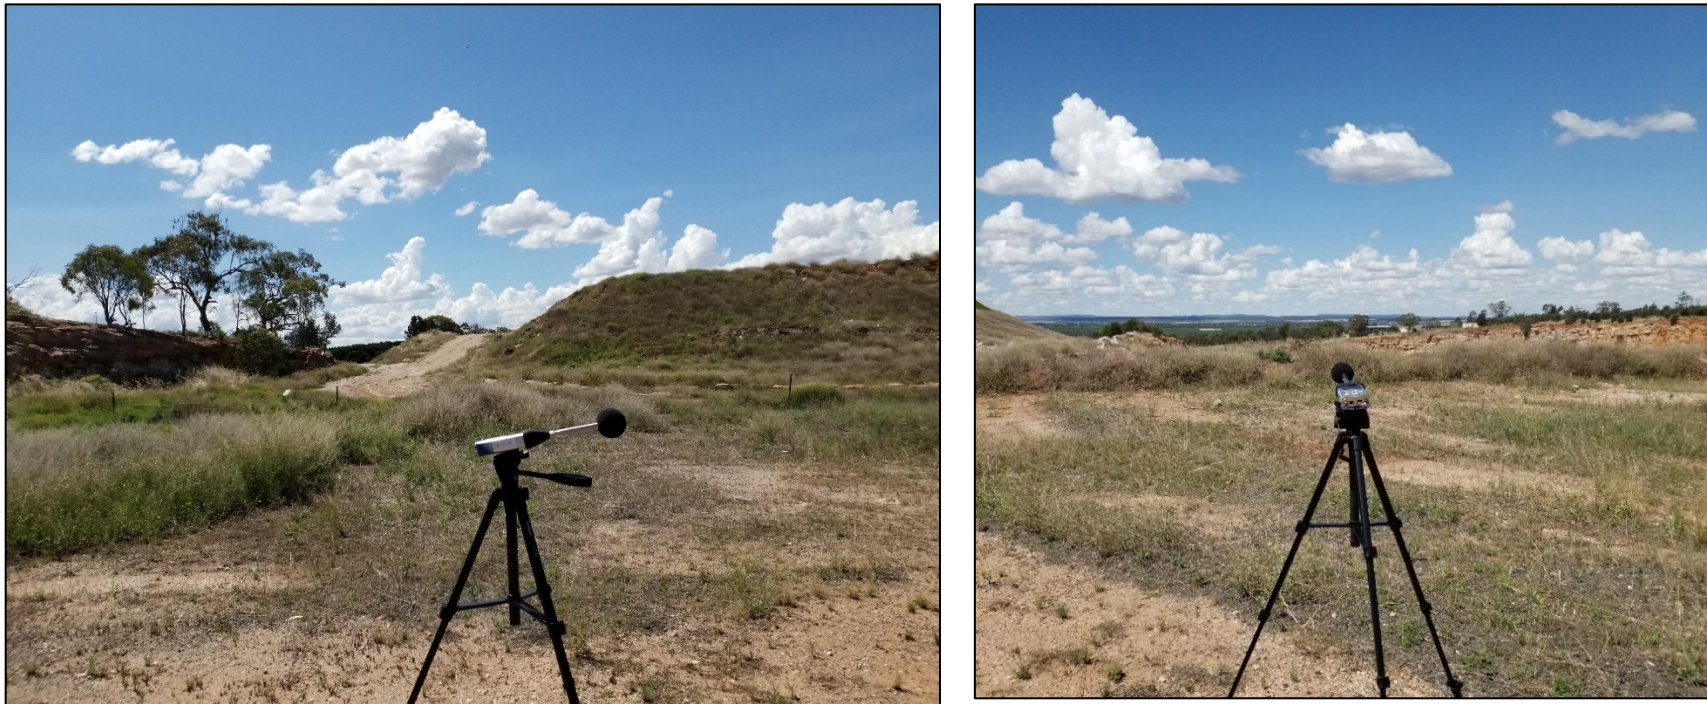
Figure 2-8 Noise monitoring location for Quarry location 2

The noise logger was positioned facing into the quarry, in an easterly direction, approximately 60m from the edge of the quarry (Figure 2-8).

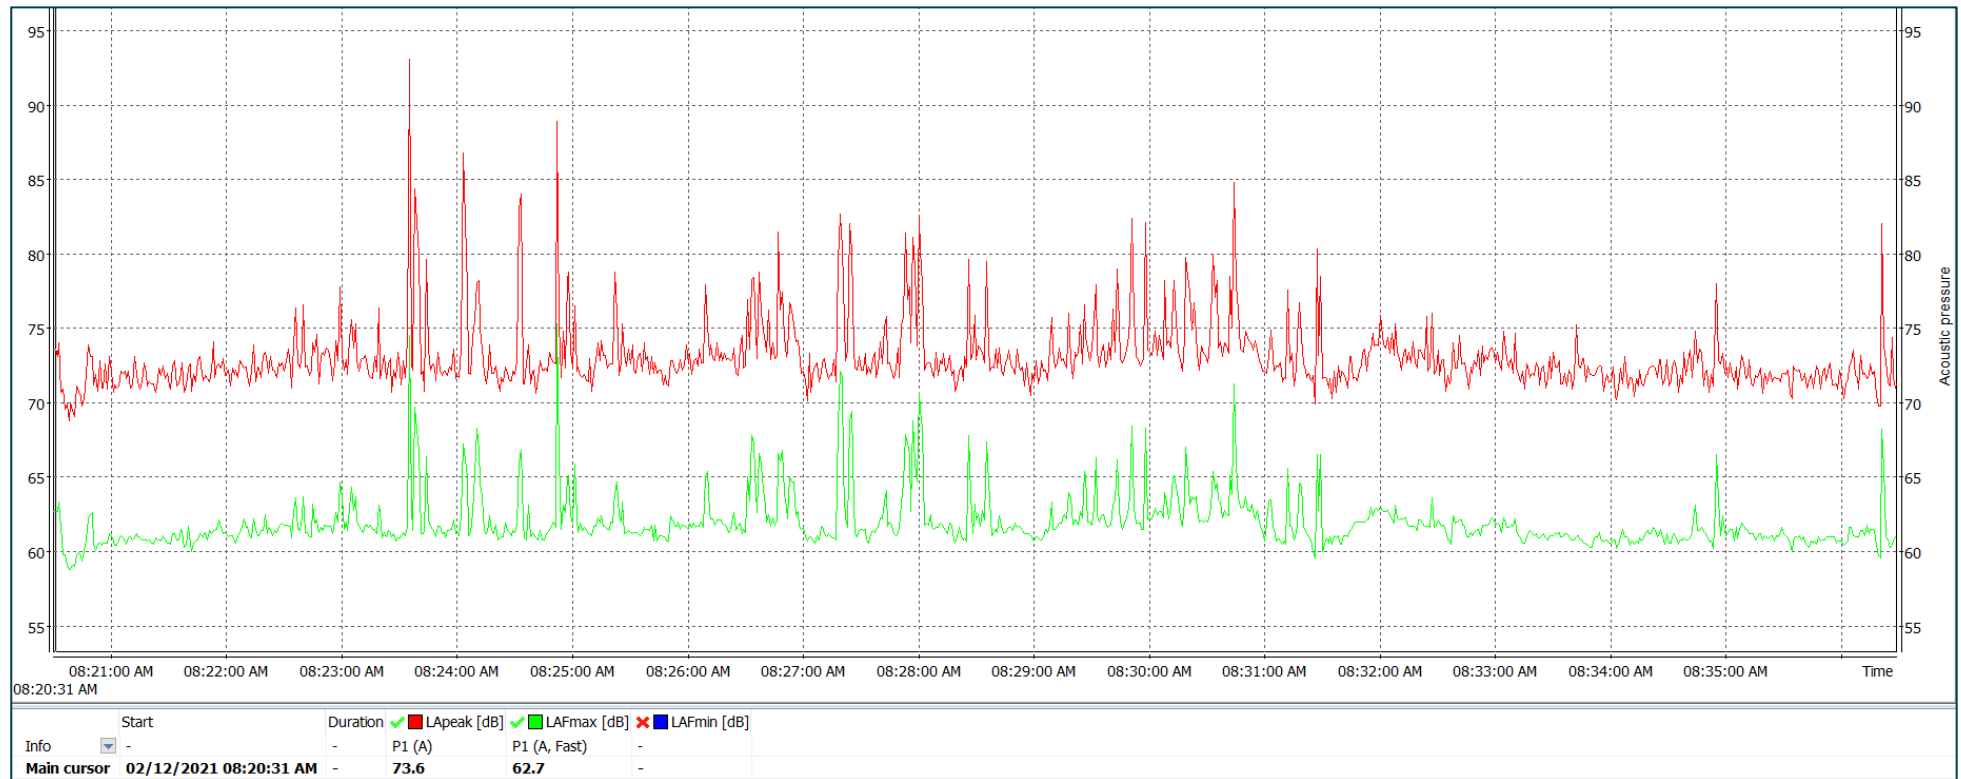
An on-site processing plant, excavator and two light vehicles were observed during the recording periods. At the time of monitoring a number of heavy vehicles arrived onsite to deliver waste and one light vehicle entered and exited the site. Background noises included bird activity. The  $L_{Aeq}$  (15 min) for the monitoring period was 62.7dB, which was above the 35  $L_{Aeq}$  (15 min) assessment criterion.

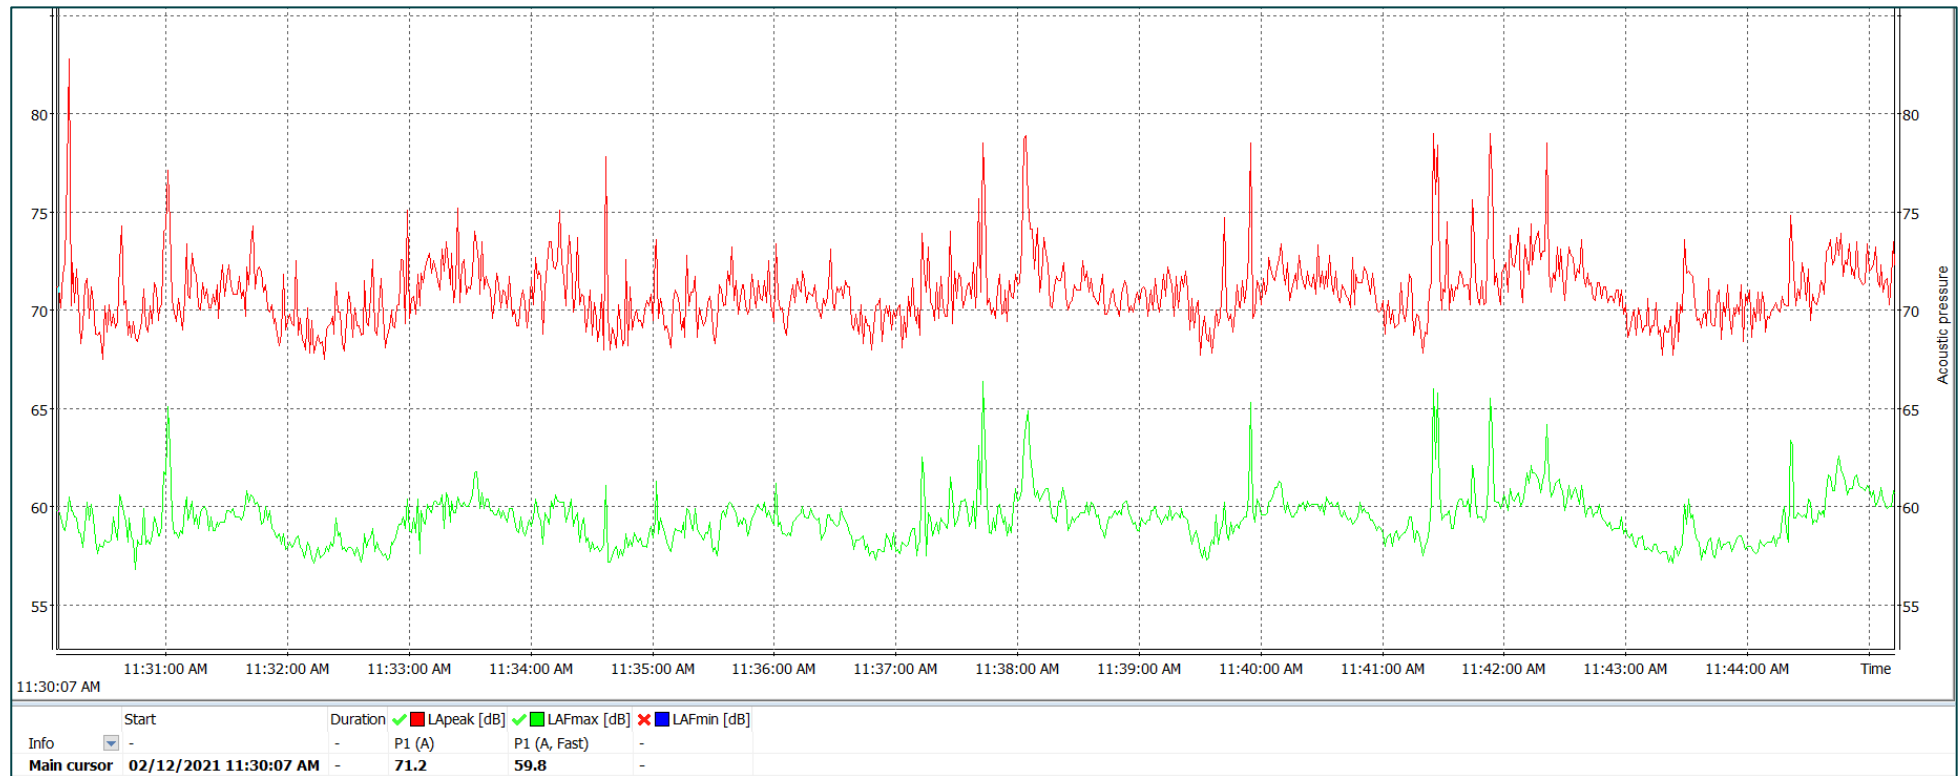
An on-site processing plant, excavator and two light vehicles were observed during the recording periods. At the time of monitoring a number of heavy vehicles arrived onsite to deliver waste. Background noises included bird activity. The  $L_{Aeq}$  (15 min) for the monitoring period was 59.8dB, which was above the 35  $L_{Aeq}$  (15 min) assessment criterion but lower than the midday  $L_{Aeq}$  (15 min) recorded for receiver 1.

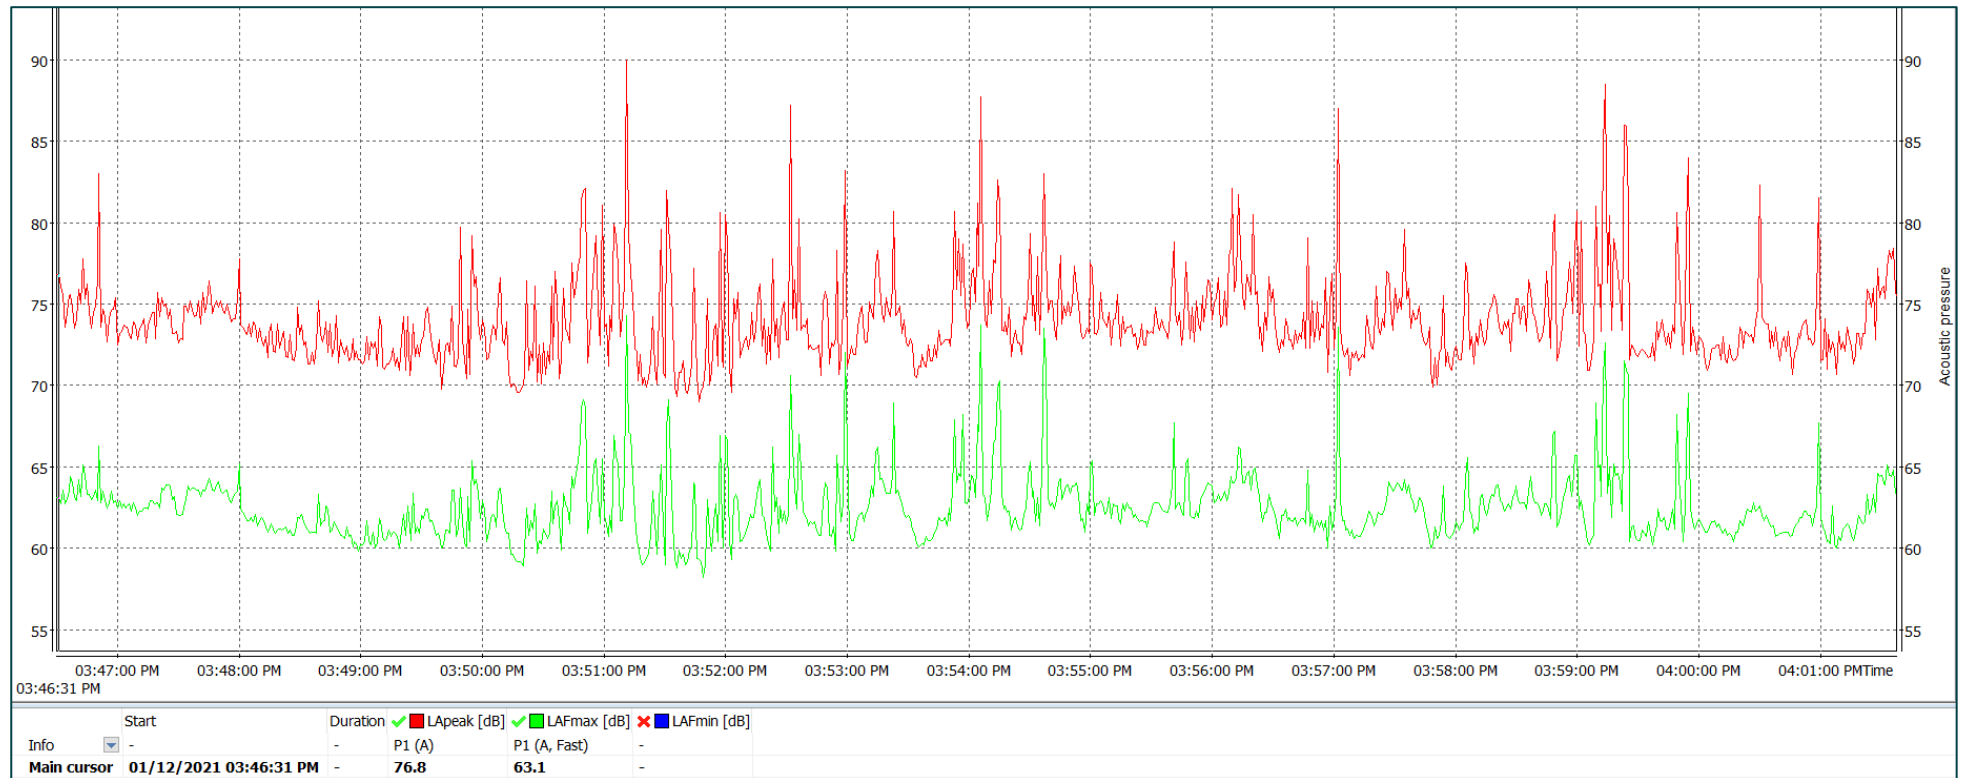
An on-site processing plant, front end loader and two light vehicles were observed during the recording periods. At the time of monitoring one heavy vehicle arrived onsite to deliver waste and one light vehicle entered and exited the site. Background noises included bird activity. The  $L_{Aeq}$  (15 min) for the monitoring period was 63.1dB, which was above the 35  $L_{Aeq}$  (15 min) assessment criterion but lower than the afternoon  $L_{Aeq}$  (15 min) recorded for receiver 1.
