2021 Annual Environmental Management Report

Tharbogang Waste Management Centre

Annual Environmental Management Report 2021

Prepared for: Griffith City Council

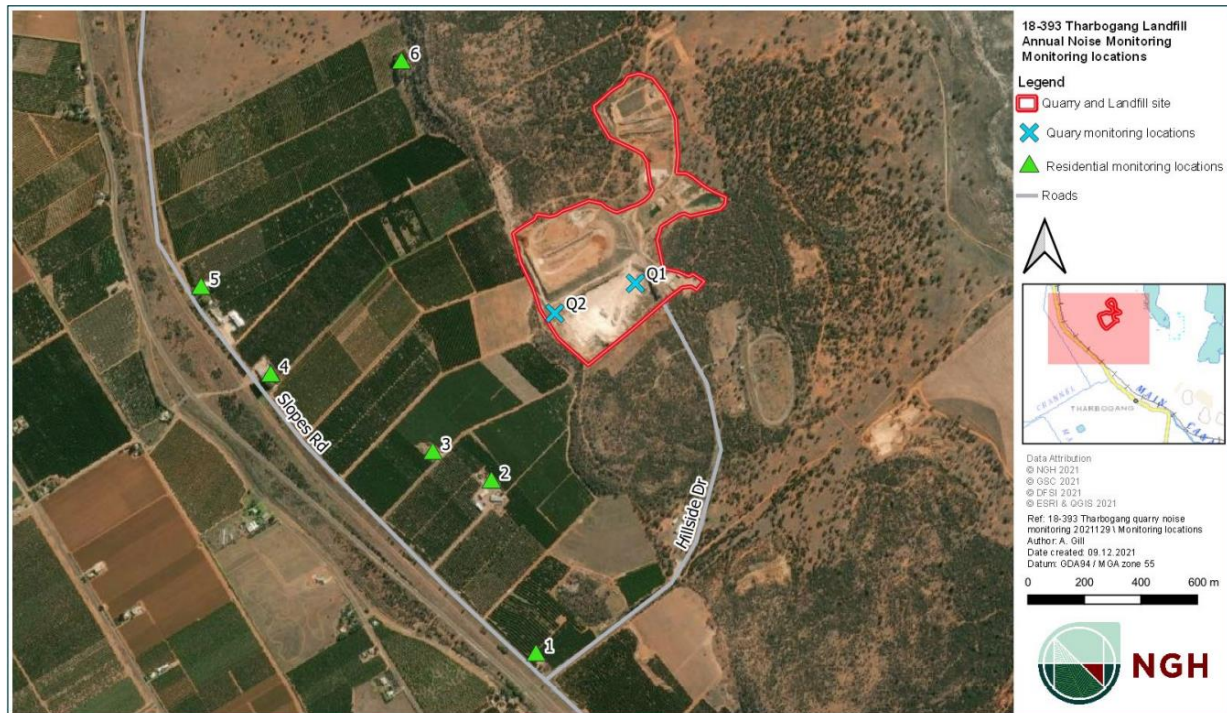
Figure 2.1: Location of noise sensitive receivers (monitoring locations) – taken from NGH 2021b

Noise monitoring of Tharbogang Quarry Operations 18-393 was undertaken by NGH in 2021 using six sensitive receivers in close proximity to quarry operations. Note that while the sensitive receivers are located in the same place as previous surveys, the numerical nomenclature of the receivers has changed since 2020. An additional two sensitive receivers were positioned within the quarry footprint. Monitoring was conducted three times during operating hours on the 1st and 2nd of December 2021. The landfill site and quarry were in operation during the time of the monitoring (NGH 2021b).

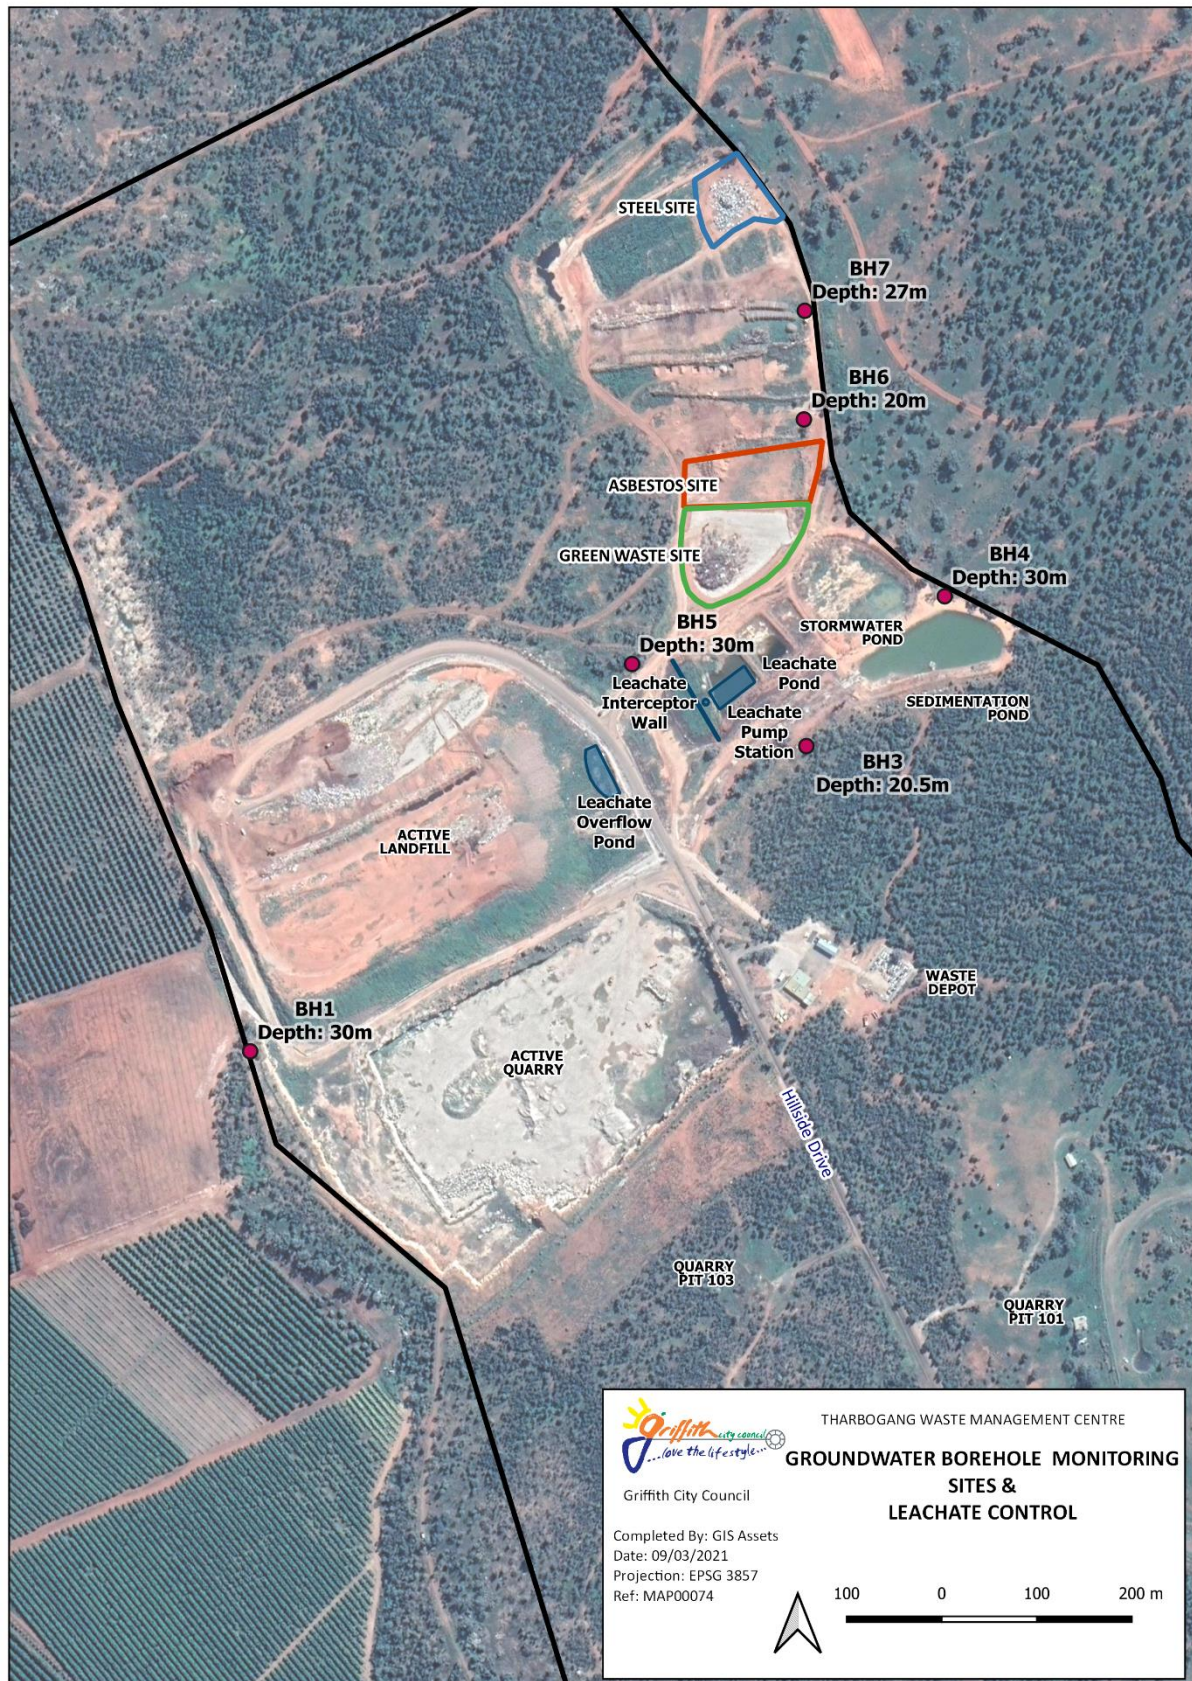
Figure 4.2: Groundwater Borehole Monitoring Sites and Leachate Control

The most significant declines in groundwater level over the drier 2017-18 period occurred in Bore 4 and Bore 5, whereas Bore 6 and Bore 7 recorded higher values. Bore 1 and 3 have remained relatively stable over the last 5 years. Bores 4 and 5 appear most responsive to major rainfall events and indicate a strong connection and rapid recharge of the groundwater within 1-2 weeks. These bores are located adjacent to the sediment pond and main landfill pit respectively. Bore 1, 6 and 7 demonstrate a delayed or minor response of approximately 12 months to rainfall and are therefore predominantly disconnected from surface flows (Stygoecologia 2019).

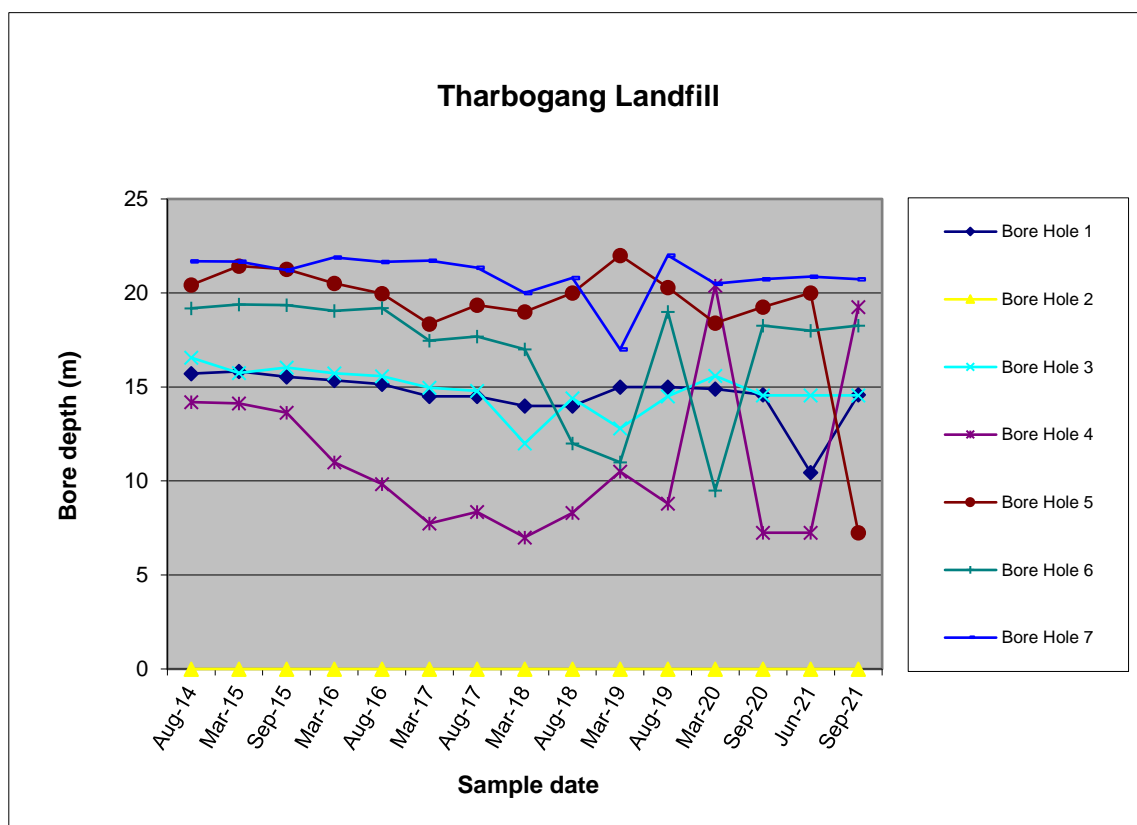
Figure 4.3: Bore water depths recorded for all sites since August 2014.

Monitoring Point	Depth (m)	
	Jun-21	Sept-21
Borehole 1	10.45	14.59
Borehole 2	0.00	0.0
Borehole 3	14.56	14.56
Borehole 4	7.25	19.25
Borehole 5	20	7.25
Borehole 6	18	18.26
Borehole 7	20.87	20.74

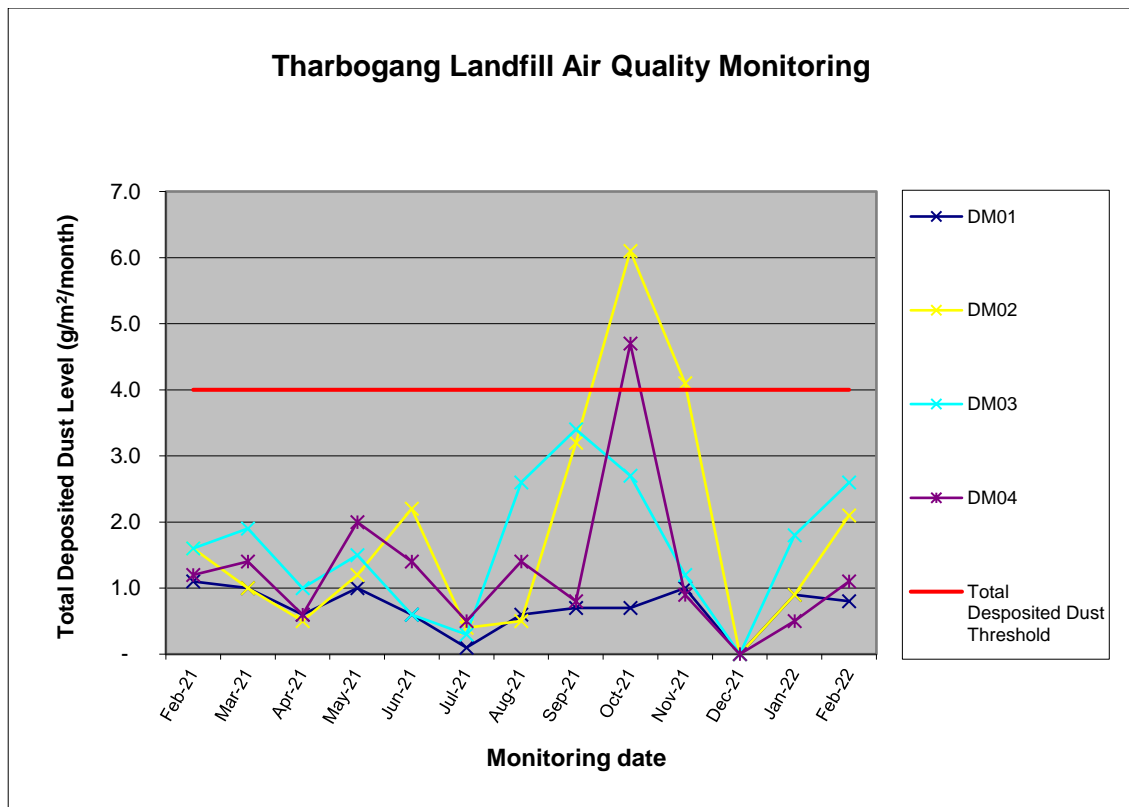
Figure 4.21: Total deposited dust level between February 2021 and February 2022.

The data indicates that no exceedances of the average annual criteria were observed at any of the dust deposition gauges during the 2021 monitoring period. Based on the requirements of section 4.1 of the AQMP, Northstar Air Quality (2021) recommends that annual dust monitoring at the Tharbogang Recycling and Waste Disposal Centre may cease.

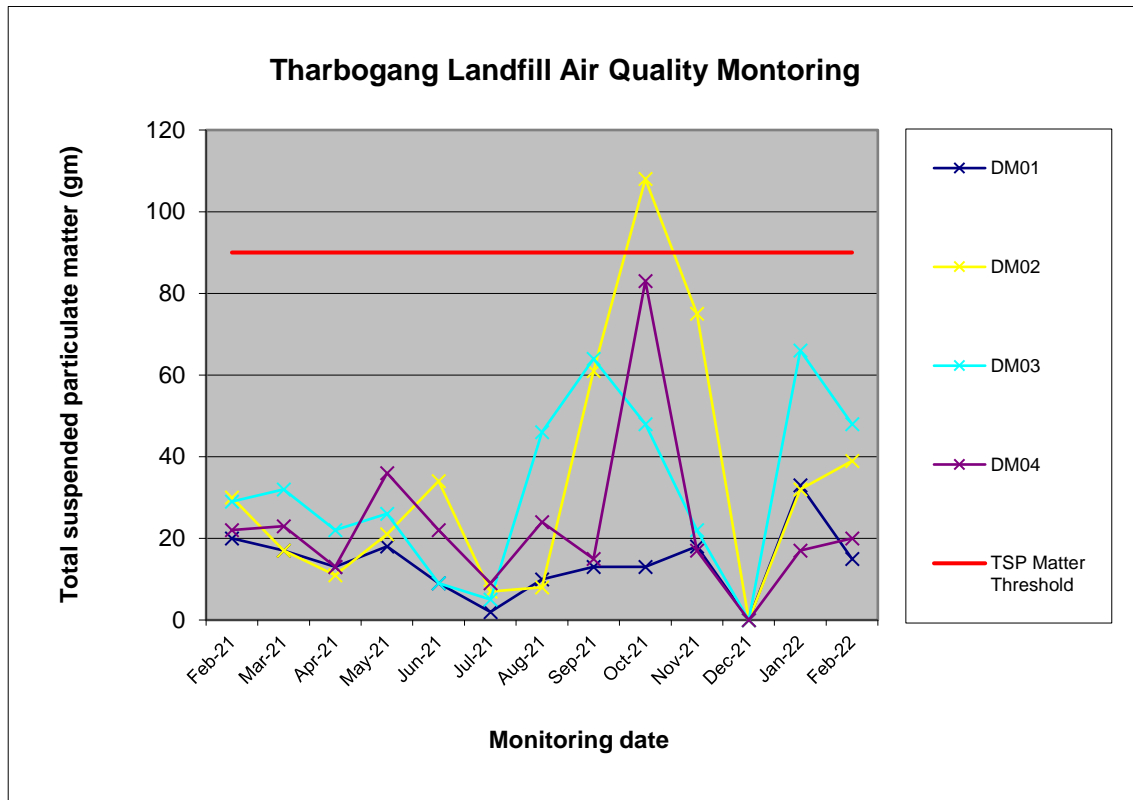
Figure 4.22: Total suspended particulate matter between February 2021 and February 2022.

Total suspended particulate matter (gm) was above the 90 gm threshold at DM02 in October 2021. This is indicated in red in **Table 4.26**. This was the only occurrence where total suspended particulate matter exceeded the recommended threshold during the 2021 monitoring period at any monitoring location. This result is an improvement compared with the previous monitoring period, where TSP matter exceeded the threshold at monitoring site 2, 3 and 4. Council may wish to consider performing an update to the AQMP, in consultation with DPE, to align the criterion averaging period applied to monitoring data to that outlined within the CoA (Northstar Air Quality 2019).

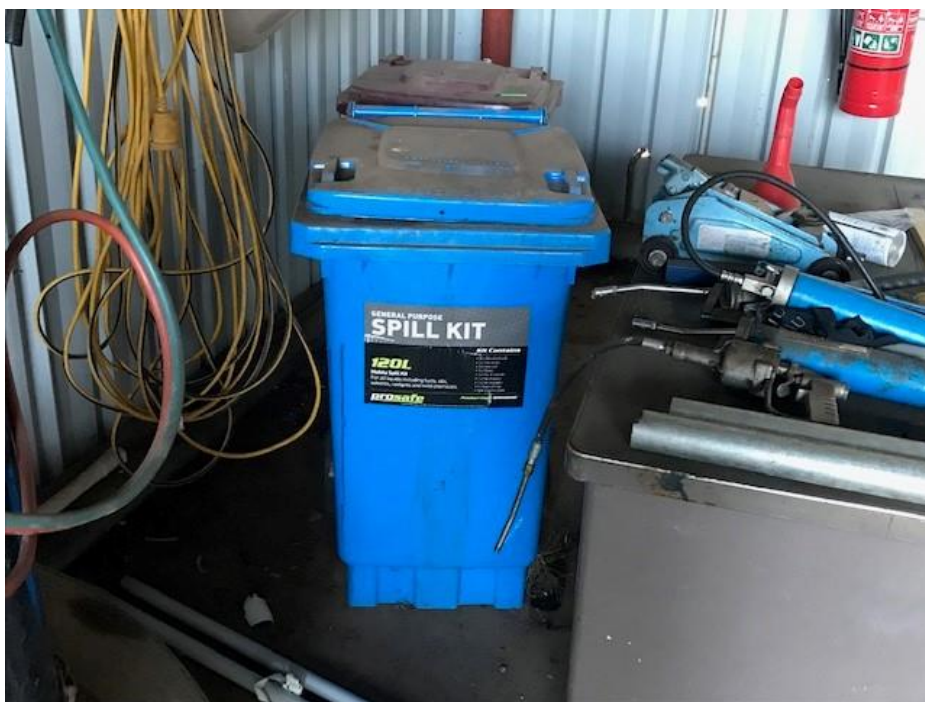
Figure 4.24: General purpose spill kit located in the landfill workshop.

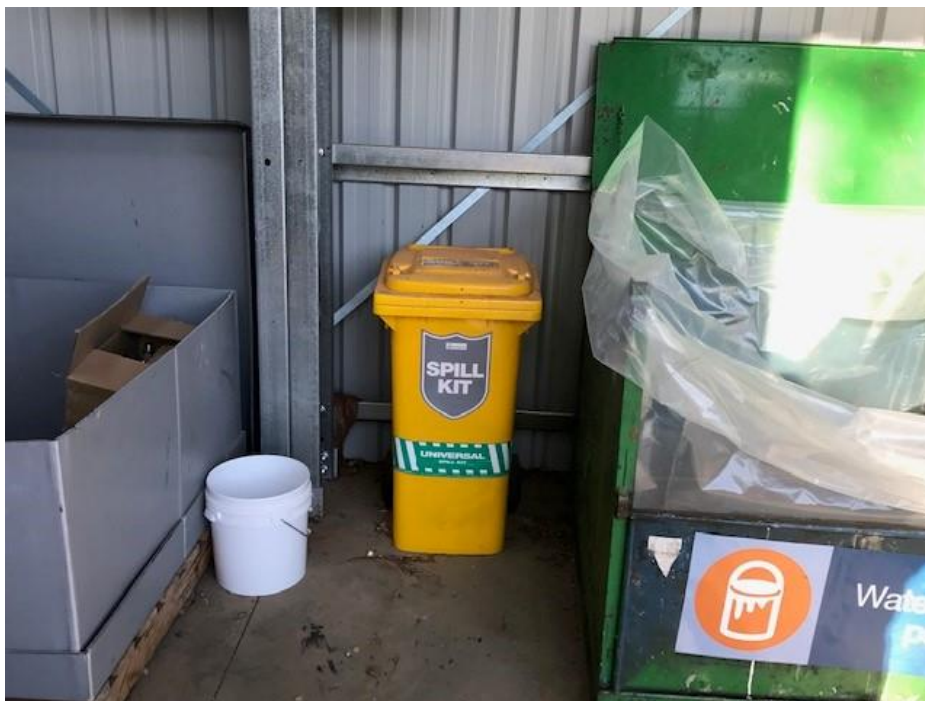
Figure 4.25: Universal spill kit located within the waste transfer station.

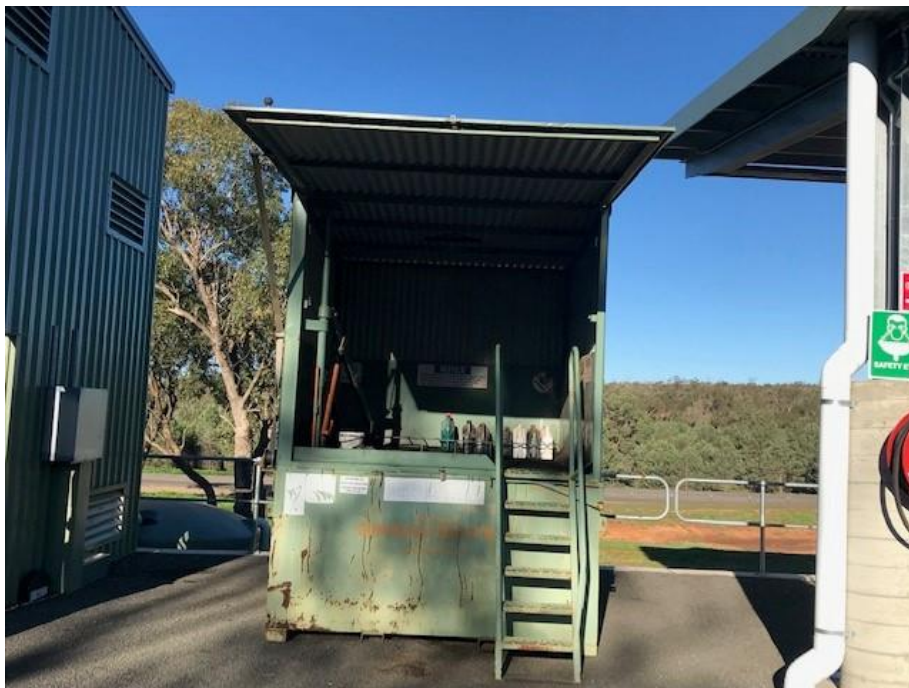
Figure 4.28: Bunded storage shed on site.

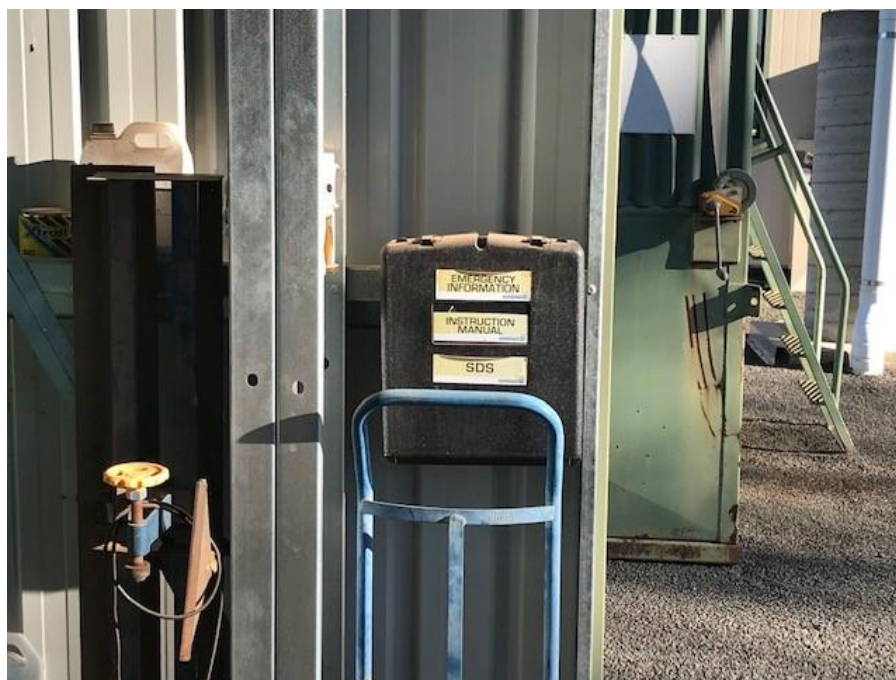
A Pollution and Incident Response Management Plan has been developed for the site (Griffith City Council 2018a). Dangerous goods and hazardous materials on site are managed via diesel bunds, spill kits and bunding around the storage of chemicals and fuels. Spill kits are located inside the landfill workshop (**Figure 4.24**) and at the waste transfer station (**Figure 4.25**). Diesel fuel is stored in an open location in a self-bunded 4000L storage tank on a concrete bund (**Figure 4.26**). Bunds are also utilised for battery storage and chemical storage (**Figure 4.27** and **Figure 4.28**) on site. Chemicals used on site are stored in coloured and clearly signed cabinets within the landfill workshop (**Figure 4.29**). Additionally, there is a MDS folder kept on site, which contains the technical details (safe handling procedures, spill clean-up and disposal) of all the chemicals which are held on site (**Figure 4.30**).

Figure 4.30: MDS folder located on site.
